# Optical Properties of Thomson Scattering Diagnostics Lower Window Glass under Laser Irradiation

**Citation:** Zhou, J.; Zang, Q.; Zhao, J.; Xiao, S.; Che, Y.; Ren, M. Optical Properties of Thomson Scattering Diagnostics Lower Window Glass under Laser Irradiation. *Materials* **2021**, *14*, 2702. <https://doi.org/10.3390/ma14112702>

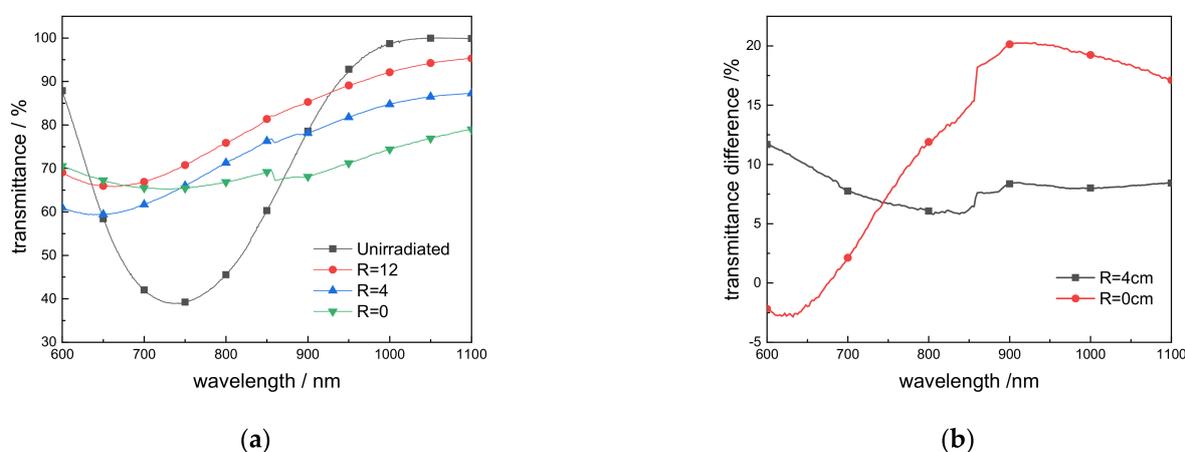
**Figure 3.** (a) Transmittance at glass  $R = 0$  cm,  $R = 4$  cm,  $R = 12$  cm and unirradiated coated glass; (b) Transmissivity difference  $\Delta T = (T_{R=12} - T_i) / T_{R=12}$ .  $i = 0$  cm, 4 cm.

Compared with the 99.99% transmittance of the intact coated glass at 1064 nm, after long-term experiments, the edge of the window glass ( $R = 12$  cm) still had 94.62% transmittance at 1064 nm. At the middle position ( $R = 4$  cm), the transmittance dropped to 86.79%, while it was only 77.61% at  $R = 0$  cm. Compared with the intact coated glass, the transmittance difference at the edge position ( $R = 12$  cm) was 5.44%, while it was 13.26% at the middle position ( $R = 4$  cm) and 22.43% at the center position ( $R = 0$  cm), showing that the transmittance has decreased to varying degrees. At the same time, the differences in transmittance between the center position  $R = 4$  cm and the center position  $R = 0$  cm compared to the edge position were 8.26% and 17.97%, respectively.

As shown in Figure 1, when the laser is transmitted to the front of the lower window glass, its average energy is 2.4 J. When the glass film layer maintains a transmittance of 99.999%, 2.4 J energy can completely enter the vacuum chamber, but after the film layer is damaged, when the transmittance drops to 77.61%, the laser energy is only 1.862 J. When the electron temperature inside the device is 5 keV, the Thomson scattering spectrum formed after the laser enters the vacuum chamber after the film is intact and damaged is shown in Figure 4. It means that the resulting density measurement error exceeded 20%, which substantially impacted the diagnostic accuracy.

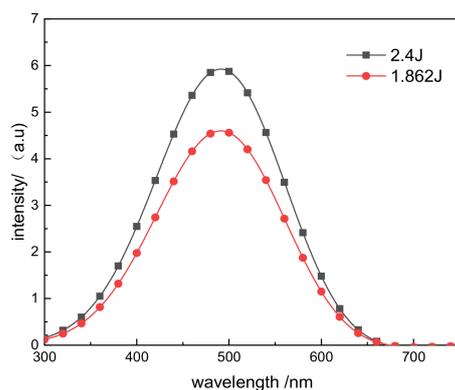
**Figure 4.** Thomson scattering spectrum generated by the laser when the coating was intact versus damaged.

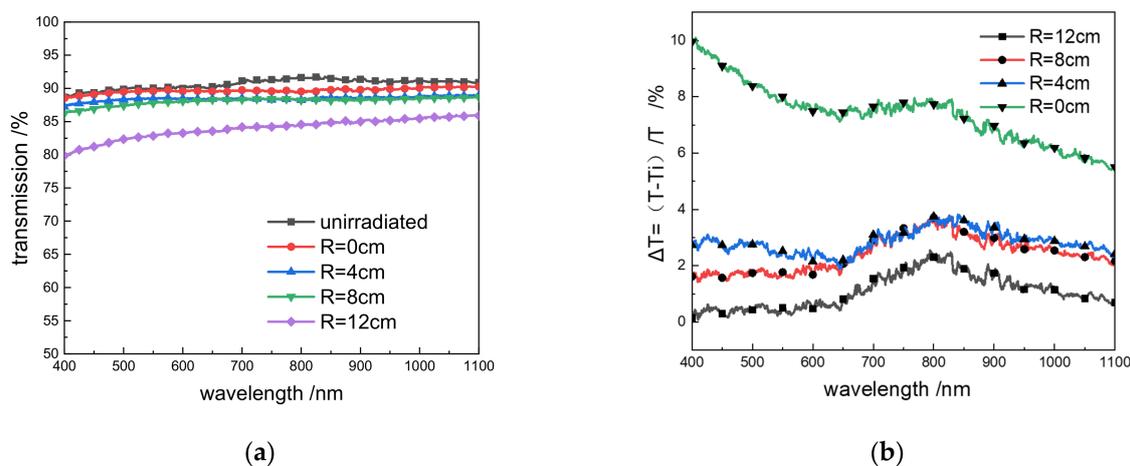
**Figure 5.** (a) After polishing,  $R = 0$  cm,  $R = 4$  cm,  $R = 8$  cm,  $R = 12$  cm and the transmittance of unirradiated glass after polishing; (b) The ratio of the transmittance between different positions of the glass and the unirradiated glass  $\Delta T = (T - T_i)/T$ ,  $T$  is the transmittance of unirradiated glass.

It can be seen from Figure 5 that, after polishing, the 600–1100 nm transmittance curve became flat, and the overall glass transmittance decreased, and the visible light band dropped significantly, indicating that the glass was exposed to radiation and laser irradiation. The absorption in the visible light band increased. At a laser wavelength of 1064 nm, compared with the 91.06% transmittance of the uncoated new window glass, the transmittances at  $R = 0$  cm,  $R = 4$  cm,  $R = 8$  cm, and  $R = 12$  cm were 85.86%, 87.24%, 88.66%, and 90.23%, respectively, decreasing by 0.9%, 2.25%, 2.63%, and 5.71%. Thus, the drop in the glass transmittance increased as the sample position was closer to the center.

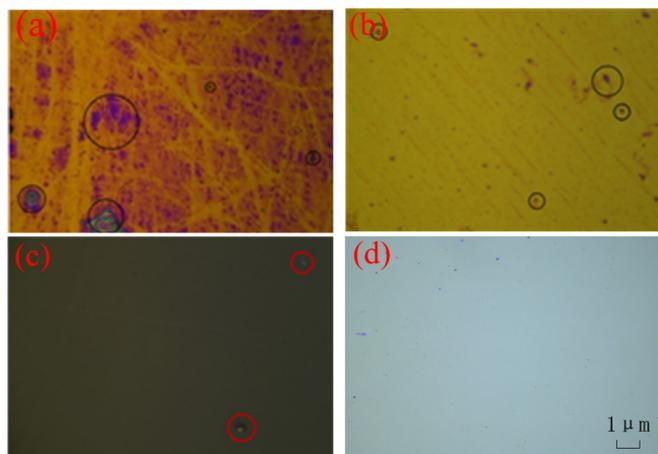
Figure 6 shows the glass surface under a high-magnification microscope. At the center, large ablation marks and surface contamination were observed, while relatively small contamination was found at  $R = 4$  cm. At  $R = 8$  cm and  $R = 12$ , almost no scars or contamination was obtained. It shows that the dense laser beam caused serious ablation

damage on the surface of the  $\text{HfO}_2$  film, and a certain degree of contamination appeared on the surface of the film. However, no obvious scars or contamination were found in the locations that received less laser radiation.

**Figure 6.** Glass surface at different positions under the microscope: (a)  $R = 0$ ; (b)  $R = 4$ ; (c)  $R = 8$ ; (d)  $R = 12$ .

Under the influence of device radiation and impurities, the performance of the film also decreased to a certain extent. The deposition of carbon impurities inside the EAST device strengthens the film absorption and strengthens the film damage. To reduce the damage of the film, strengthening the cleaning of carbon impurities in the divertor can be effective, extending the service life of the film.

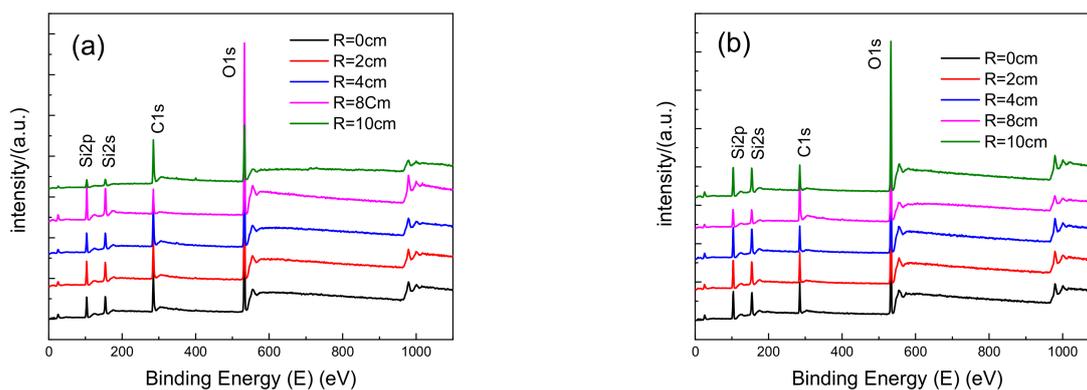
To further analyze the composition of the contaminants on the film surface, five locations with an interval of 2 cm from the center to the edge were equidistantly selected for XPS analysis. Figure 7 shows the XPS energy spectra of the (a) upper and (b) lower glass surfaces. Most contaminants on the glass surface were C-based. The source of the impurity was the lower divertor in the EAST device. Due to the plasma discharge, the plasma hit the lower divertor, causing it to produce C impurity. The impurity fell on the glass surface through the lower neck tube and then passed for a long time. The laser was irradiated to deposit the C element on the glass surface.

**Figure 7.** XPS analysis (a) of the upper surface, (b) underneath the surface.

The XPS surface analysis and the surface content ratio showed that at the same location, the upper surface C element content was higher than that underneath the surface (Table 3). As the glass sample position got closer to the center, the surface C ratio and content increased. The closer the upper surface was to the center, more C elements were deposited on the surface of the film. At the same time, the content of C elements in different positions showed randomness. As the main environmental pollution factor, C impurity is deposited on the surface of the film under the action of the laser, which increases the absorption capacity of the film surface to the laser, deepens the accumulated damage to the film, and causes the film performance to decline rapidly.

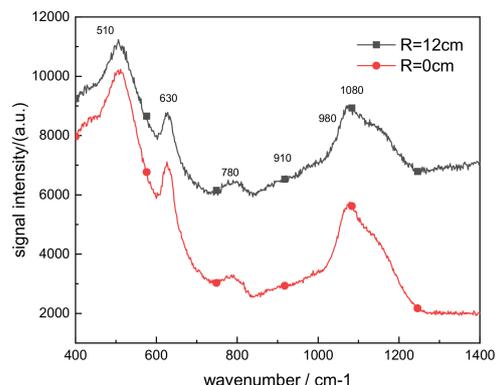
Figure 8 shows the Raman spectra at the center of the glass at  $R = 0$  cm and the edge at  $R = 12$  cm. The peak positions at the edge and center were almost the same, but their intensities were slightly different. From the front position and intensity, it can be seen that the peak position shift of  $510\text{ cm}^{-1}$  Si–O–Si is the result of receiving laser and environmental radiations [13]. Glass is mainly composed of  $\text{SiO}_4$  tetrahedrons,  $\text{BO}_4$  tetrahedrons, cyclic silicon metaborate groups, and a small amount of boron oxygen groups. Among them,  $\text{SiO}_4$  tetrahedrons are mainly connected by single non-bridged groups, and  $\text{BO}_4$  tetrahedrons are connected by hexaborate [14]. The connection mode of  $\text{SiO}_4$  tetrahedrons characterizes the degree of polymerization of the internal network of the glass. The higher the number of bridge oxygen bonds, the higher the degree of polymerization [15,16]. Figure 8 indicates more single non-oxygen bridges taking place in the center position rather than the edge, meaning that the degree of internal polymerization was not high because a large number of point defects are formed inside the glass. Many ring networks of different sizes leading to increased light absorption and decreased glass transmittance were formed.

**Figure 8.** Raman scattering spectra at  $R = 0$  cm and  $R = 12$  cm.

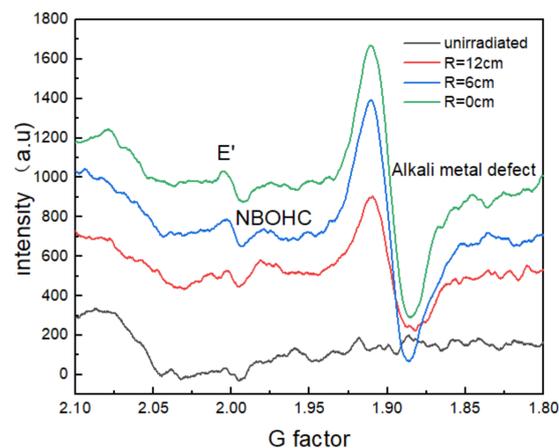
EPR spectroscopy qualitatively analyzes possible defects in the glass. We selected three equidistant positions from the edge to the center of the glass and compared their EPR spectra with that of the nonirradiated glass (Figure 9). According to the  $g$ -factor analysis, at three different positions, compared with the nonirradiated glass,  $E'$  centers ( $\equiv\text{Si}$ ,  $g = 2.0006$ ) and NBOHC ( $g = 2.0093$ ) appeared [17], and a non-bridge formed by the B ion group was formed in the center position. The strong signal front formed at  $g = 1.901$  may originate from point defects formed by alkali metal impurity ions [18], such as  $\text{Na}^+$  and  $\text{Ti}^{4+}$  in the glass under the combined influence of laser and environmental radiation. The defect signal strength at the center position was significantly higher than the edge position, indicating that the center position had more defects than the edge position. This conclusion confirms the larger decrease in transmittance at the center position than that at the edge position.

Figure 9. EPR spectra of nonirradiated and irradiated glass at different positions.

- (2) Under the combined action of radiation, impurities, and the laser, the optical performance of the glass in the middle of the experiment can no longer meet high-precision diagnostic use. It needs to be replaced when the experiment time is about 100 h to avoid influence on the later stages of the experiment.
- (3) Given the electromagnetic radiation environment of the EAST device during the discharge process, choosing a film and glass with a higher laser threshold and better radiation resistance can extend the service life of the glass and restrict the damage of radiation.
