Cause Analysis of the Large-Scale LPG Explosion Accident Based on Key Investigation Technology: A Case Study

ABSTRACT: Blending dimethyl ether (DME) into liquefied petroleum gas (LPG) has become a common phenomenon. On December 3, 2019, an LPG/DME explosion occurred in Beijing, resulting in 4 deaths and 10 injuries. To deeply investigate the cause and explosion process of the explosion accident, the accident investigation method combining on-site inspection, material evidence analysis, experimental verification, and logical reasoning was used. In addition, the location of the ignition point, the explosive substances, the cause of the gas leakage, the process and the distribution characteristics of the gas leakage, and the ignition process were successively reasoned and analyzed in detail. The results show that the LPG/DME-blended gas can effectively corrode silicone flange gaskets, forming laminar fractures and radial cracks on the gasket. As a result, the tensile strength of the gasket decreased. Under the action of the gas pressure inside the pipeline, the gasket was torn and a leakage hole was formed. The leaked combustible gas formed at least 305 m³ of the explosive gas mixtur

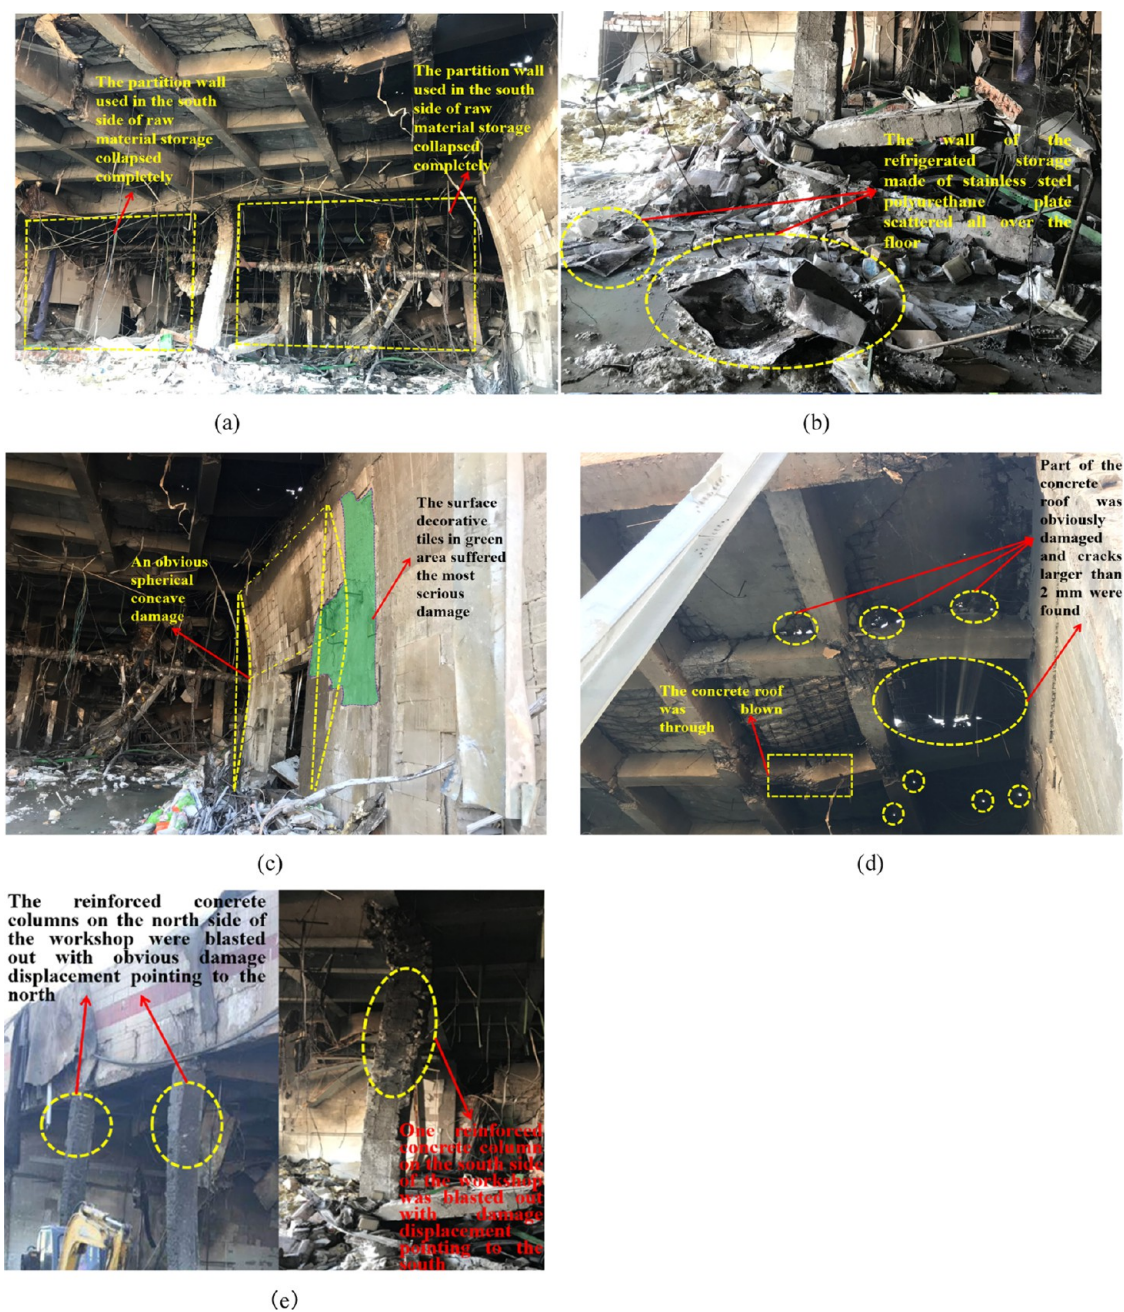
- (1) The 240 mm thick perforated brick partition wall used in the inner side of the gas cylinder room and south side of the raw material storage collapsed completely, as shown in Figure 4a.

- (2) The 370 mm thick perforated brick external wall on the north side of the gas cylinder room, refrigerated storage, and cold springhouse collapsed completely.

- (3) The refrigerated storage made of stainless steel polyurethane plate was the most seriously damaged, most of the polyurethane burnt out, as shown in Figure 4b.

- (4) The reinforced concrete wall on the west side of the explosion site was blasted out with an obvious spherical concave, its center height was about 3 m, and some cracks larger than 2 mm appeared on this wall, as shown in Figure 4c.

- (5) The reinforced concrete roof of the refrigerated storage was obviously damaged and cracks larger than 2 mm were found. The roof near the west wall suffered the most serious damage, specifically, the roof was blown through and a lot of steel bars were exposed, as shown in Figure 4d.

- (6) Two reinforced concrete columns on the north side of the explosion site were blasted out with obvious damage displacement pointing to the northeast, and one reinforced concrete column on the south was blasted out with damage displacement pointing to the southeast, as shown in Figure 4e.

Figure 4. Damage condition of the main explosion area. (a) Perforated brick partition wall on the south side; (b) stainless steel polyurethane plate around the refrigerated storage; (c) reinforced concrete wall on the west side; (d) reinforced concrete roof; and (e) reinforced concrete columns.

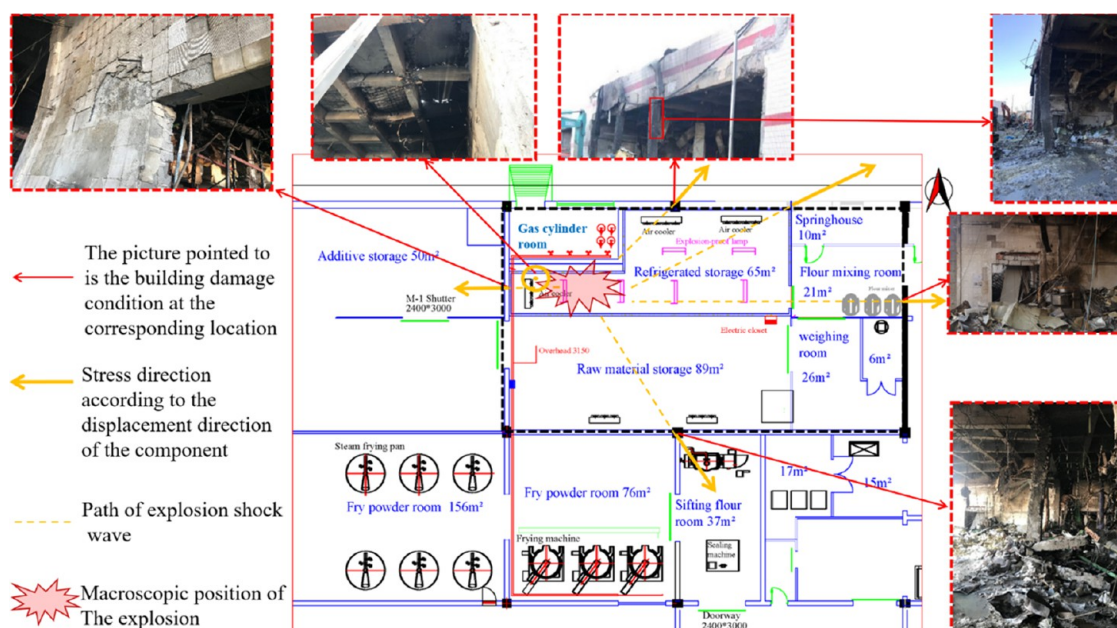
Figure 5. Characteristics and distribution of damage traces of components with strong compression resistance at the explosion site.

The stress directions of the components can be determined according to the damage traces and displacement directions of the reinforced walls on the east and west sides of the refrigerated storage, the two reinforced columns on the north side of the refrigerated storage, and one reinforced column in the center of the south side of the raw material storage. In [Figure 5](#), the stress directions of the abovementioned components were marked using yellow arrows. By drawing the reverse extension lines (yellow dotted lines) for the stress directions, the intersection range of multiple reverse extension lines was obtained. Therefore, it was determined that the macroscopic location of the ignition point was on the west side of the refrigerated storage. Furthermore, the point with maximum damage displacement on the reinforced wall on the west side of the refrigerated storage was about 3 m. It can be seen from [Figure 4d](#) that the decorative tiles around this height fell most seriously. In addition, this location was consistent with the height of the ceiling of the refrigerated storage. Therefore, the vertical location of the ignition point can be determined. In summary, it was determined that the ignition point of the gas explosion was near the ceiling on the west side of the refrigerated storage.

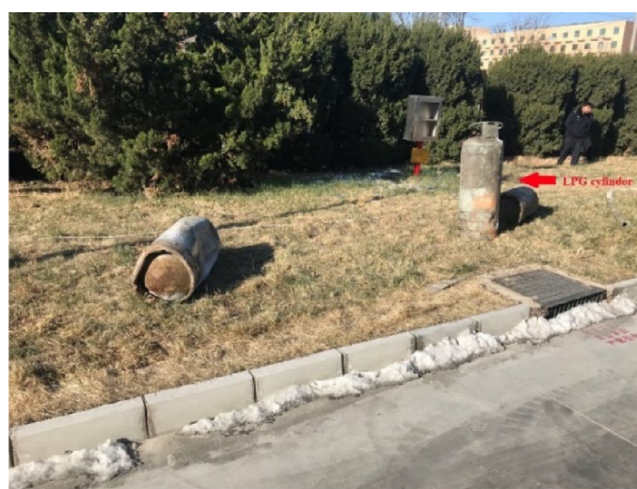
2.2.2. Determination of the Explosive Substance Based on Analysis and Identification of Material Evidence. There was a gas cylinder room at the explosion accident site. At the time of the incident, four 50 kg LPG cylinders were stored in the gas cylinder room at the same time. [Figure 6](#) shows the LPG cylinders that were damaged after the explosion. At the same time, there were three LPG stir-frying machines in the stir-frying powder room connected to the gas cylinders through the gas pipeline, as shown in [Figure 7](#). According to the surveillance video and the survivors' testimony, around 23 min before the accident, many workers on site smelled "gas"—the smell of tetrahydrothiophene in fact, which confirmed the leakage and the presence of LPG.

Figure 6. LPG cylinders after the explosion (damaged).

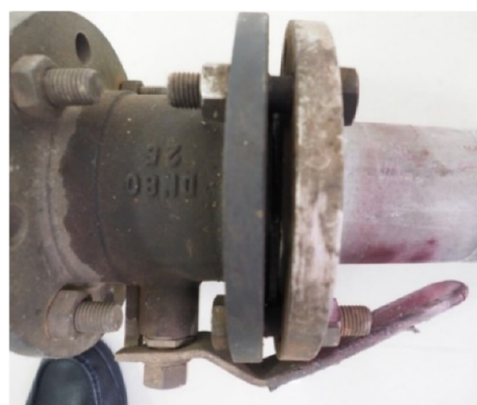
2.3.2. Flange Connections and the Medium Resistance Test on Flange Gaskets. As for the connection and installation of flanges, the two flanges used in the pipeline were both 8-hole flanges (temporarily named flange A and flange B), and both flanges A and flange B were equipped with only four sets of M16 bolts. In addition, no spring washer was used when tightening the bolts, and for both flange A and flange B, two sets of bolts were loose. The connection condition between the ball valve and the flange is shown in Figure 11.

Figure 11. Connection condition between the ball valve and the flange.

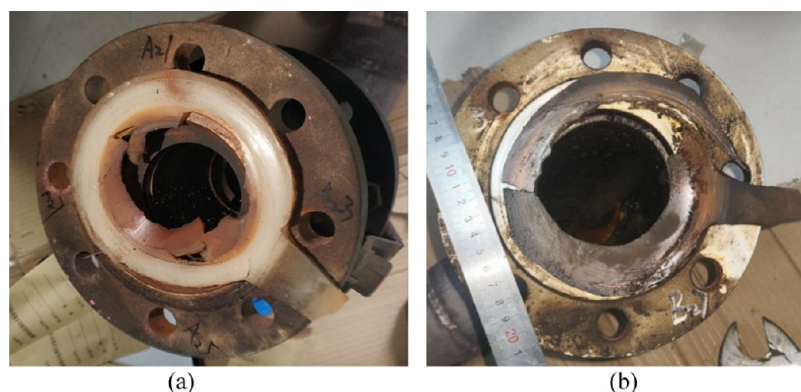
Two flange gaskets (flange gasket A and flange gasket B) were removed from the explosion site. The original condition of the gaskets is shown in Figure 12. Overall, the condition of flange gasket A was slightly better than that of flange gasket B. In addition, flange gasket B was severely corroded and there were two obvious fractures. As for the concentricity of the

Figure 12. Flange gaskets: (a) flange gasket A and (b) flange gasket B.

gaskets, there was no locating slot between the gaskets and the flanges. The compressed area of flange gasket A had a good concentricity, while the compressed area of flange gasket B had a large eccentricity. As for the thickness of the gaskets, flange gasket A was 1.62 mm thicker than flange gasket B on average. When tightening, the compression of flange gasket A was higher and the sealing effect of flange gasket A was better than that of flange gasket B.

As shown in Figure 12, the crack on the right side of flange gasket B conformed to the characteristics of a long-term corrosion crack, and the location of the leakage hole was directly facing the access hole of the refrigerated storage. The crack on the left side of flange gasket B was relatively new and there was no obvious evidence of corrosion along the crack. The crack on the left side did not conform to the characteristics of a long-term corrosion crack. This was because after the crack on the right side fractured and leaked, the corresponding location on the left side of the gasket was subjected to a large torque generated by the gas ejection and it was twisted and fractured.

Some materials were selected from flange gaskets A and B and sent to China National Tyre Quality Supervision and Inspection Center for testing. The test results showed that the materials of both flange gaskets A and B were methyl vinyl silicone rubber. At the same time, it was detected that both the outer parts and the inner parts of the gaskets contained DME, which indicated the long-term leakage of the blended gas.

In summary, the laminar fractures or radial cracks were formed on the nonstandard flange gaskets under the long-term swelling and corrosion effects of nonstandard LPG, resulting in a decrease in the mechanical strength (such as the tensile strength) of the gaskets. In addition, under the action of the gas pressure inside the pipeline, the gasket was torn and a leakage hole was formed, causing a gas leakage. The spatial location of the failed flange gasket is shown in Figure 13. The flange gasket was located exactly in the space between the refrigerated storage and the gas cylinder room, and its height was consistent with the height of the access hole.

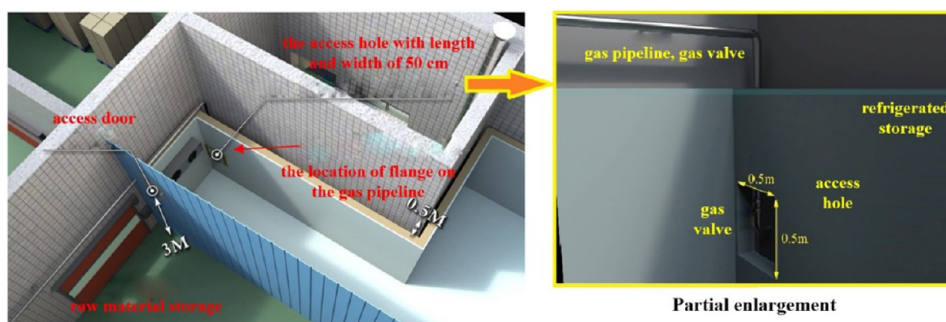
Figure 13. Spatial location of the leakage hole.
