Role of computed tomography in determining the choice of treatment for delayed ceramic acetabular liner fracture: A case report

Ferdi Dirvar

Department of Orthopedics and Traumatology, Metin Sabancı Baltalimanı Bone Diseases Training and Research Hospital, Istanbul, Turkey

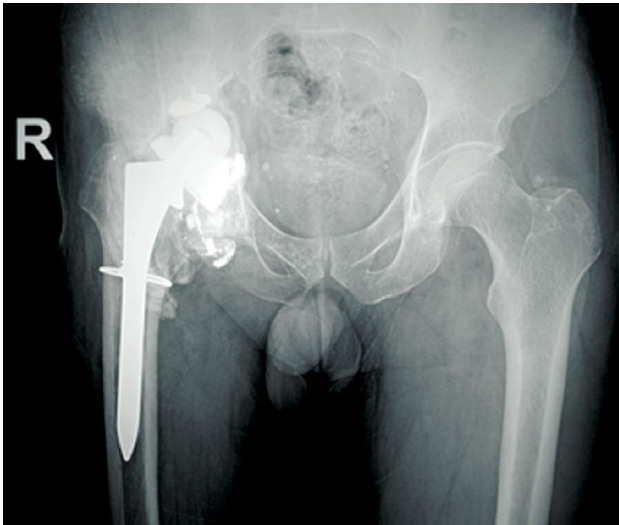
A 50-year-old male patient was admitted with complaint of pain at the right hip and also limb length shortening. A total right hip prosthesis had been applied in 2012 in another medical center. Patient had a traumatic event in 2014 and after examination and a proper X-ray imaging, acetabular liner fracture was diagnosed. Patient refused the choice of revision hip arthroplasty and continued full weight bearing for three years. In 2017, the patient was accepted to our hospital whose pelvis anteroposterior X-ray visualized a catastrophic acetabular component failure (Figure 1). A written informed consent was obtained from the patient.

FIGURE 1. A 50-year-old male patient with untreated acetabular liner fracture. On pelvis anteroposterior radiograph, catastrophic failure of acetabular component can be observed.

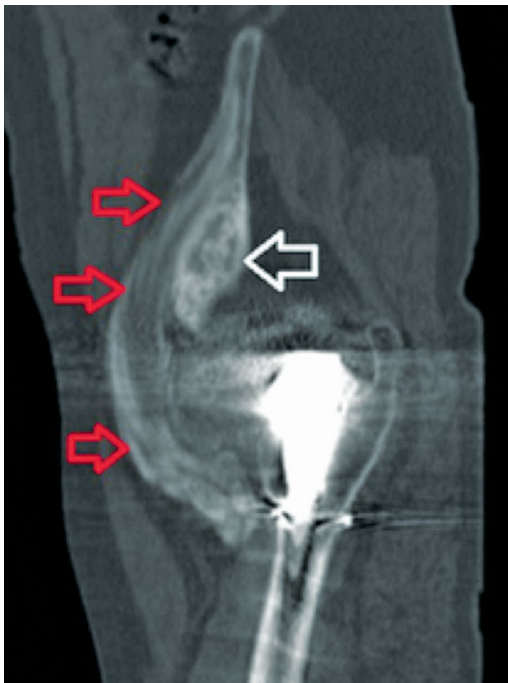
muscle's proximal portion neighboring to iliopsoas muscle's distal portion. Same high-density amorphous morphological sites were visualized inside the iliac bone at periacetabular region (Figure 2). We evaluated these amorphous high-density sites with patient's clinical information as metallosis components. On CT images, we applied "whiting out" (window level 2,500 HU and width 7,000 HU); then, tissues affected by metallosis became less visible while ceramic fragments could be seen more clearly (Figure 3). We detected an oval defect at the superomedial portion of the acetabular shell and femoral head protrusion through acetabular shell component. Also, there were local resorption bone sites at the acetabular roof's medial and lateral contours. Through the resorption site, we could see the marked protrusion of the head of the prosthesis to iliac fossa. There were multiple high-signal-density particles 1 cm largest in size located at medial and inferior to right hip joint and at the acetabular roof and its medial border indicating ceramic fragments. Also, we could see the same high-signal-density millimetric particles anterior to right hip joint in less numbers (Figure 4).

FIGURE 2. Metallosis distribution in iliopsoas muscle (red arrows) and iliac bone (white arrow) in periacetabular region is demonstrated on sagittal computed tomography image.

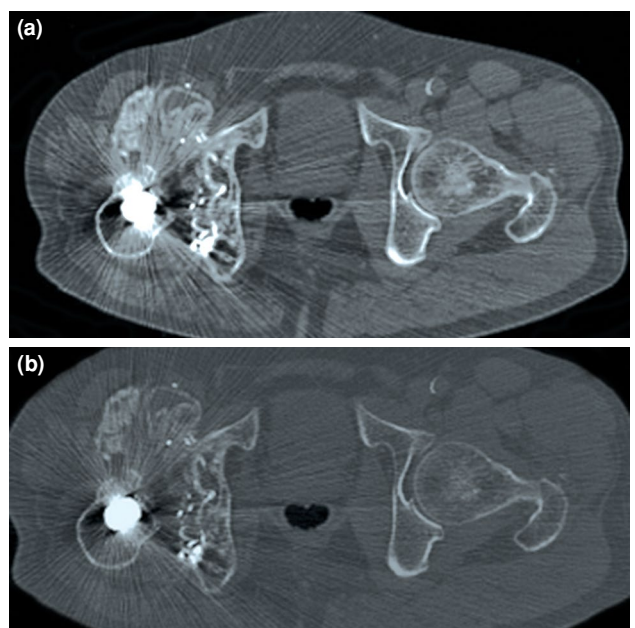
FIGURE 3. (a) Amorphous high-density sites can be observed on rectus femoris muscle's proximal portion and hip joint space in axial views. (b) After application of whiting out technique, ceramic fragments can be seen more clearly on computed tomography image.

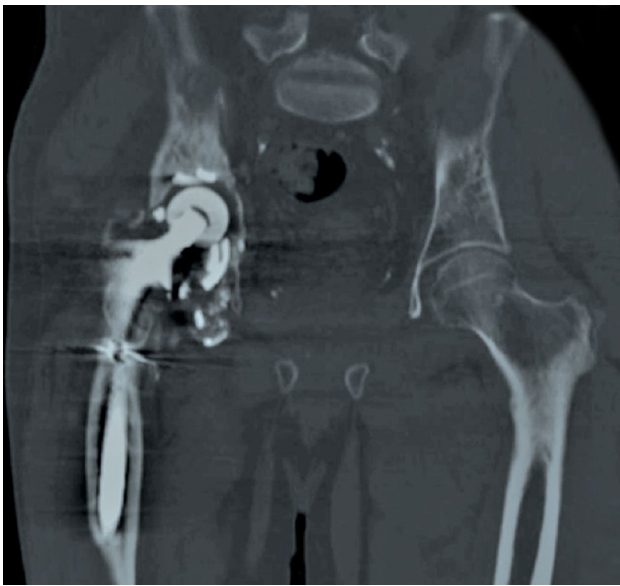
FIGURE 4. Femoral head protrusion through acetabular shell component is observed and ceramic fragments can be readily seen in acetabular roof region in coronal computed tomography image of right hip.

At preoperative planning based on CT imaging, we concluded that it would not be possible to clean out all the ceramic debris particles safely. Thus we decided to use ceramic on ceramic bearing surface revision hip

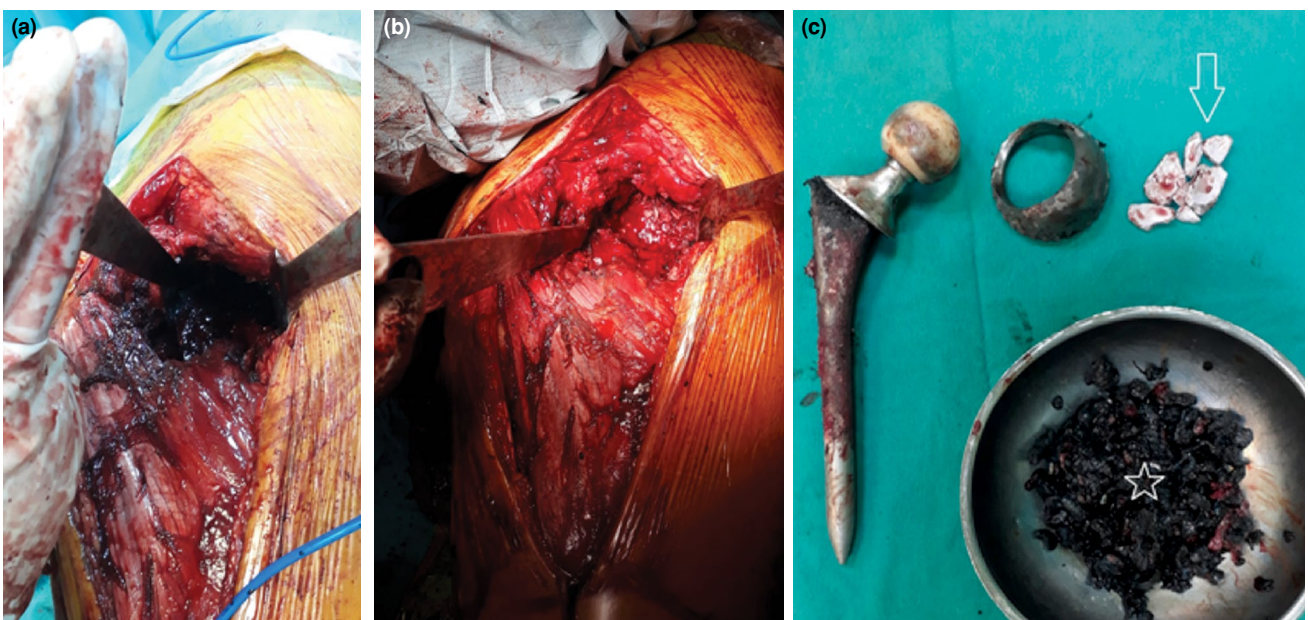
FIGURE 5. (a) Hip joint view before debridement. (b) Hip joint view after debridement and implant extraction. (c) Extracted implants, debrided metallosis tissue (white star), and fractured ceramic fragments (white arrow) are shown.

prosthesis which is much more resistant to ceramic debris. Use of extended trochanteric osteotomy led to effortless extraction of protruded femoral stem, then wide exposure for acetabular shell extraction, after enabling the hip joint to be more reachable for debridement of metallosis and ceramic fragments

(Figure 5). Reconstruction was performed with medial acetabular defect allograft grafting, PINNACLE® acetabular 56 mm multihole revision cup with two cancellous acetabular screws (Depuy, Warsaw, IN, USA), and BIOLOX® delta ceramic acetabular liner (CeramTec GmbH, Plochingen, Germany). Femoral side was reconstructed with long-stemmed extensively coated 13.5 mm cementless revision stem (Solution™ DePuy, Warsaw IN, USA), BIOLOX® delta 36 mm +1.5 ceramic head, and extended trochanteric osteotomy fixation with Dall-Miles cable grip. Ceramic fragments were still present at early postoperative radiography (Figure 6). There was no indication for a postoperative control CT, as exact localization of ceramic fragments was not required for follow-up treatment.

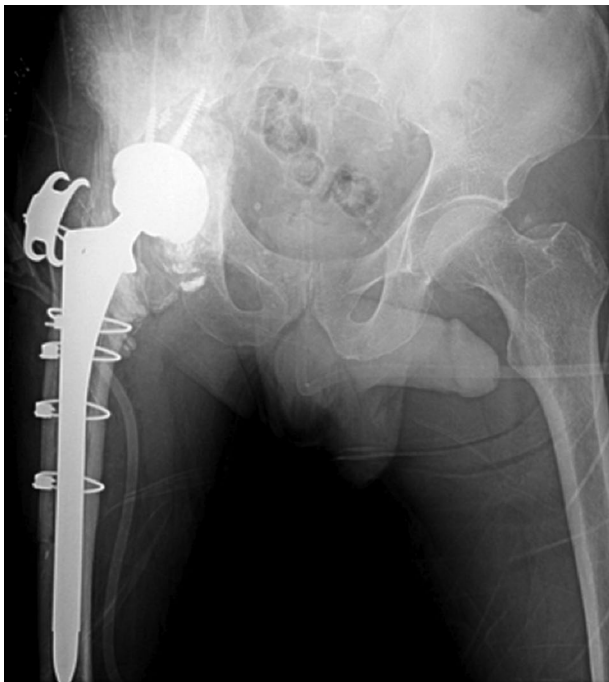
FIGURE 6. Right hip metallosis and ceramic fragments inferior to acetabular component are still present on early postoperative pelvis anteroposterior radiography.

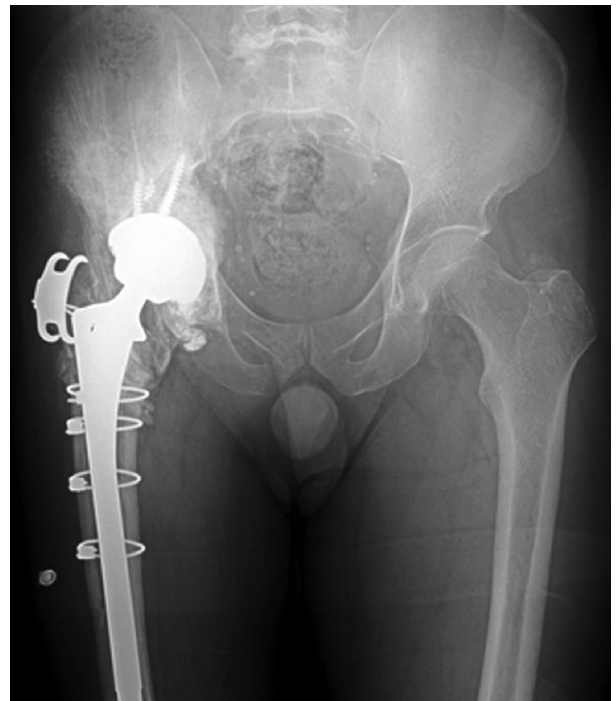
At two-year follow-up examination, Harris hip score was 96.65% with no evidence of osteolysis or implant deformity (Figure 7).

FIGURE 7. Follow-up pelvis anteroposterior radiograph two years after revision total hip arthroplasty.
