CASE REPORT: CLINICAL CASE

Electrostatic Discharge Causing Pump Shutdown in HeartMate 3

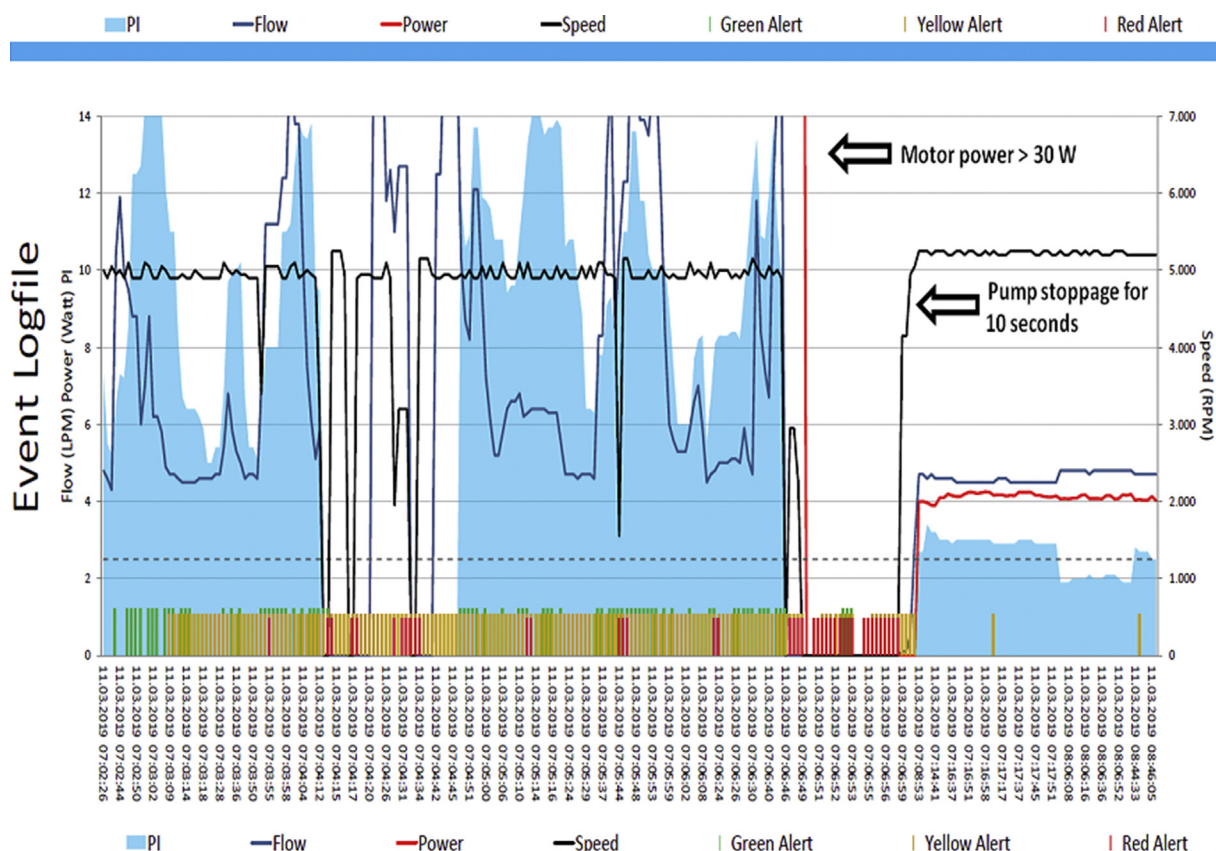
Analysis of log files data showed many alarms including low flow alarms, LVAD faults, and red heart alarms (Figure 1). There was 1 event of pump stoppage with a duration of 10 s and a maximum power of 36 W.

FIGURE 1 Log Files Showing the Sudden Shutdown of HM3 Secondary to High Motor Power Causing Red Heart Alarms
