## Case Reports

# Medial subclavicular musculotendinous complex and insulation break: Rare cause of late pacemaker lead malfunction

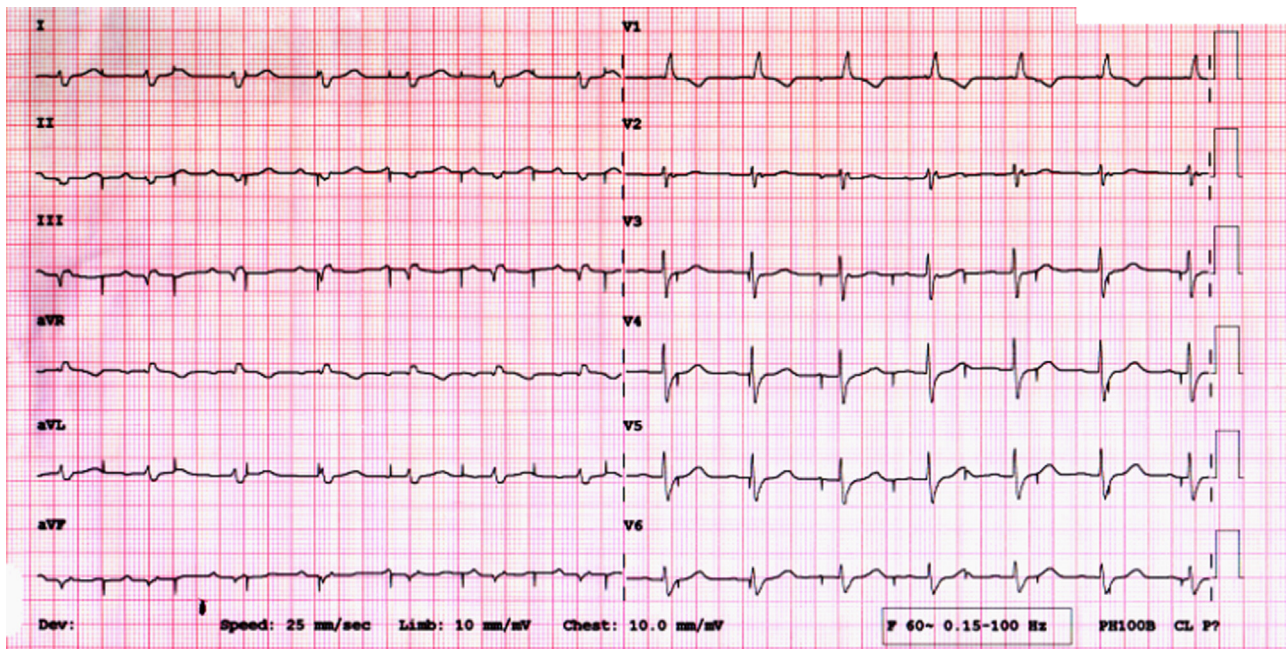
Fig. 1 – ECG more than 3 years after the initial implant procedure. Magnet application shows spike delivery but failure to capture.

After more than 3 years of the initial implantation, he presented with an episode of presyncope. His resting ECG showed spontaneous rhythm at the rate of 82 bpm, and magnet application revealed spike delivery but failure to capture (Fig. 1). Our patient was fortunate not to be completely dependent on the pacemaker. Pacemaker interrogation revealed an elevated pacing threshold of 6 V and decreased lead impedance to 260  $\Omega$  (a fall in lead impedance by more than 300  $\Omega$ ). The cumulative ventricular pacing was 20%. On fluoroscopic screening of the pacemaker system in the Cath Lab, a defect in the pacemaker lead could be clearly appreciated at the point where it crossed between the clavicle and first rib on its way to the subclavian vein (Fig. 2). There was no evidence of loose setscrews or lead dislodgement. Therefore, considering the fluoroscopic observation combined with the clinical and telemetry data, a diagnosis of insulation break was established and the patient underwent definitive correction with replacement of the lead using a more lateral access to the left subclavian vein.

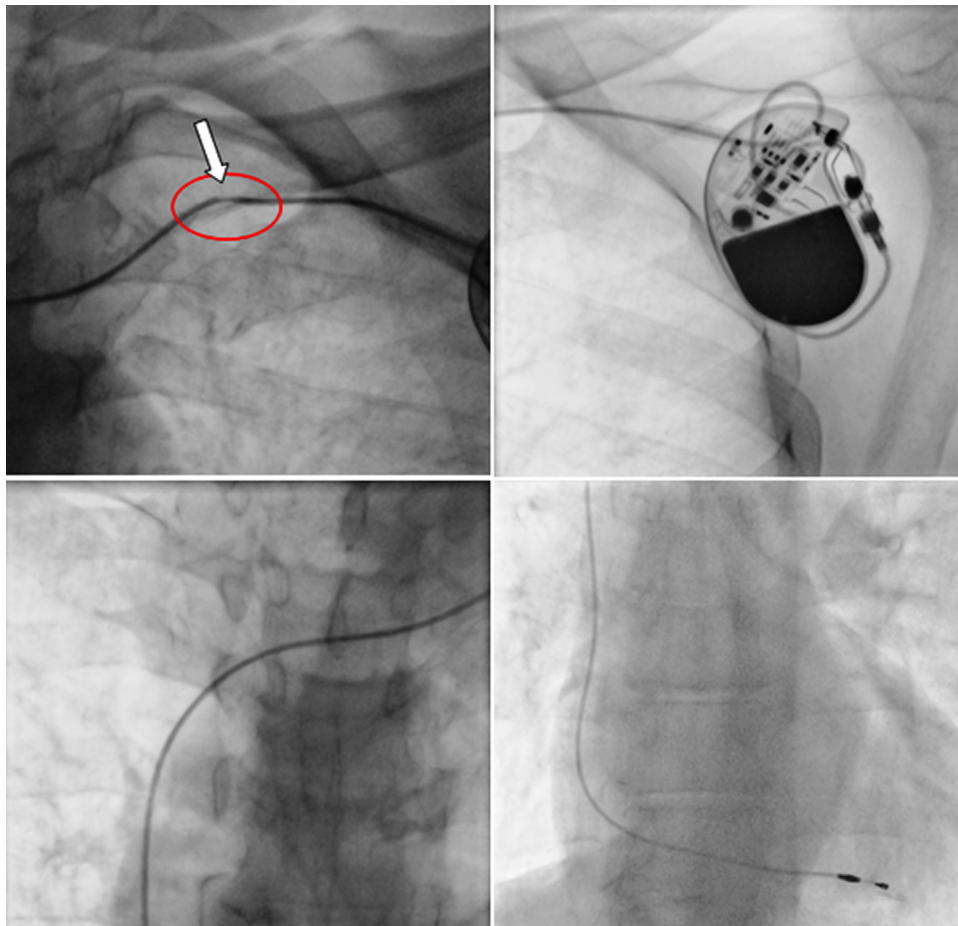
Fig. 2 – Fluoroscopic examination of the pacemaker system revealed defect of the pacemaker lead at the point where it crossed between the clavicle and first rib (arrow and circle) on its way to the subclavian vein. There was no evidence of loose setscrews or lead dislodgement.

Lead insulation defect is a very rare late complication of pacemaker implantation reported in 0.4–0.5%<sup>3,4</sup> patients. Available literature suggests that approximately 93% of all pacemaker lead fractures or insulation breaks occur in the segment of the lead lateral to the venous entry, and costoclavicular compression has been implicated. However, cadaveric studies suggest that lead damage in that region is caused by soft tissue entrapment rather than bony contact. It has been noted that leads inserted by standard subclavian puncture techniques, as in this particular case, usually pass through the *medial subclavicular musculotendinous complex* (MSMC) before entering the vein. The MSMC comprises the subclavius muscle, the costoclavicular ligament, and the costocoracoid ligament. Entrapment of the lead by any of these structures could impose a static load upon the lead, and

repeated flexing of leads about the point of entrapment during ipsilateral arm movements may be responsible for damage previously attributed to cyclic costoclavicular compression.<sup>5</sup> Therefore, it has been suggested that the use of cephalic vein cutdown or a more lateral percutaneous entry into the subclavian or axillary vein may help avoid lead compression and damage associated with the standard subclavian puncture technique.<sup>6,7</sup>

Lead failure due to insulation break is a rare but important cause of late pacemaker malfunction, requiring lead replacement. An abnormally low impedance with demonstrable lead malfunction is diagnostic for insulation break. Majority of pacemaker lead fractures or insulation breaks occur in the segment of the lead lateral to the venous entry. Lead entrapment by components of the MSMC has been suggested to contribute to pacemaker and ICD lead damage and pacemaker malfunction over time, especially those inserted using the standard subclavian puncture techniques. Novel approaches of lead introduction into the subclavian vein near the lateral border of the first rib avoids soft tissue entrapment and may extend the longevity of the leads.
