Case report

Fracture of the femoral adapter bolt and taper adapter in a modern rotating platform knee arthroplasty

Elexis C. Baral, BS^{a, *}, Alexander S. McLawhorn, MD, MBA^b, Timothy M. Wright, PhD^a, Edwin P. Su, MD^b^a Department of Biomechanics, Hospital for Special Surgery, New York, NY, USA^b Department of Orthopaedic Surgery, Adult Reconstruction & Joint Replacement Division, Hospital for Special Surgery, New York, NY, USA

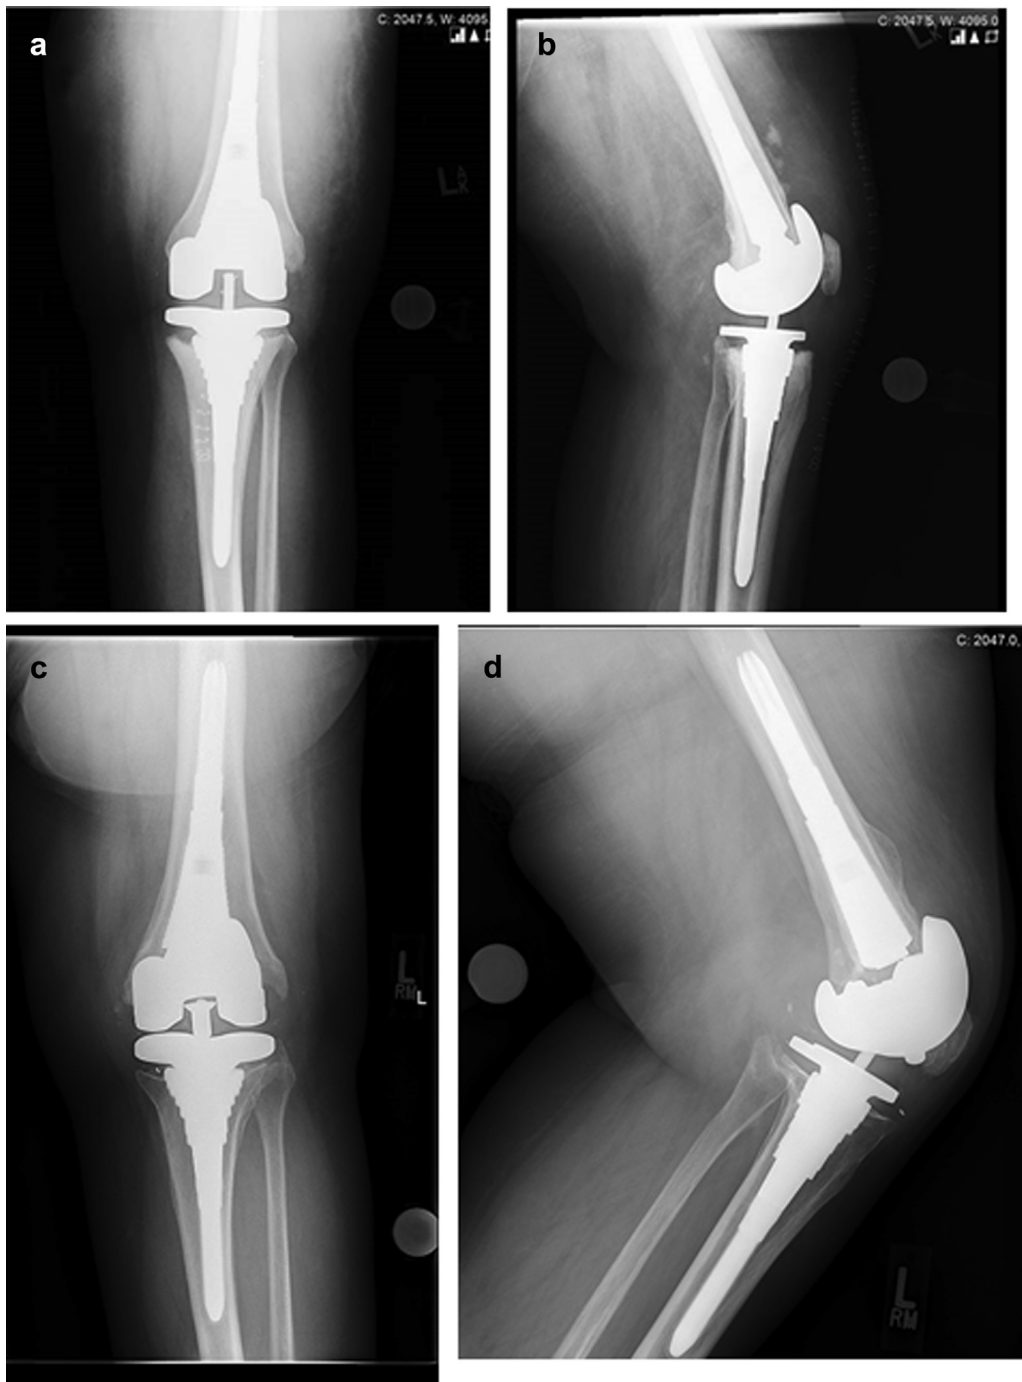
Figure 1. Anteroposterior (AP) (a) and lateral (b) radiographs obtained at revision surgery in 2010. 4.5 years later, the patient presented with onset of pain and AP (c) and lateral (d) views confirmed fracture of the implant and taper disengagement from the metaphyseal stem.

sound. The patient was subsequently unable to bear weight. Anteroposterior and lateral radiographs (Fig. 1) revealed fracture of the femoral component of the implant. The radiographs showed that the distal femoral sleeve had disconnected from the femoral articular component and that a large metal fragment was freely floating in the intercondylar region of the joint space.

A second revision surgery was performed. Preoperative serological tests were not concerning for infection. A tourniquet was used during the surgery. The old incision was used, and the medial and lateral gutters were reestablished to gain exposure to the broken implant. The articular component was found to have broken at the taper connection. It was grossly loose and was removed. The freely floating broken piece of the bolt was removed from the joint space; the remaining broken fragment was retained inside the taper adapter. When attempting to disconnect the taper adapter from the femoral component, the broken fragment was observed spinning in the threads of the adapter. Therefore, the broken fragment was unthreaded from the taper adapter. The taper adapter could then be disengaged from the femoral sleeve by attaching a Winquist extractor (Shukla Medical, Piscataway, NJ) and backslapping

the component. The metaphyseal sleeve was completely encased in bone with excellent ingrowth. Therefore, it was left *in situ*. A hinged femoral component was prepared and press-fit into place, which allowed for a one-piece connection, without any taper bolts, to the intact metaphyseal sleeve. The distal femoral bone was contoured using a barrel tip Midas Rex (Medtronic, Fridley, MN), and bone cuts were made to fit the extra small size femur. A 16-mm polyethylene insert permitted full extension. All other components in the tibia were intact and left in place. A lateral release was performed to improve patellar tracking.

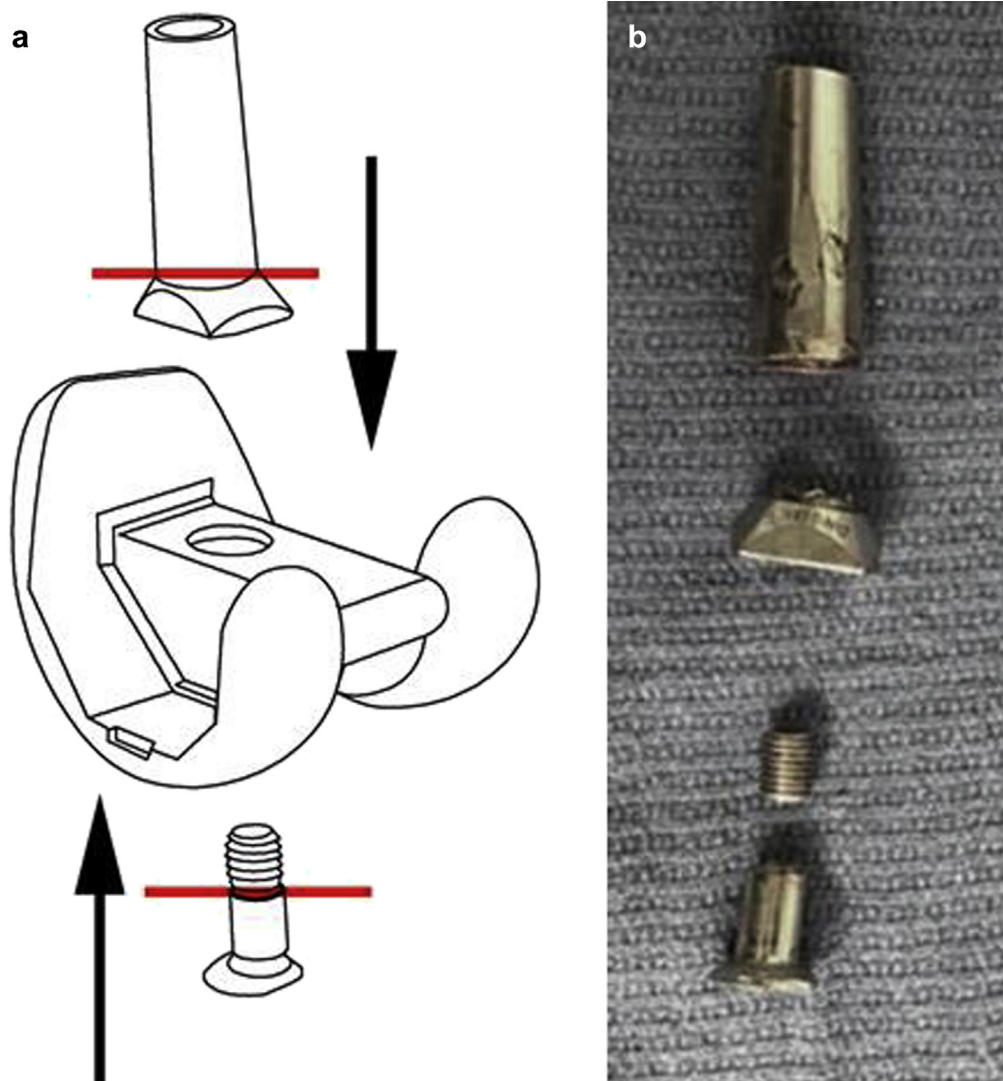
Figure 2. (a) Drawing displaying assembly of the femoral component. The red lines indicate location of implant fracture. (b) Intraoperative picture of the fractured segments after removal.

The retrieved DePuy TC3 Rotating Platform implant was cleaned and analyzed with both light and scanning electron microscopy (SEM). A drawing of the component accompanied by intraoperative images depicts the setup of the modular interfaces and the location of the failure (Fig. 2a and b). SEM examination of the fracture surface confirmed that the implant failed because of a fatigue fracture from cyclic loading. The flat shapes of the beach marks indicate a mild stress concentration near the origin of the fracture [6]. SEM images revealed beach marks propagating laterally across the surface, ending at the final fracture location on the posterolateral edge of the bolt (Fig. 3). The femoral component had no visible damage; the polyethylene insert had evidence of moderate pitting and scratching. The post of the femoral component was slightly damaged anteriorly, likely from hyperextension of the knee. This implant was uncemented, which could provide evidence for the high stress environment in the surrounding host bone and distal femoral stem [3].

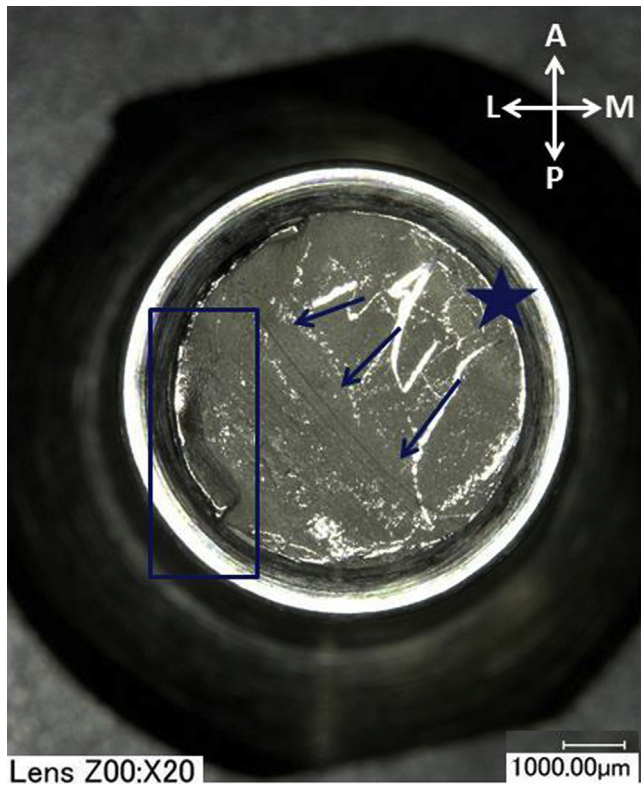
Figure 3. Magnified image of the fracture surface of the femoral bolt showing the point of fracture initiation (denoted by the star), beach or clamshell markings indicative of fracture progression posterolaterally across the surface (indicated by the arrows), and the area of final fracture (highlighted within the box at the posterolateral edge).

The patient's allergy to cement must be emphasized. This implant is recommended for use with cement and failed at an unusual junction likely because of high cyclic loads unevenly distributed through the joint. Whenever possible, we advise using cement to prevent the type of fatigue failure that occurred in this case. If the patient has a cement allergy, we would advise against using this implant to avoid the described implant failure. A custom implant designed with biologic fixation, either through bone ongrowth or ingrowth, would be a strong recommendation for similar cases, as most stems use hybrid fixation involving bone cement. An additional option might be a monolithic design, but the sacrifice in modularity makes a revision TKA more challenging.
