Case report

Late Breakage of a Dual-Mobility Polyethylene Insert in a Revision Total Hip Arthroplasty: An Unusual Failure Mode

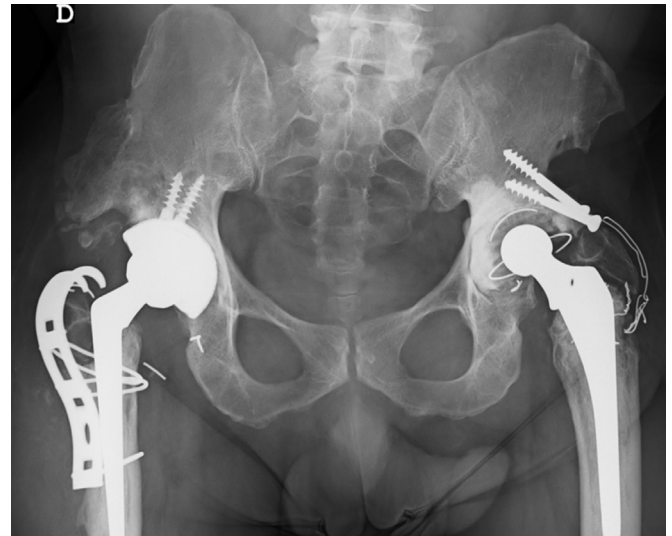
Figure 2. Anteroposterior radiograph of the pelvis showing the results of the revision surgery.

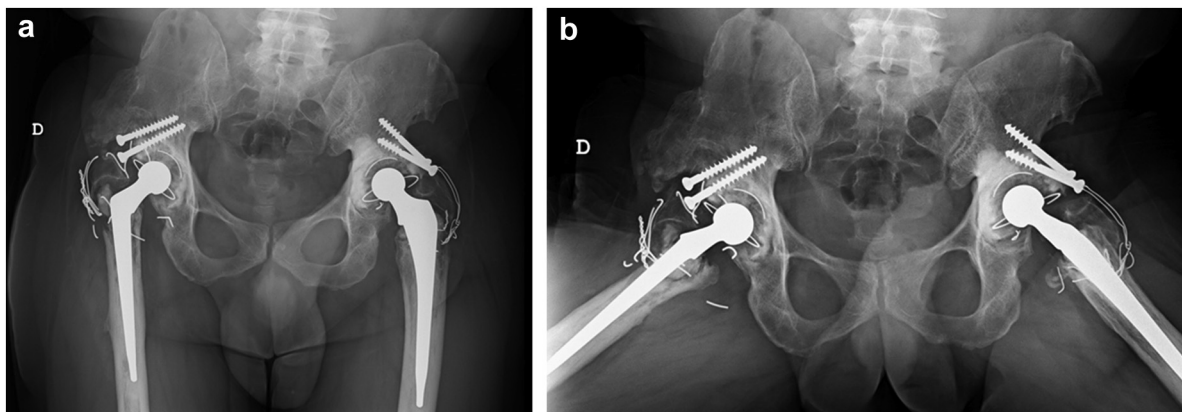
reported an excellent functional outcome since. Radiographs demonstrated significant eccentric wear of the polyethylene bearing with osteolysis around the cup and the stem. Broken wires from a failed trochanteric fixation were also present (Fig. 1a and b). The patient, who showed no spinopelvic imbalance, was proposed as a candidate for revision surgery with a diagnosis of aseptic loosening, polyethylene wear, and pseudoarthrosis of the greater trochanter.

Figure 1. Anteroposterior (a) and frog-leg lateral (b) radiographs of the pelvis showing significant eccentric wear of the polyethylene mobile bearing and osteolysis around the right cup (DeLee and Charnley zone III) and the stem (Gruen zones 1 and 7). Some broken wires from a failed trochanteric fixation were also present.

The same posterolateral approach was used. The loose cup was removed and replaced with a DMC construct consisting of a G7 Osseotri multihole cup (Zimmer-Biomet, Warsaw, IN), a dual-mobility liner, an E1-infused dual-mobility highly crosslinked polyethylene bearing, and a 28-mm Protasul S-30 head (Zimmer-Biomet, Warsaw, IN). The broken wires were removed, and the greater trochanter was stabilized by means of a BMP cobalt chrome trochanteric grip plate (Zimmer-Biomet, Warsaw, IN) (Fig. 2). The stem was stable; therefore, it was not replaced. The patient was discharged 7 days after surgery and was allowed to ambulate with partial weight-bearing for 2 weeks and full weight-bearing thereafter. There were no postoperative complications, and intraoperative cultures were negative.

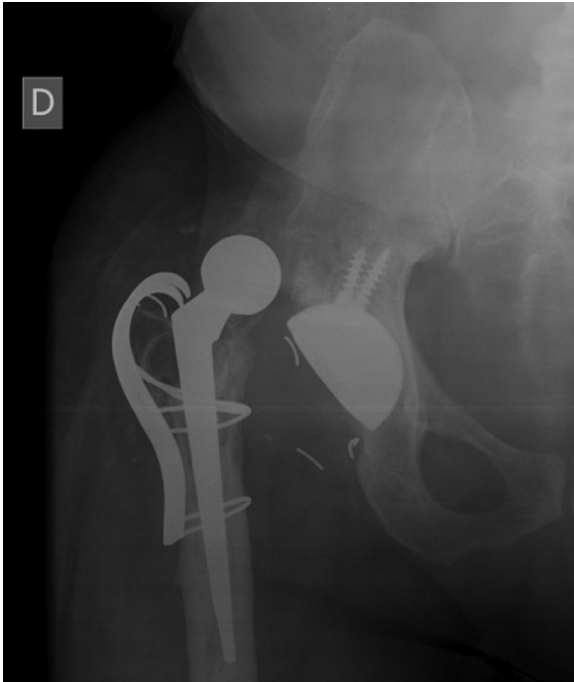
Three months later, the patient was admitted to the emergency department with superior-posterior prosthetic hip dislocation after a fall (Fig. 3). Closed reduction was performed under sedation and image intensifier control [18]. The radiograph showed concentric head positioning and no impingement between the trochanteric plate and the cup in the entire range of movement.

Figure 3. Anteroposterior hip radiograph showing prosthetic hip dislocation.

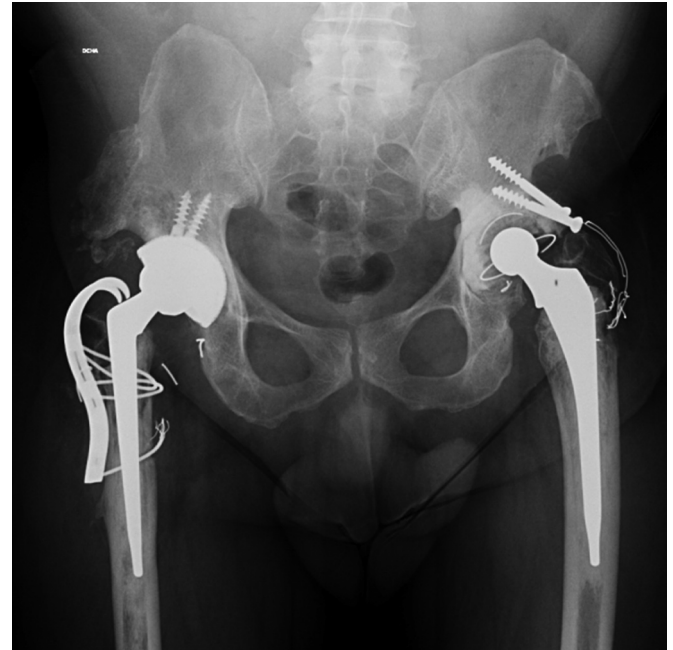
For almost 2 years, the patient's physical and radiological examinations were normal (Fig. 4a and b), showing nearly complete range of motion (10° of flexion deficit) and 5° of internal rotation. After that period, however, the patient began to feel progressive anterior groin pain and gait changes. An anteroposterior radiograph showed eccentric placement of the metal head and signs of failure in the greater trochanter synthesis (Fig. 5).

Figure 5. Anteroposterior radiograph of the pelvis where eccentric placement of the metal head can be seen. Signs of failure of the greater trochanter synthesis were also present.

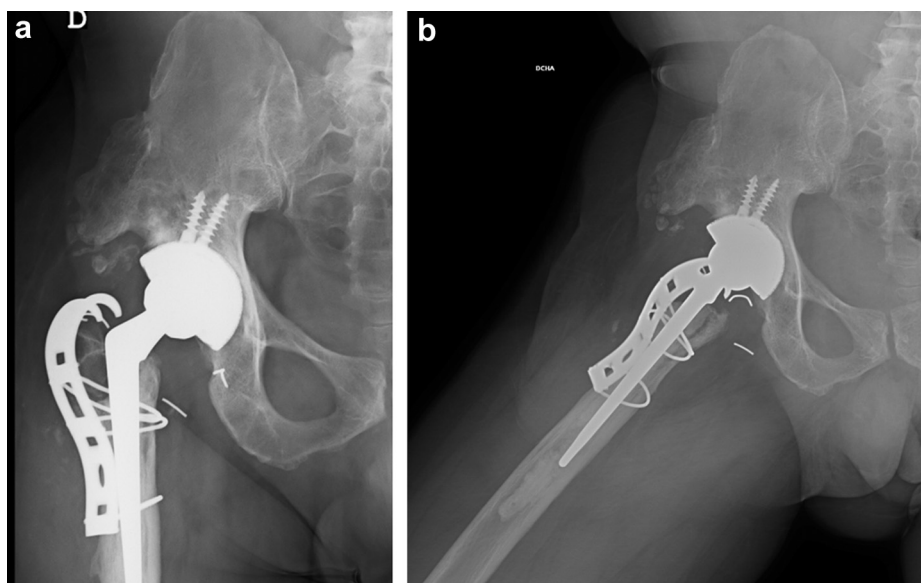
Figure 4. Anteroposterior (a) and frog-leg lateral (b) radiographies of the pelvis demonstrating good concentric reduction of the dislocation.

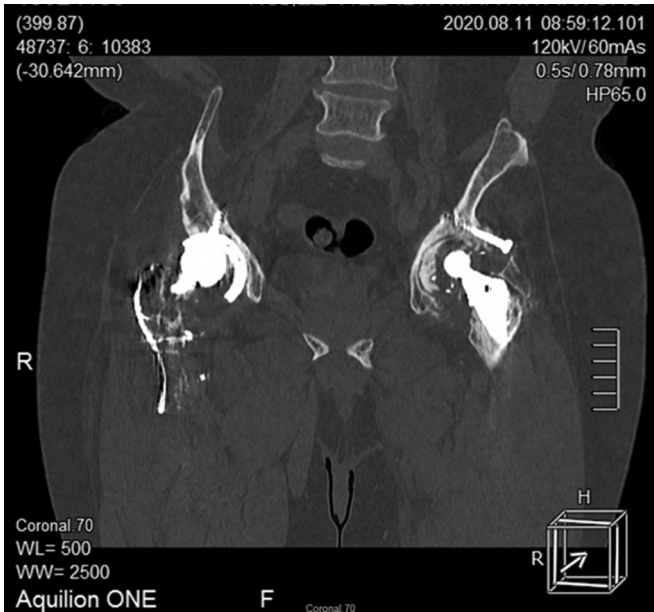
Although a computed tomography scan was prescribed, we lost contact with the patient for some time, and the scan was not performed until 4 months later. Eccentricity of the metal head was observed, but no circular radiolucent zone ("bubble sign" [6,20,23]) was present (Fig. 6). There was no evidence of elevated serum metal levels detected during his workup.

Figure 6. Coronal computed tomography image showing eccentricity of the metal head. Anteversion was reported to be 25°, and inclination was measured at 48°.

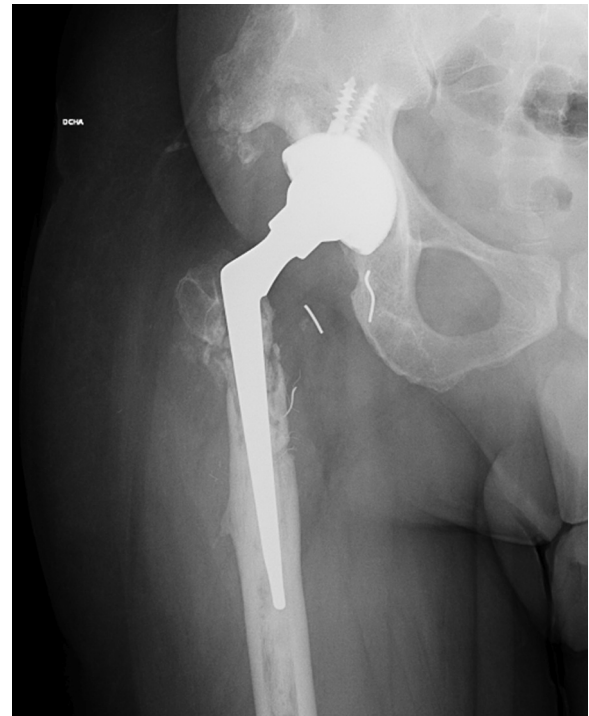
Figure 8. Postoperative anteroposterior radiograph of the hip after the second revision.

The integrity of the trunnion and the stability of both the cup and the dual-mobility liner were assessed intraoperatively. As no abnormalities were detected, the femoral head and the broken insert were removed and replaced with new ones. The well-fixed stem was left in place, and a long-neck skirted head (+10.5 mm) was chosen to provide adequate stability. The trochanteric plate was removed along with all visible and reachable wires, and the remaining bone of the trochanter was fixed to the femur by means of a tension band (FiberTape, Arthrex, FL). No complications were registered during or after the surgery (Fig. 8).

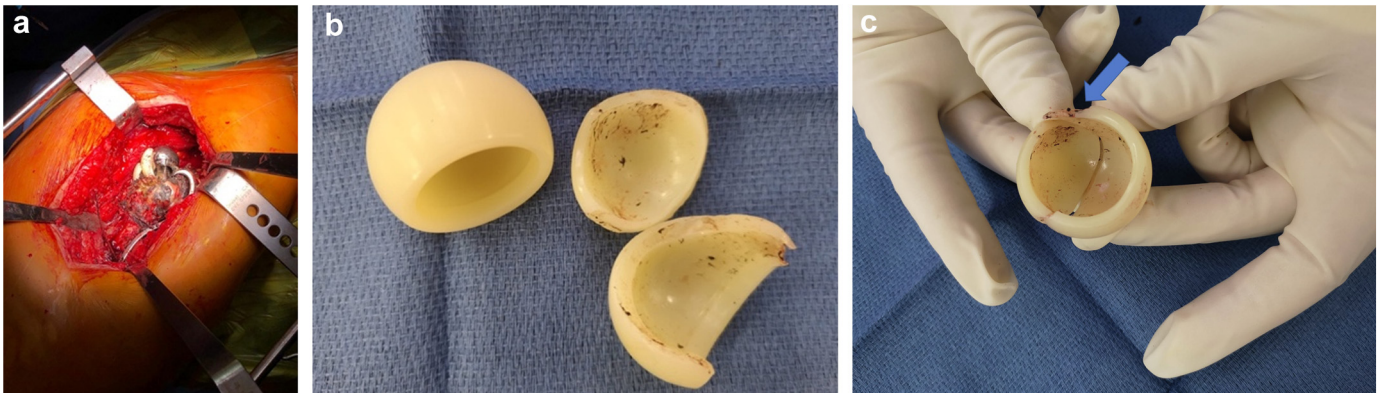
A second revision was performed, in which the polyethylene bearing was split into 2 parts with a notched area at the edge of the crack. No fragments of wire were found between the head and the insert or between the insert and the metal shell. The stem was stable, and the nonunion at the greater trochanter was still present (Fig. 7a-c).

An investigation report by the implant manufacturer stated that a visual examination of the components revealed normal signs of usage in the taper of the head and a fractured dual-mobility polyethylene bearing. The manufacturer could not identify the root cause of this issue and could not find any other comparable report.

any other case where the implant split in such a drastic fashion. Owing to this lack of precedent, we hypothesize that this complication may have been caused by the following reasons:

- A notch, similar to what was described by Di Laura et al. [27], may have been caused by luxation (or reduction) and later evolved into a complete breakage of the polyethylene. The breakage of polyethylene liners in conventional THA is a rare but known complication [28] that has been related to the progression of fatigue cracks in modern, highly cross-linked polyethylene [29]. As a notch was present in the removed implant (Fig. 7C), we believe this is the most likely cause of the failure. That notch might have been caused by the trochanteric plate during the luxation or the reduction. Although we could not see impingement in different radiological projections, plate involvement cannot be ruled out.

- A crack may have occurred during the introduction of the snap-fit head and later progressed [30].
- Wires, bone cement debris or both may have caused third-body wear. However, we could not find any visible debris during the revision procedure.

Figure 7. Intraoperative picture (a) and images of the broken insert (b and c) with a notched zone (arrow).
