## Preplacement check of complete central venous pressure catheter assembly: Should it be made routine?

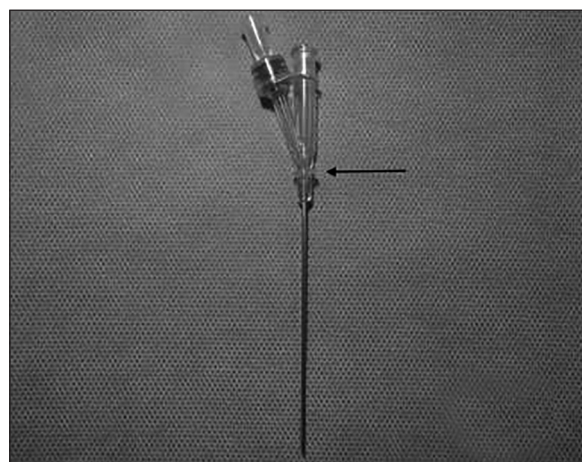
On examining the first set, we found that the guide wire could not be negotiated beyond the junction of the plastic port and the metallic needle [Figure 1]. On insertion of the guide wire from the distal (puncturing) end of the needle, the guide wire could not be threaded beyond the metallic end of the needle to the plastic hub [Figure 1]. The defect could not be appreciated by naked eye, but we assumed it to be because of a narrow inlet of the metallic needle relative to the guide wire (a possible manufacturing defect).

**Figure 1:** Central venous catheter set showing the site of obstruction (arrow)

As conventionally it is recommended to check the central venous catheters prior to insertion, we suggest such a directive should also be laid down for prior inspection of other equipment like needle and guide wire prior to insertion. Should we see it as an isolated rare case or should regular check of the CVP catheter also be done prior to insertion, as many a times inability to pass the guide wire is assumed to be due to operator related or to some inherent problem in the patient e.g., presence of thrombus or anatomical variation in the vessel lumen? Prior check of epidural catheter assembly has been advocated routinely.<sup>[2]</sup> Although the manufacturers have advised to verifying the patency of the lumen of the catheter by physiological saline, we feel a regular preplacement check of the needle/cannula for guide wire patency along with catheter patency maintaining strict asepsis would be beneficial.
