Establishing the quality management baseline in the use of computed tomography machines in Kenya

The objective of this study was to assess the level of compliance to quality assurance and image quality standards in computed tomography facilities in Kenyan hospitals. A quality assurance inspection and physical image quality assessment in eighteen representative computed tomography facilities were completed. A quantitative method was developed and used to score the results obtained from the physical image quality measurements using the American Association of Physicists in Medicine (AAPM) water phantom. Inspection was done in order to establish the level of compliance with internationally recognized standards such as those stipulated in the European Guidelines Quality Criteria for Computed Tomography and the International Basic Safety Standards for Protection against Ionizing Radiation. The overall findings placed the national quality management performance at $50 \pm 3\%$, while image quality and quality assurance performance were $61 \pm 3\%$ and $37 \pm 3\%$, respectively. The quality assurance assessment benchmarked the country's level of quality management system compliance in

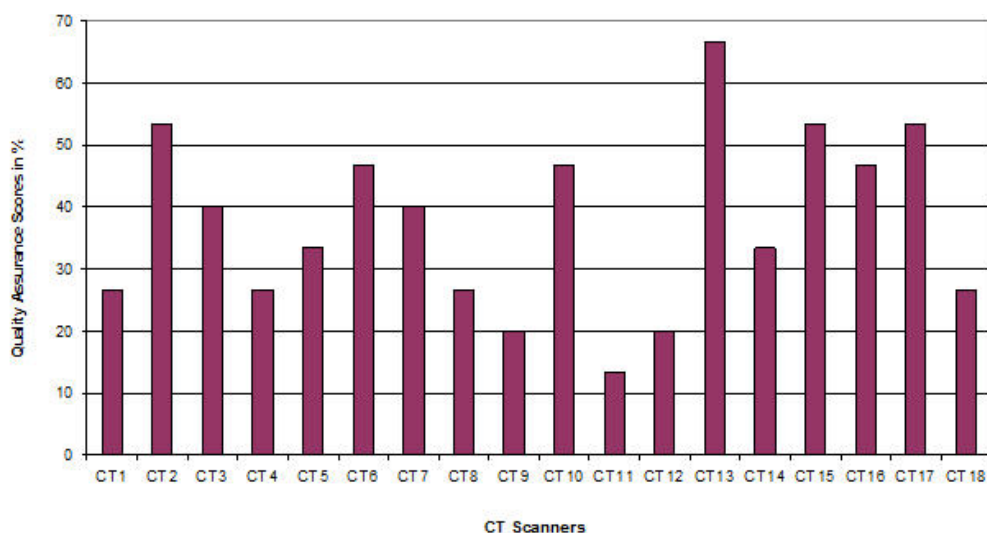
FIG. 1. Quality assurance performance per CT scanner facility.

Figure 1 indicates the quality assurance performance results for each CT scanner facility with respect to all four categories stated above. According to the criteria used, none of the CT scanner facility scored above 75% or excellent, four were good, seven were fair, and seven were poor.

The contents in Table 3 indicate fair performance with respect to compliance with annual effective dose limits. In most facilities, the shielding integrity was compromised by lack of lead overlaps between the doors and door frames, as well as with the adjacent walls. In the control room, there was no lead equivalence between the observation window and the window frame.

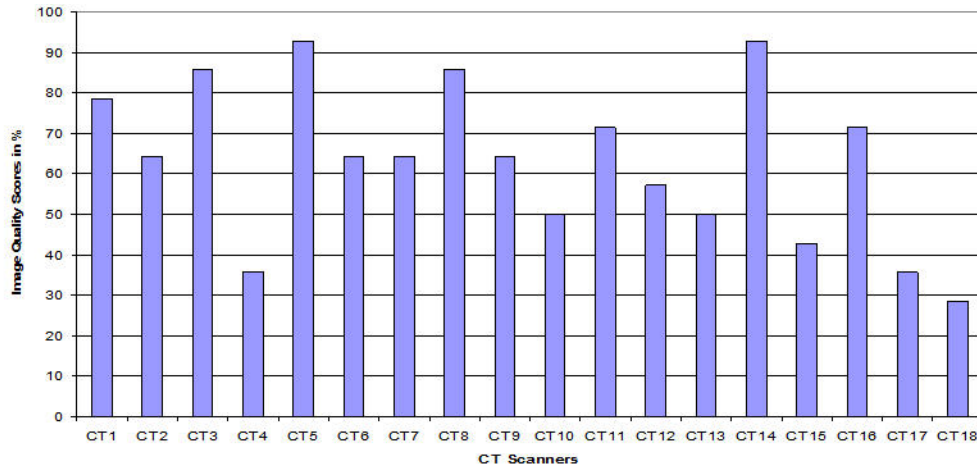
FIG. 2. Image quality performance per CT scanner facility.

Figure 2 indicates the image quality performance. According to the criteria, five CT scanners achieved excellent image quality, seven were good, six were fair, and none was poor.

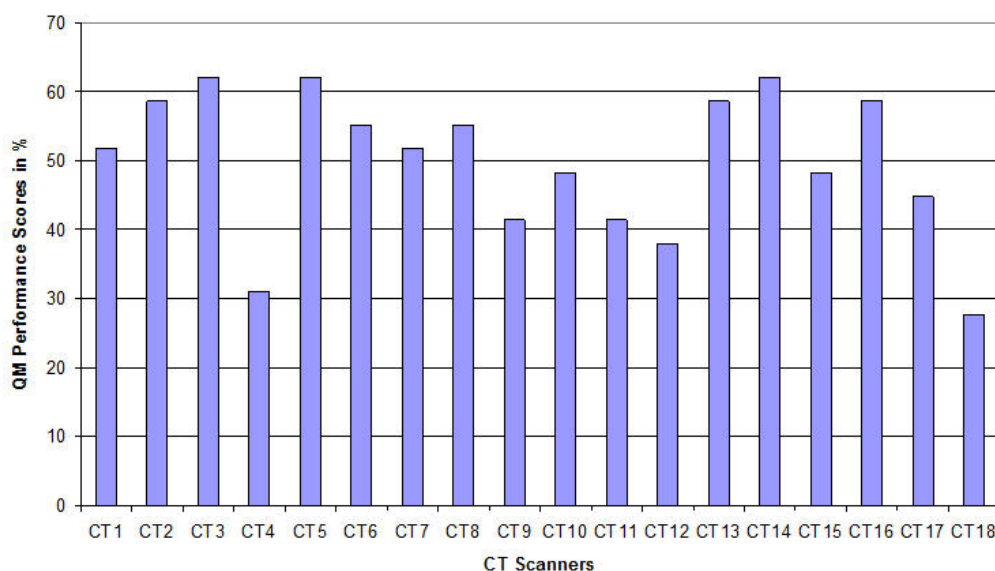
FIG. 3. The quality management performance per CT scanner facility.

Figure 3 indicates the overall quality management performance. None of the CT scanner facilities scored above 75%, 10 were good, seven fair and one poor. Most CT scanners were accurate with respect to CT number uniformity (83%) and least accurate in high spatial resolution measurements (17%).
