CASE REPORT

Metallosis following full thickness wear in total hip arthroplasty

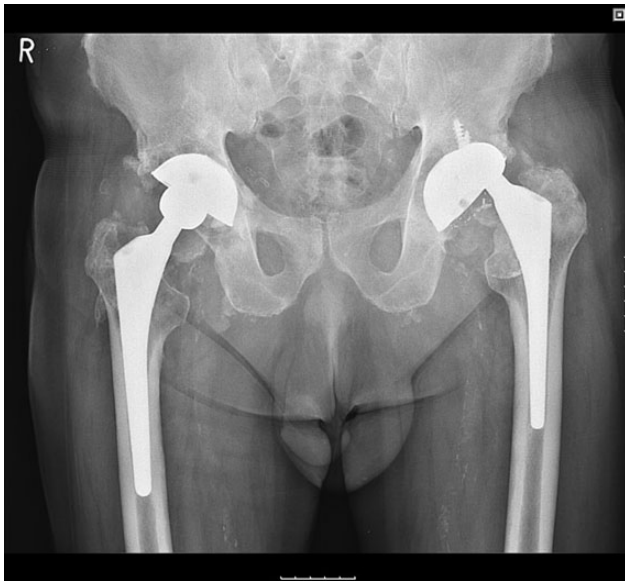
Pelvic radiographs demonstrated that the femoral head had migrated superolaterally through the polyethylene (PE) liner and the acetabular cup with metallic fragments inferior to this, and was articulating with the superior wall of the acetabulum

Figure 1: Pelvic radiograph demonstrating superolateral migration of the femoral head, metallic fragments around the neck and bony destruction of the acetabular wall.

causing bony destruction. There was no radiographic evidence of loosening to the stem (Fig. 1).

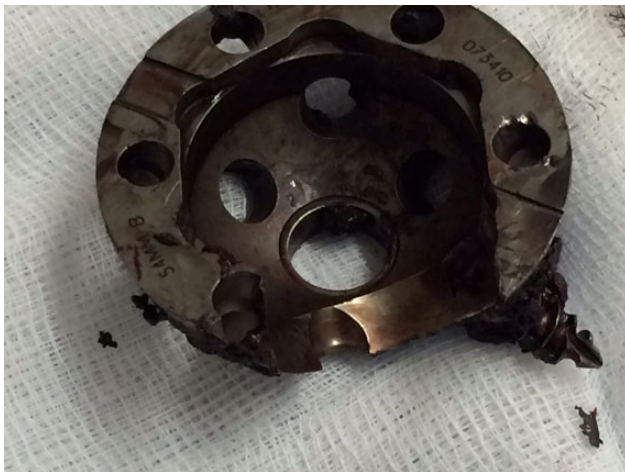
Figure 2: The acetabular component showing extreme wear-through and metallic fragments.

The patient was subsequently scheduled for revision surgery of the acetabular component. Intraoperatively, there was blackening of the periprosthetic tissue and metal debris throughout. The PE liner remained engaged within the acetabular cup with significant wear through its back. The femoral head had migrated superolaterally through the acetabular cup and was articulating with the superior acetabular wall causing bony destruction. The acetabular cup remained well fixed within the acetabulum with good bony ingrowth (Figs 2 and 3).

The femoral stem was kept firm in its proper position. Structural porous titanium acetabular augment (Regenerex™), reinforced with a cancellous allogeneic bone graft, was used to reconstruct the superior acetabular wall. The cup was completely revised using a Biomet® Regenerex Ringloc® multihole

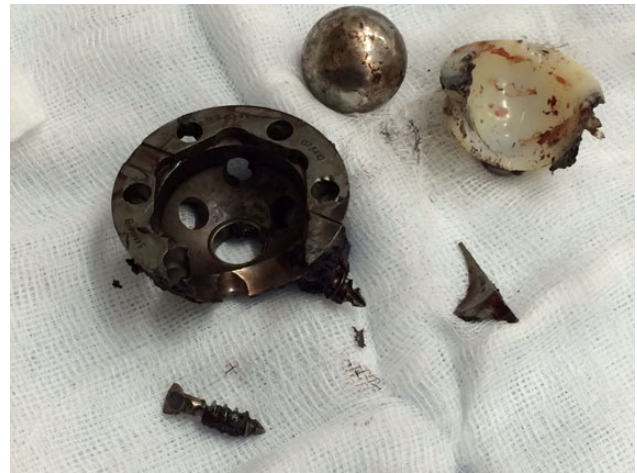
Figure 3: The acetabular component and liner showing extreme wear.

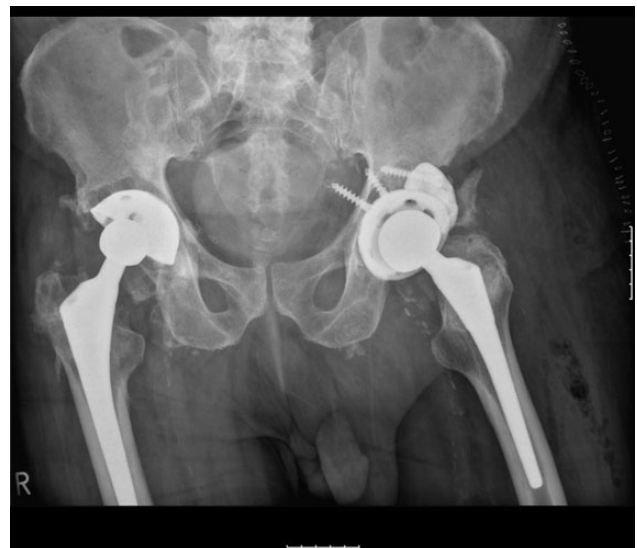
Figure 4: A post-revision radiograph demonstrating a structural graft using the acetabular augment (Regenerex™) and revised cup in situ.

56-mm acetabular cup and a Hi-wall Ringloc-x PE 54-mm liner. The previous 32-mm femoral head was replaced with a Bioball® 36-mm metal head and a Bioball® adapter standard (0 mm) Taper 11/13 (4° 3°), correcting the offset and achieving stability (Fig. 4).

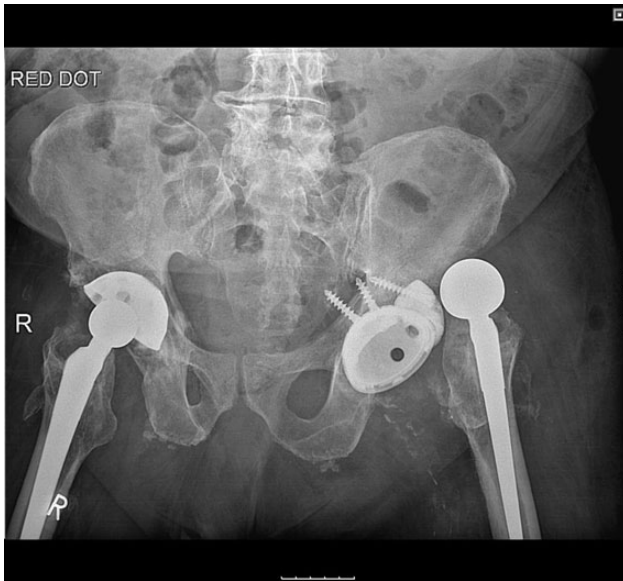
Postoperatively, the patient fell on the ward resulting in posterior dislocation (Fig. 5) requiring an open reduction. Subsequently, the patient developed a superficial surgical site infection, which resolved with antibiotic therapy. Three months following discharge, the patient was pain-free and could ambulate with a Zimmer frame.

Figure 5: Radiograph following postoperative fall demonstrating posterior dislocation.
