Case report

Superior rim fracture of a vitamin E-infused highly cross-linked polyethylene (HXLPE) liner leading to total hip arthroplasty revision

Brett G. Brazier, BA ^{a,*}, J. Wesley Mesko, MD ^b

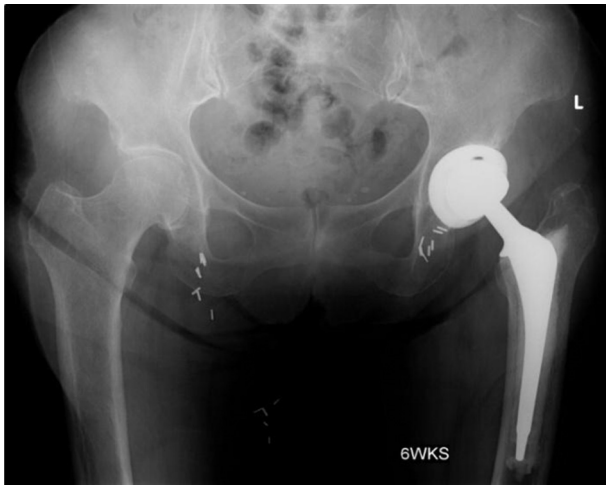
Figure 1. Anteroposterior (AP) radiograph of the pelvis made 6 weeks postoperatively showing acceptable position of the components.

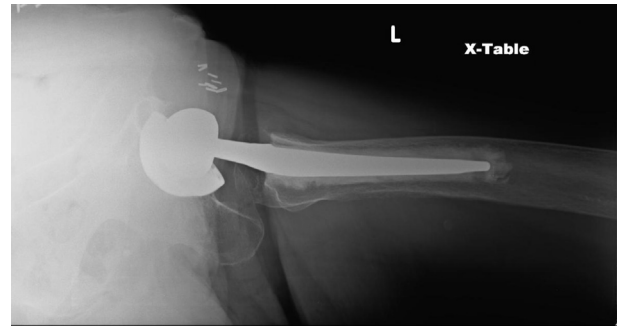
Figure 2. Cross-table lateral radiograph of the left hip 6 weeks postoperatively showing 45° of anteversion of the acetabular component.

While the 2 most recent cases are not sufficient in the amount of information to support that there should be a minimal thickness of the superior rim of E-poly liners, it does establish a probable cause of polyethylene fracture in this case. While polyethylene thickness is a potential cause, there were other confounding factors in this case which limits our ability to establish a definitive cause of fracture. First, there was the traumatic event which ultimately led to dislocation and the discovery of the fractured polyethylene liner. Second, the patient was at added risk of polyethylene failure because it was a 36-mm liner with a 52-mm cup. Third, the acetabular component had approximately 45° of anteversion after primary THA which is greater than optimal and could contribute to failure.

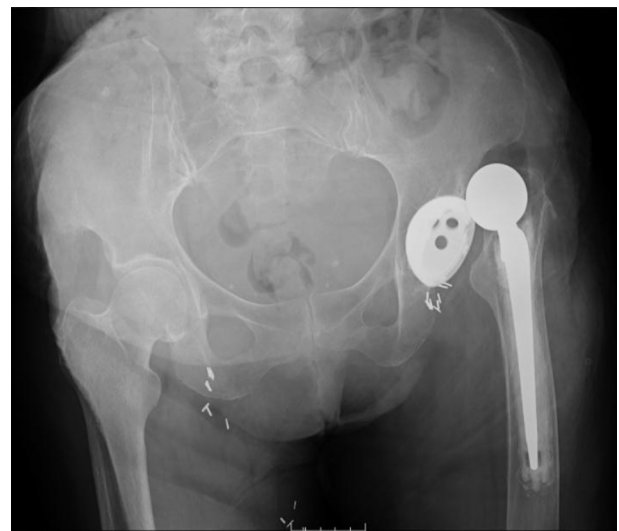
Surgery and the postoperative course ensued uneventfully until 25 months postoperatively when she presented to the emergency department because of a fall at home where she suffered an anterosuperior dislocation of her left total hip arthroplasty. There was no record of any problems with the patient's total hip before dislocation (Fig. 3). An attempt of closed reduction under conscious sedation was performed in the emergency department and was unsuccessful. The patient was then taken to the operating room where general anesthetic was induced but a stable reduction could not be achieved. The patient was awoken, the dilemma was discussed with her, and consent for an open reduction and possible revision of the implants was granted. At the time of revision, it was discovered that the acetabular component was still in 45° of anteversion which was unchanged from the 6-week postoperative primary total hip arthroplasty (THA) and that the polyethylene liner had fractured superiorly into 2 main fragments (Fig. 4) and then removed. There was no visual evidence of excessive polyethylene wear; however, the polyethylene bearing was not sent for analysis. For the revision procedure, a 56-mm Trident hemispherical shell with 3 dome screws and a 36 X3 neutral polyethylene liner (Stryker, Mahwah, NJ). The cemented stem was found to be loose and revised with a Modular Restoration 21-mm × 195-mm bowed stem with a 23 + 10 cone body and a 36 + 5 cobalt-chrome head (Stryker, Mahwah, NJ) (Fig. 5). Intraoperative cultures were taken and found to be negative. The patient had an uneventful postoperative course and continues to do well at 1-year postsurgery.

Figure 3. AP radiograph of the pelvis made 25 months postoperatively showing anterior and superior dislocation of the femoral head and was later discovered to be due to polyethylene fracture.

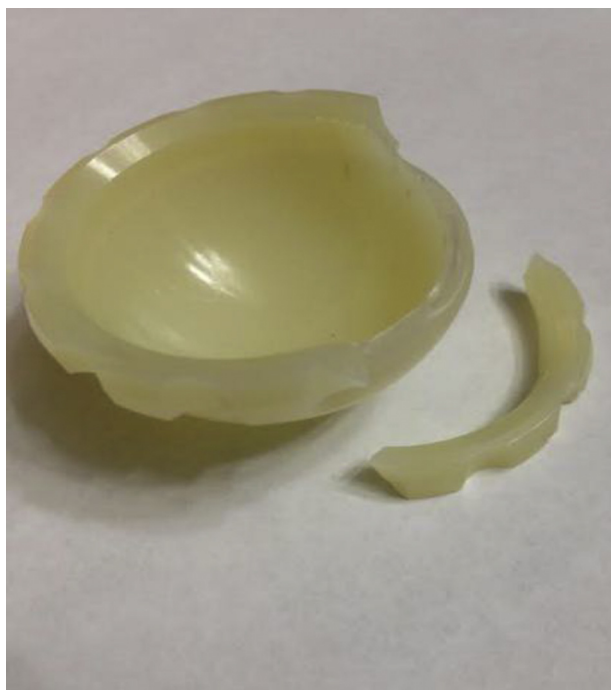
Figure 4. Photograph of fractured polyethylene component at the superior rim into 2 fragments with no visible thinning of the liner.

E-infused product or a flaw in the initial design of the liner or a combination of the 2. Should this size of acetabular liner be used with a locking mechanism? Owing to locking mechanism indentations, there is an even further decrease in minimal thickness at the superior rim of acetabular liners. Material failure was reported by Berry et al. where they looked at 10 cases of polyethylene liner failure in THA with 3 different manufacturers. They found that all 10 liners that fractured had thin polyethylene at the rim with a minimum thickness of <5 mm. They believed that having a thin polyethylene rim was a contributing factor that could increase the risk for catastrophic failure in polyethylene liners. In a case report by Waewsawangwong et al. [11], they reported that the minimum thickness of HXLPE at the rim in addition to mechanical properties of HXLPE, a more vertical cup and the use of a large femoral head all played a role in fracture of the superior rim of the liner in their case. However, they end their report by stating that they believe that there should be a minimum rim liner thickness and that they would recommend at least 6 mm to minimize failure. In a study by Tower et al. [12], they suggested that the minimum thickness at the equatorial region was the critical dimension with respect to liner failure. In their report, all 4 liners that cracked at the superior rim had a minimum rim thickness of <4 mm. Additionally, they state that in offset liners, the minimum rim dimension can be much less than the specified nominal thickness especially with indentations that are part of the locking mechanism. It is important to note that in the report by Bates and Mauerhan [9], there was also failure of the superior aspect of the vitamin E-infused polyethylene liner and that there was a minimum thickness of 4.8 mm in their case. In the current study, the minimum polyethylene thickness for the offset liner dome was 5.8 mm, at 45° was 4.8 mm, and at the rim locking mechanism was 3 mm. While there was no visual evidence of excess wear, the bearing was not sent for analysis and we can not determine what the wear was at the site of fracture. From Yamaguchi et al. [13], the mean wear vector in the coronal plane is

8.1° laterally and this in combination with the decreased thickness at the rim could have contributed to the fracture.
