“Phacoemulsification tip fracture and how to manage it.”

Sukkarieh Georges^{*}, Al Soueidy Amine, Bejjani Riad, Chelala Elias

Ophthalmology Department, Hôtel-Dieu de France Hospital, Beirut, Lebanon

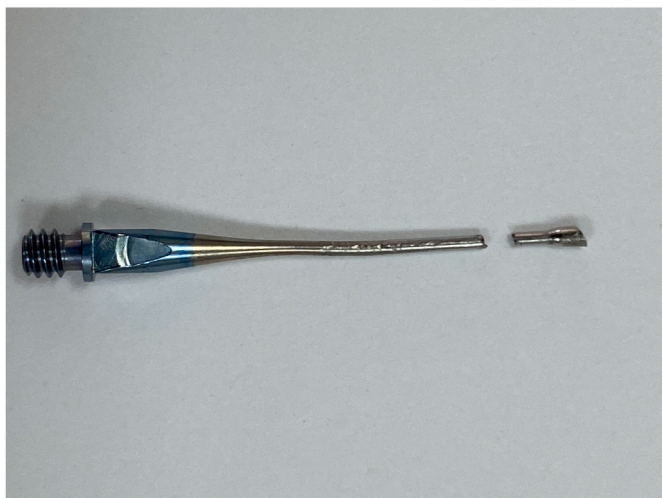
Surgery was performed on the left eye under topical anesthesia with 2% Xylocaine gel. Paracentesis, temporal corneal incision, continuous curvilinear capsulorrhexis, hydrodissection and hydrodelineation were then performed uneventfully. Phacoemulsification was then carried out using a round tip 20-gauge Aspiration Bypass System (ABS) phaco tip (Infiniti, Alcon laboratories, Inc., Fort Worth, TX, USA) on the standard handpiece of the Alcon Infiniti phacoemulsification machine. During sculpting, the followability of the nucleus was poor and there was no vacuum build up in system. A break of the phaco tip, while it was still inside the sleeve, was detected by the surgeon. The break was transverse and located at the distal quarter of the phaco tip (Fig. 1). The surgeon

Fig. 1. Picture showing the two parts of the broken phaco tip with multiple pits on its lateral side.

In our case, the phaco tip fracture was probably due to the ABS design and to the reuse of the phaco tip. ABS microholes are two small full thickness openings present in the walls of the distal end of the phaco

tip. Their role is to reduce post-occlusion surge by reducing vacuum build-up inside the tubing system when the phaco tip is occluded. Their presence renders the phaco tip at risk of breakage following a minor trauma. On the other hand, reuse of phaco tips has been previously described to cause many side effects such as dissemination of metallic foreign bodies, loss of occlusion during chopping and excessive use of ineffective U/S energy.¹⁰ In our institution, phaco tips are used ten times and are reesterilized using a steam-sterilizing autoclave at 134° Celsius. We believe that the sterilization and reuse of phaco tips causes the metal to wear making it more susceptible to break and could lead to undetected trauma during the sterilization procedure. In fact, as shown in Fig. 1, the broken phaco tip presented multiple small pits on its lateral side indicating metal wear and microtrauma due to the reesterilization.

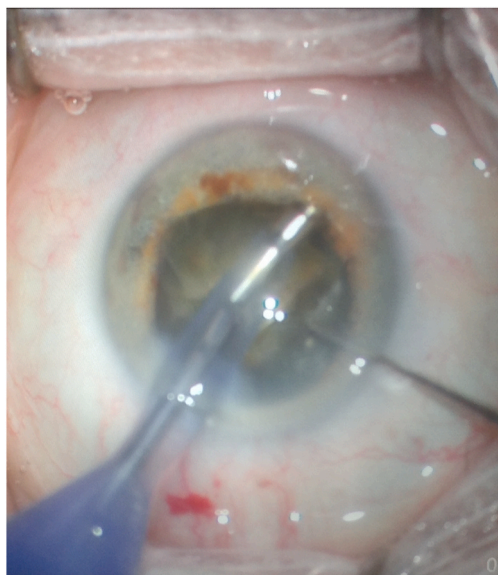
Fig. 2. Picture showing the broken phaco tip inside the sleeve and the second instrument of the operator inserted through the side port.

then inserted a Lebuissou manipulator (Moria/Microtek Inc., Doylestown, PA, USA) through the side port and used it to stabilize the broken distal end of the phaco tip inside the sleeve (Fig. 2). He then slowly retrieved the phaco tip through the main incision while maintaining the broken end inside the sleeve using the Lebuissou manipulator. The phaco tip was replaced with a new one and nuclear sculpting was attempted again. On the second attempt of sculpting, followability was still poor and the machine signaled an error. The surgeon then manually flushed the handpiece, using a 5 ml syringe containing balanced salt solution, through the aspiration port. While flushing, resistance was initially felt and then dissipated concomitantly with small metallic foreign bodies going out of the phaco tip. To eliminate the risk of metal foreign bodies being entrapped inside the tubes, tubing was changed and the system tested successfully. The surgery was carried out with no further complications. Ophthalmological examination of the patient was normal 48-h postoperatively with uncorrected visual acuity of 20/30. Ophthalmological examination remained stable through 1 month postoperatively except for an ameliorated uncorrected visual acuity of 20/20.

The best way to extract the fractured phaco tip is by retrieving it from the eye while maintaining it inside the phaco sleeve. In that way, the sleeve will play a protective role preventing any contact between the sharp edge of the broken phaco tip and any intraocular component. To do so, when the fracture is detected, the surgeon should immediately stop aspiration and ultrasound delivery. Ophthalmic viscosurgical device should then be inserted through the side port to protect the corneal endothelium during the extraction of the broken tip. The second instrument (Lebuisson manipulator, cyclodialysis spatula or other instruments) should then be used to help the main hand slowly remove the fractured phaco tip from the eye by maintaining the fractured end inside the sleeve. Before proceeding with the surgery, the handpiece should be flushed with balanced salt solution, the irrigation and aspiration tubes should be replaced by new ones and the machine should be tested to make sure that all metallic bodies originating from the break were washed out of the system.
