Research Article

Failure of Polyethylene Inlays in Cementless Total Hip Arthroplasty: A Retrieval Analysis

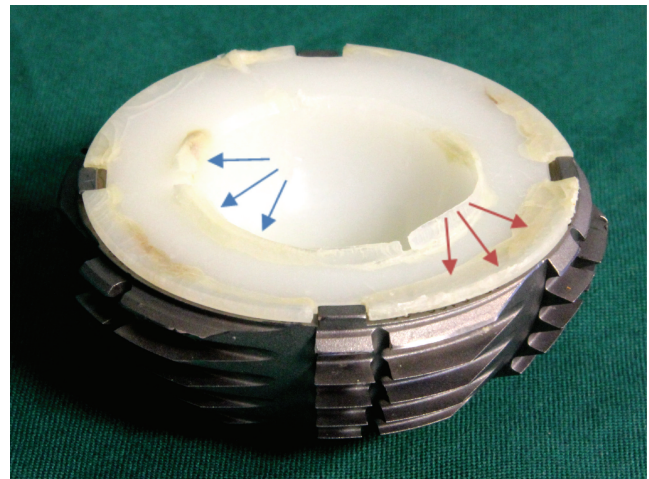
- (1) Deformation and fatigue at the collar of the polyethylene inlay in the area, where the collar (outer rim) is in contact with the titanium acetabular shell: this has been defined as *collar fatigue*. An example is given in Figure 1 (red arrows).
- (2) Creep and deformation at the inner rim of the polyethylene inlay, leading to narrowing at the cup opening: this has been defined as *rim creep*. An example is given in Figure 1 (blue arrows).
- (3) Wear at the protruding back of the polyethylene inlay: this has been defined as *backside wear*. An example is given in Figure 2.

FIGURE 1: Examples for the design-specific damage modes: rim creep at the cup opening (blue arrows) and collar fatigue at the flanges on the outer rim (red arrows).

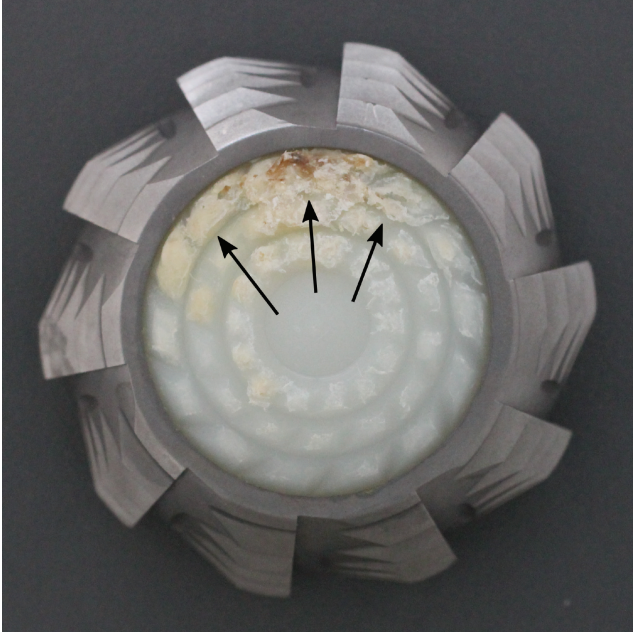
FIGURE 2: Example for backside wear at the underside of the inlays (black arrows).

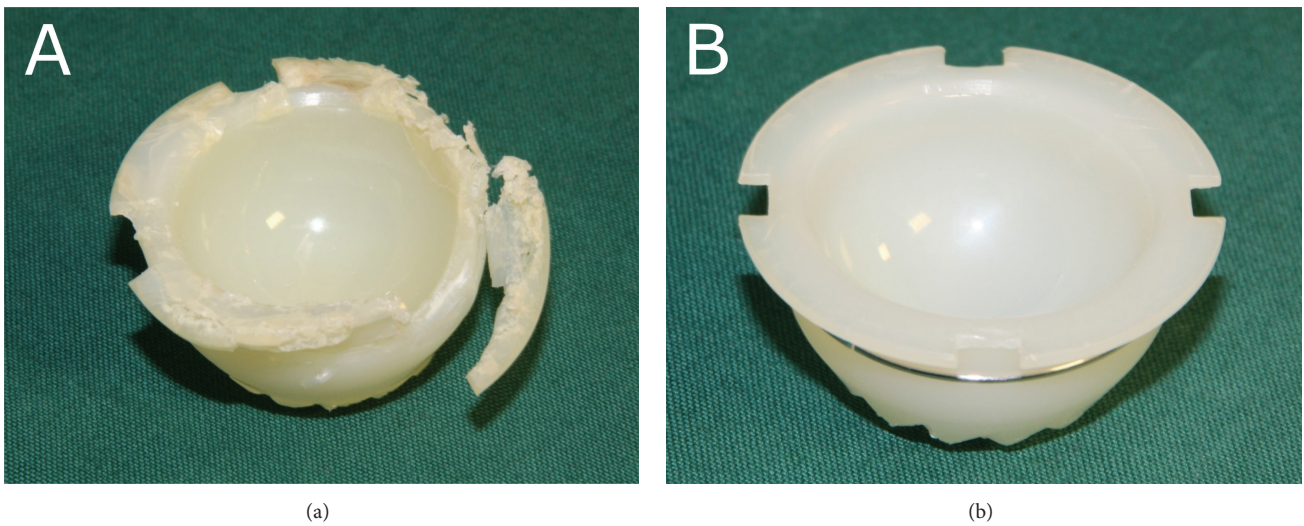
3.2. Damage Scores. Rim creep was present in 38% of the polyethylene inlays, whereas backside wear was seen in 90% of the inlays and collar fatigue occurred in 68% of the cases. The total damage score ranged from 1 to 27 (14.5 ± 7.2). Examples for a severe damaged inlay (damage score = 26.5) and an inlay with low damage (damage score = 1) are shown in Figure 4. The assessed damage scores for each type of damage are given in Figure 5.

FIGURE 4: Two examples of the polyethylene inlays: severe damage in terms of backside wear, rim creep, and collar fatigue is obvious after 18.5 years in situ (a) and a mild case whereas only minimal backside wear occurred after 7.6 years in situ (b).

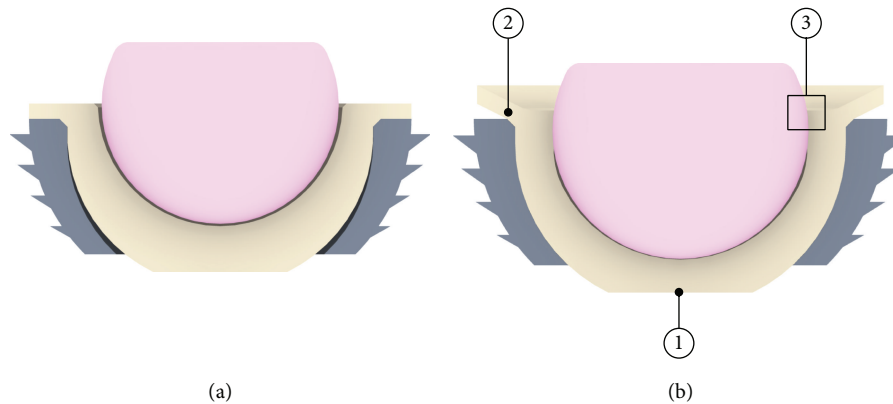
The following mechanism may explain these observations: it is assumed that the inlays were originally manufactured with a sufficient clearance that allows free articulation of the head in the insert. Thus, the inlay geometry might have changed over time in situ. This geometrical alteration is related to a missing support on the back of the inlay and overloading of the collar over time. Initially the inlay is well fixed based on the snap-fit mechanism and the collar is equally supported by the cup (Figure 8(a)). Due to in vivo loading the polyethylene begins to creep and this causes a flow of the material into the cup. As the cup is open, creep will not be limited to a certain extent. Consequently, the polyethylene gets into contact with the bone behind

the cup and backside wear may occur (Figure 8(b)(1)). Simultaneously, increased stresses are acting at the back of the collar leading to deformation and fatigue (Figure 8(b)(2)). In progress the deformation will lead to narrowing of the inner rim of the polyethylene inlay (Figure 8(b)(3)). This will result in a reduced diameter at the cup opening and decreased clearance. Increased friction between the head and the inlay will cause higher stresses at the bone implant interface and may contribute to loosening of the implant.

FIGURE 8: Assumed failure mechanism of the Mecring: the correct function of the PE inlay in the cup as initial state is shown in (a) whereas (b) shows the deformed inlay with narrowing at the inner rim and backside wear caused by cold flow of PE.

In conclusion, a polyethylene inlay should be supported at the back to avoid ongoing creep deformation. This is of particular importance if the inlay has a collar. The combination of both may compromise the joint articulation leading to failure of the implant which should be avoided.
