Case Report

Unusual Case of a Trunnion Fracture Following a Revision Hip Arthroplasty Surgery: A Brief Review of the Literature and Discussion About Causes of Failure

Hamilton P. Vick, MD, Grayson A. Domingue, MD^{*}, Kacy Richburg, MD, Ryan Dean, MD, Fahmida Khan, MD, MPH, Rishi Thakral, MD

University of Oklahoma Health Sciences Center, Oklahoma City, OK, USA

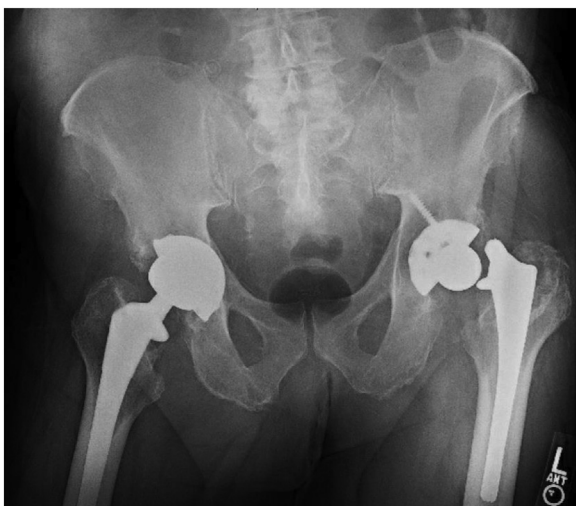
Figure 1. The preoperative anteroposterior radiograph showing our patient with hardware failure.

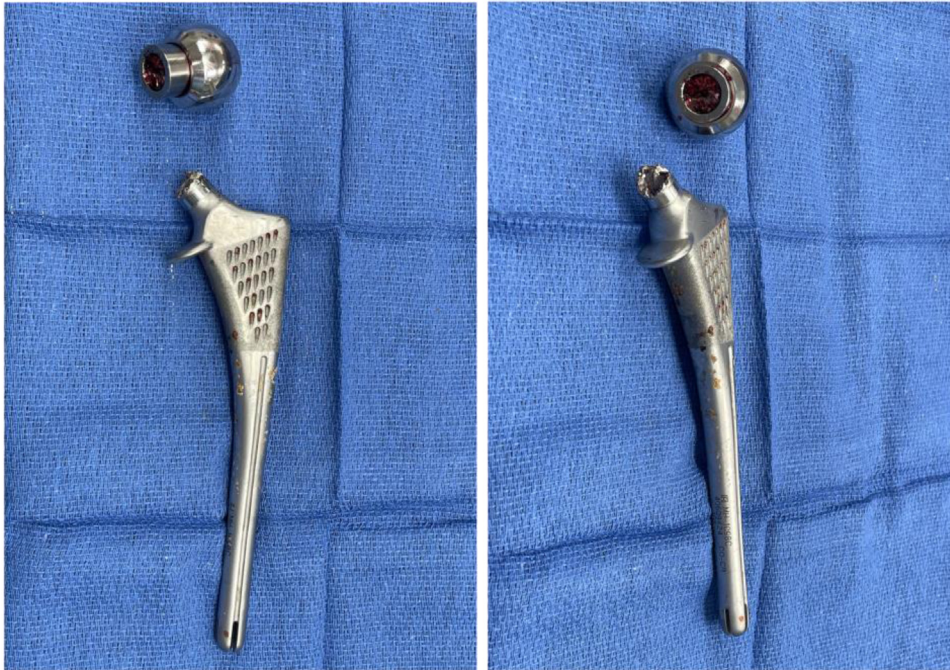
This case is unique in that the fracture through the trunnion occurred in a cemented cobalt-chromium alloy femoral component with no intraoperative evidence of significant corrosion or metallosis within the soft tissue, and there was no obvious design flaw.

Figure 2. The removed femoral component.

There are no previous Food and Drug Administration reports of similar failures with the femoral stem that was used in this patient. No known risk factors such as obesity, excessive activity, varus position of the stem, small taper size, or increased neck length or offset were present [2,6,7,9,12,13,17,19]. Our patient did have revision of the femoral head component 8 years prior to the fracture of the trunnion. At that time, a titanium sleeve and a new metal head were placed. It is likely that the trunnion was scratched or pitted during the initial or revision procedure. The small surface grooves in the metal and damage to the oxide coating then acted as stress risers and corrosion initiators, allowing for eventual crack propagation and ultimately catastrophic failure after years of cyclic mechanical loading [13,19,20]. It is possible that a ceramic head, rather than a metal one, would have halted this progression.

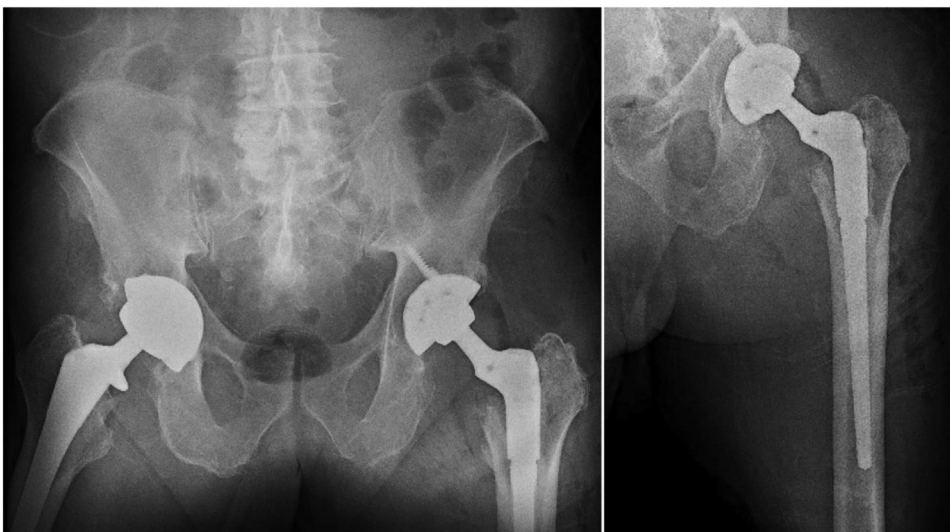
Figure 3. Postoperative anteroposterior radiographs of the pelvis and left hip.
