Case report

Failure Mode Analysis of an Exeter Stem Fracture Initiated at the Introducer Hole: Time for a Design Change?

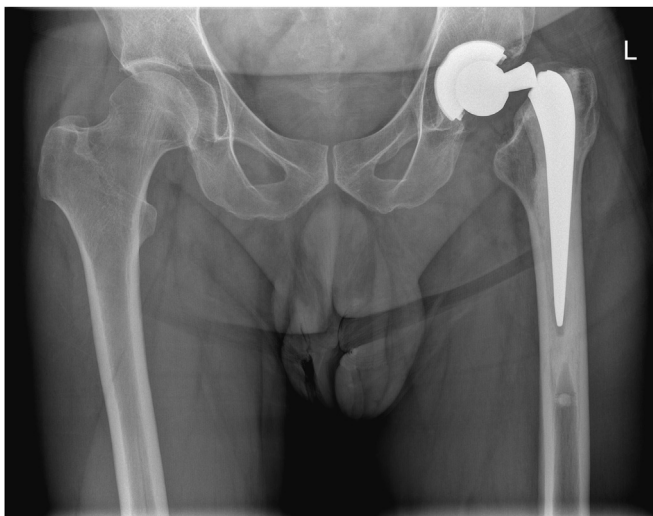
Figure 1. Anteroposterior pelvic plain radiograph showing the neck fracture of the cemented Exeter stem.

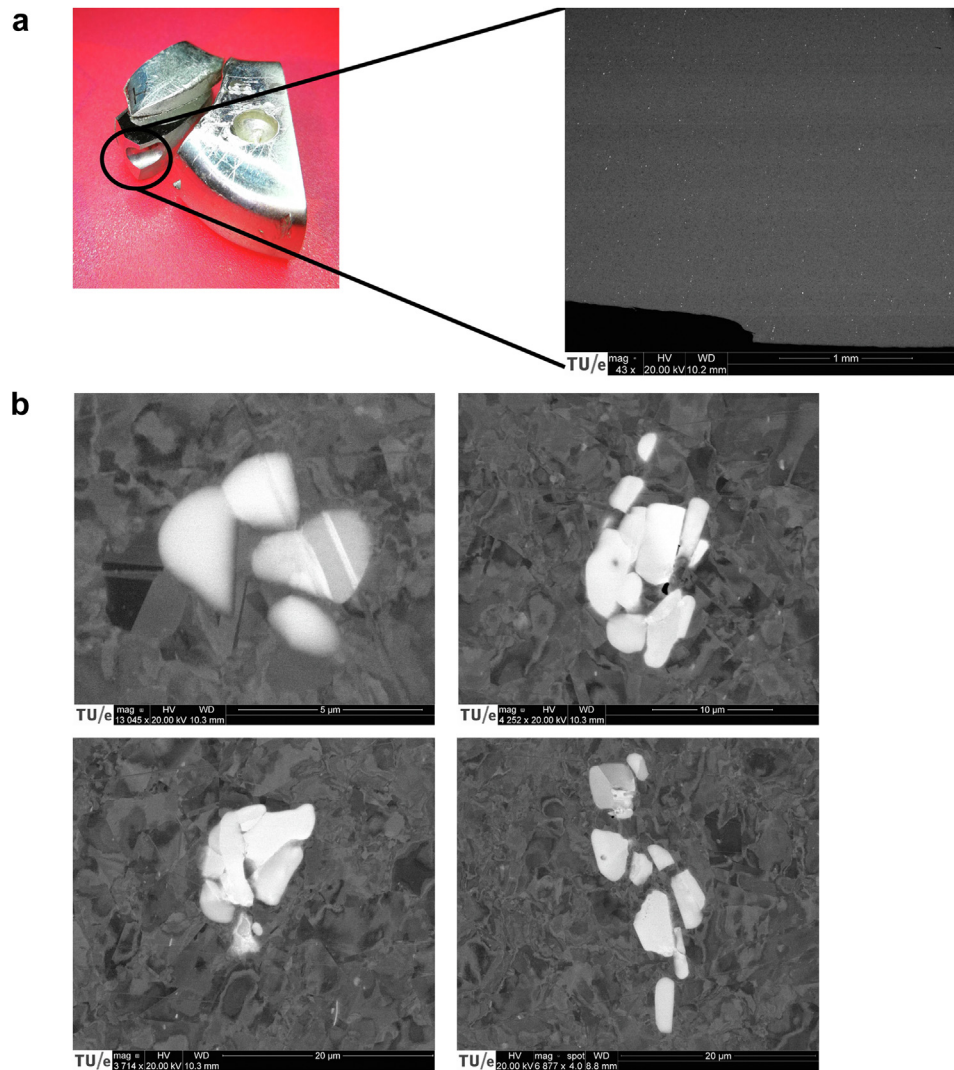
Cross-section B revealed white spots under the scanning electron microscope which appeared to be niobium (Nb)-rich phases on higher magnification (Fig. 6). Energy dispersive spectroscopy was used to identify the different elements with their compositional fraction of the metal alloy and were compared to the ISO standard. At cross-section A, most of the element fractions were in line with the expectations, except for carbon (C) and nitrogen (N), which clearly surpassed the ISO5832-9 specification (Table 2). The scanning electron micrographs and element mapping were also performed at Nb-rich locations (Fig. 7), revealing a higher concentration of N and, to some extent, also chromium (Cr). The C content in these regions is not given, as it is not accurate enough.

Figure 6. Scanning electron microscopy analysis of cross-section B (the surface perpendicular to the initiated crack near the stud hole) showing niobium (Nb)-rich phases (a) and on higher magnification (b).

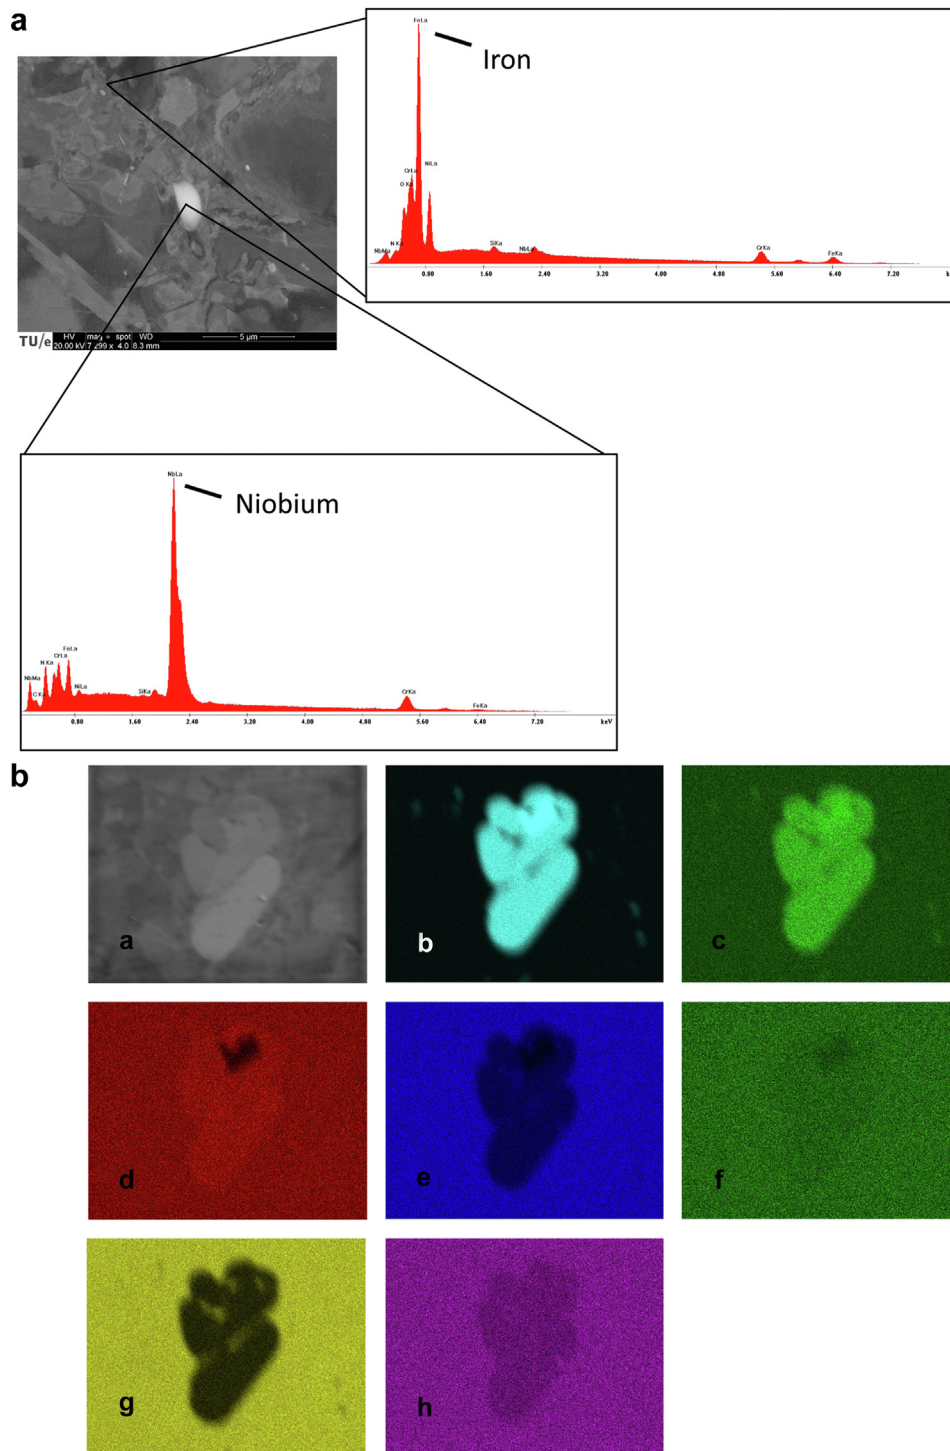
Figure 7. (a) Scanning electron microscopy image with elemental analysis at the indicated niobium-rich location (white particle) and at a control location outside the precipitate. The Nb-rich regions also reveal a higher concentration of nitrogen and, to some extent, chromium. (b) Element maps showing the concentration of elements in the Nb-rich phase (most likely CrNbN zeta phase) within the matrix (austenite). A, scanning electron microscopy overview; B, niobium; C, nitrogen; D, chromium; E, iron; F, manganese; G, nickel; H, silicon.

carbides. The addition of Nb to stainless steels is known to induce the precipitation of Nb carbonitrides, in different sizes and shapes [24]. The energy dispersive spectroscopy results indicate that the grain of the phase examined here was indeed Nb(C,N) precipitates. These precipitates have a high hardness.

From the experimental analysis, there are indications that the interfaces of the precipitates are rather weakly bonded. This also means that the precipitates are easily “broken out,” for example, during mechanical processing treatments. Voids were also observed at and near the precipitates.

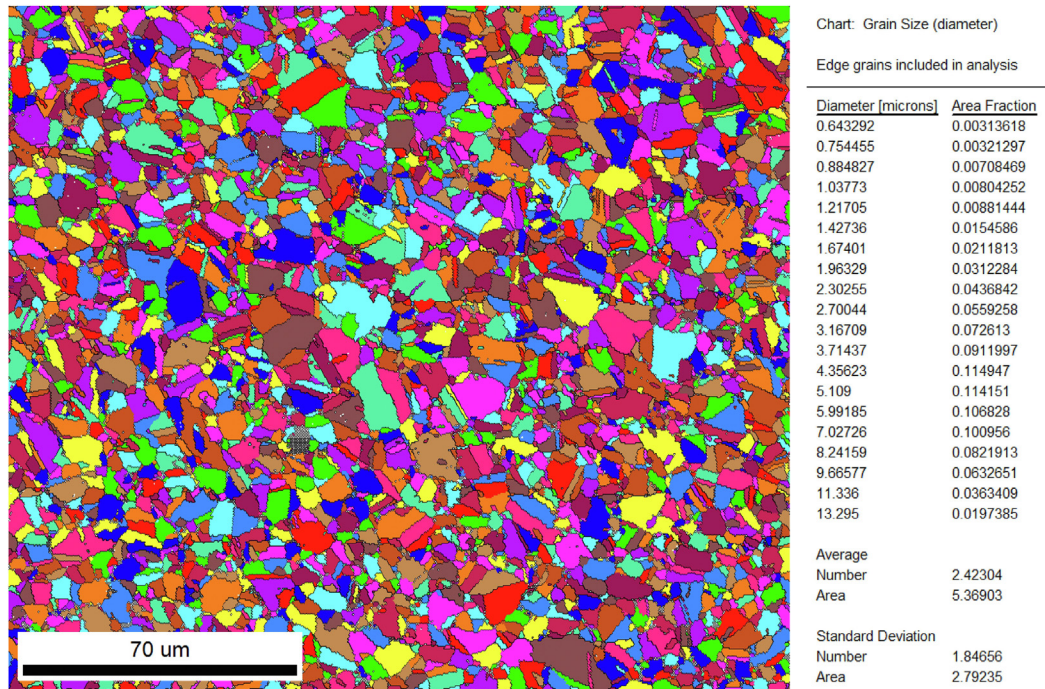
Orientation imaging microscopy was used at cross-section B to analyze the grain structure and orientation, allowing to visualize the microstructure of the base material (austenite). The average grain size was ~5 microns. The global microstructure was visualized using electron backscatter diffraction imaging (Fig. 8), whereby each grain is indicated with a separate color to distinguish it from its neighbors. The electron backscatter diffraction also revealed CrNbN Z-phases.

Figure 8. Grain size analysis using orientation imaging microscopy (colors only indicate the existence of the different grains).
