Oxidized Zirconium Bearing Surface Failure in Total Knee Arthroplasty: A Unique Case Report of Isolated Medial Compartment with Catastrophic Results

Keywords: OXINIUM™, total knee arthroplasty, metallosis, prosthetic failure.

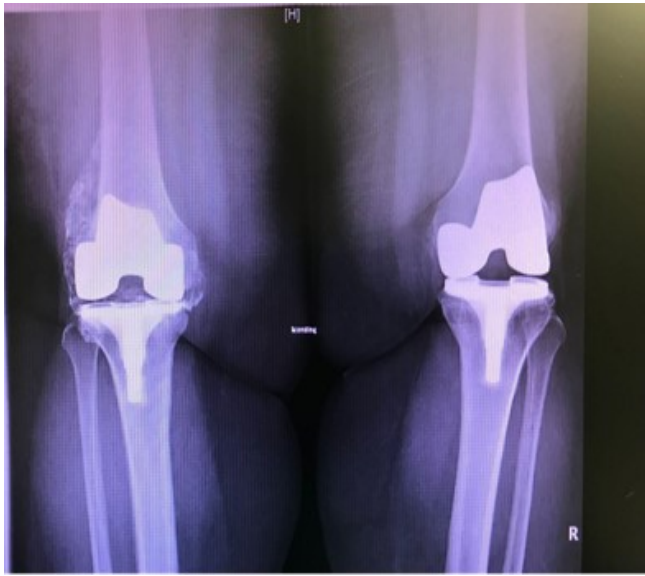
Figure 1: AP standing radiograph of bilateral knees demonstrating left-sided osteolysis and a cloud sign.

provocative testing. Imaging obtained during her evaluation confirmed this suspicion with a cloud sign noted on plain radiographs (Fig. 1).

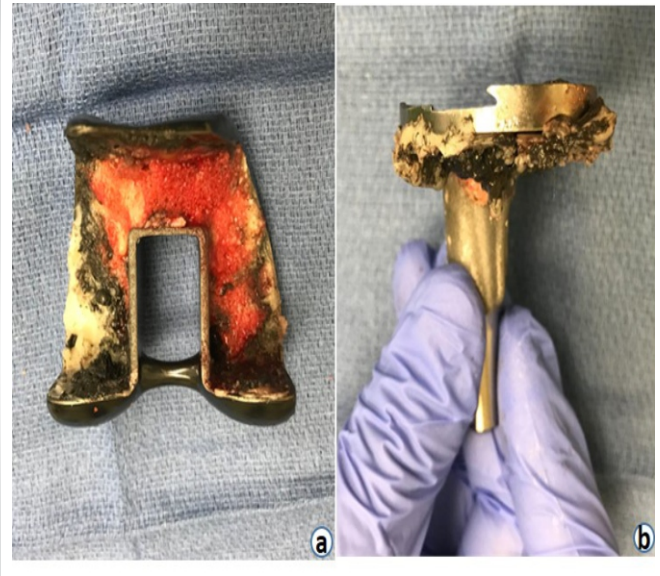
Figure 2: (a) Axial view of zirconium debris within heterotrophic bone capsule of the femoral component. (b) Sagittal view of zirconium debris within heterotrophic bone capsule of the tibial component.

During our initial medial parapatellar approach, black synovial fluid and periprosthetic tissue were noted (Fig. 2a and b) immediately when the capsule was incised. At this point, our suspicion for metallosis was confirmed when the use of the electrocautery Bovie® on the periprosthetic tissue produced sparks. A significant synovectomy and soft-tissue debridement were performed until all contaminated tissues were excised. When the primary hardware was removed and inspected, we noted disintegration of the

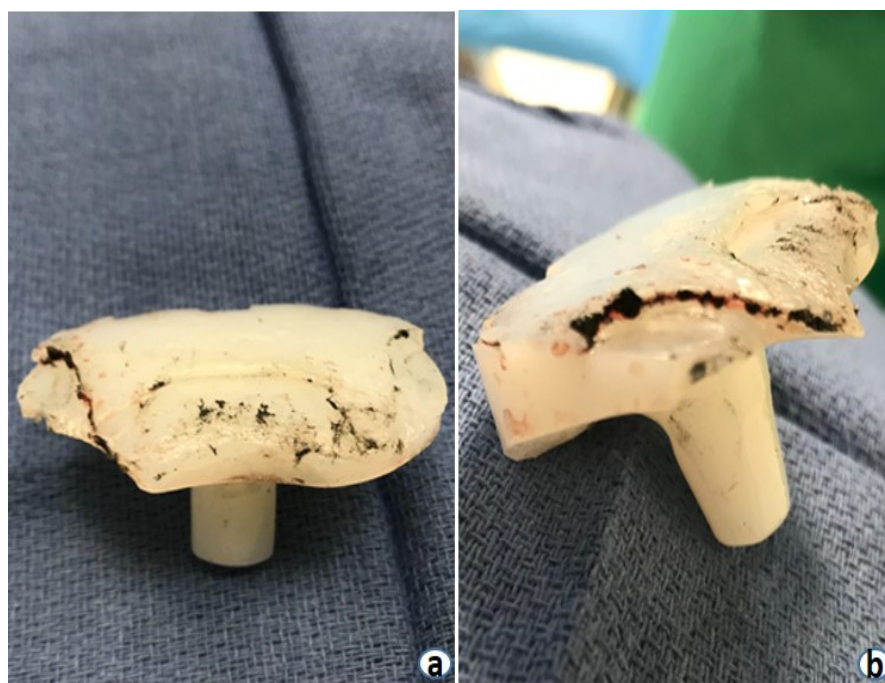
Figure 3: (a) Coronal view of polyethylene spacer demonstrating disintegration of the medial compartment. (b) Sagittal view of the polyethylene spacer further demonstrating disintegration of the medial compartment.

polyethylene spacer which was isolated to the medial compartment (Fig. 3a and b).

This would account for the loss of the zirconium coating in the medial compartment of the prosthesis, but there was no supporting evidence for the wear noted in the lateral compartment. The primary TKA components were replaced with a nickel-free prosthesis (Fig. 4).

This led us to speculate that there was an issue with the polyethylene component as it had disassociated from the tibial locking mechanism and caused the femoral and tibial components to articulate in a metal-on-metal manner – resulting in zirconium debris throughout the synovium, bone, and surrounding soft tissues. While it is worth noting that the original surgeon was concerned about the position of the tibial component, it does not appear to be the main cause of the prosthetic failure as both the tibial and femoral components were stable on intraoperative examination during revision surgery.

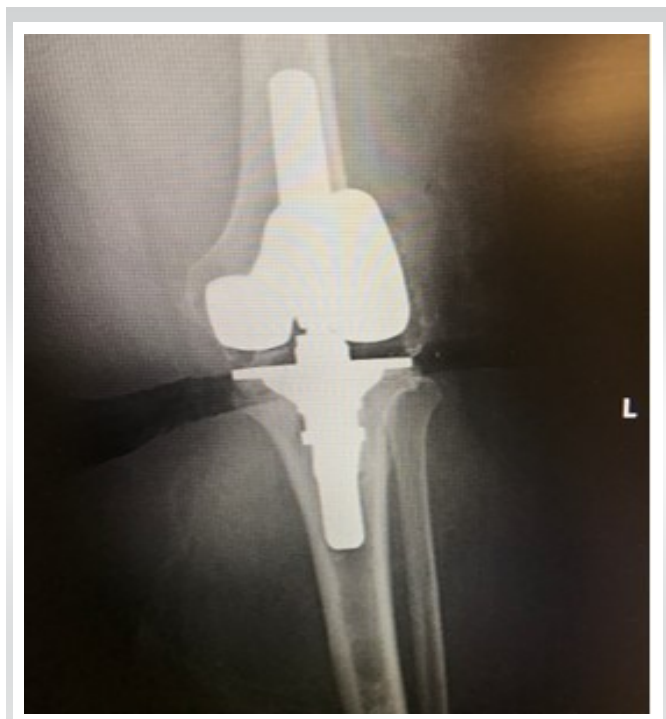
Figure 4: AP radiograph demonstrating revision total knee arthroplasty utilizing aesculap nickel-free implants.
