Radiofrequency remote monitor software patch update without cybersecurity implantable cardioverter-defibrillator firmware update increases the risk of inappropriate implantable cardioverter-defibrillator therapies

We present a case of a patient with a St. Jude Medical/Abbott Fortify Assura™ ICD without cybersecurity firmware update who received multiple inappropriate ICD shocks likely in the setting of atrial fibrillation (AF) with rapid ventricular response after the Merlin@home RF communicator software patch resulted in reversion to hardware/backup mode. This case identifies a second important reason to consider updating St. Jude Medical/Abbott CIED cybersecurity firmware.

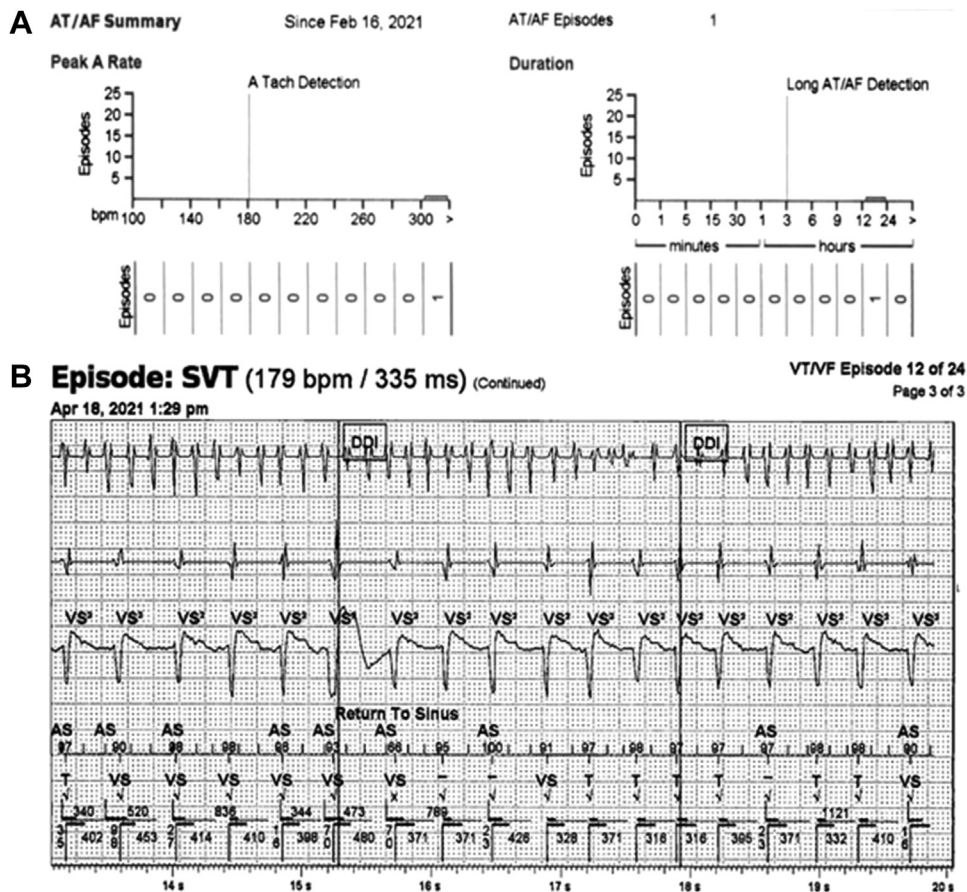
Figure 2 Device interrogation 4 weeks prior to event showed the following: **A:** 1 episode of atrial fibrillation (AF) with atrial rate >300 beats per minute, which lasted for about 14 hours; **B:** same episode of AF with ventricular rate >179 beats per minute.
