Inside-out abrasion and contained conductor cable externalization in a defibrillation lead with asymmetric conductor cable lumen distribution

Ernest W. Lau, MD, Michael J.D. Roberts, MD

From the Department of Cardiology, Royal Victoria Hospital, Belfast, Northern Ireland.

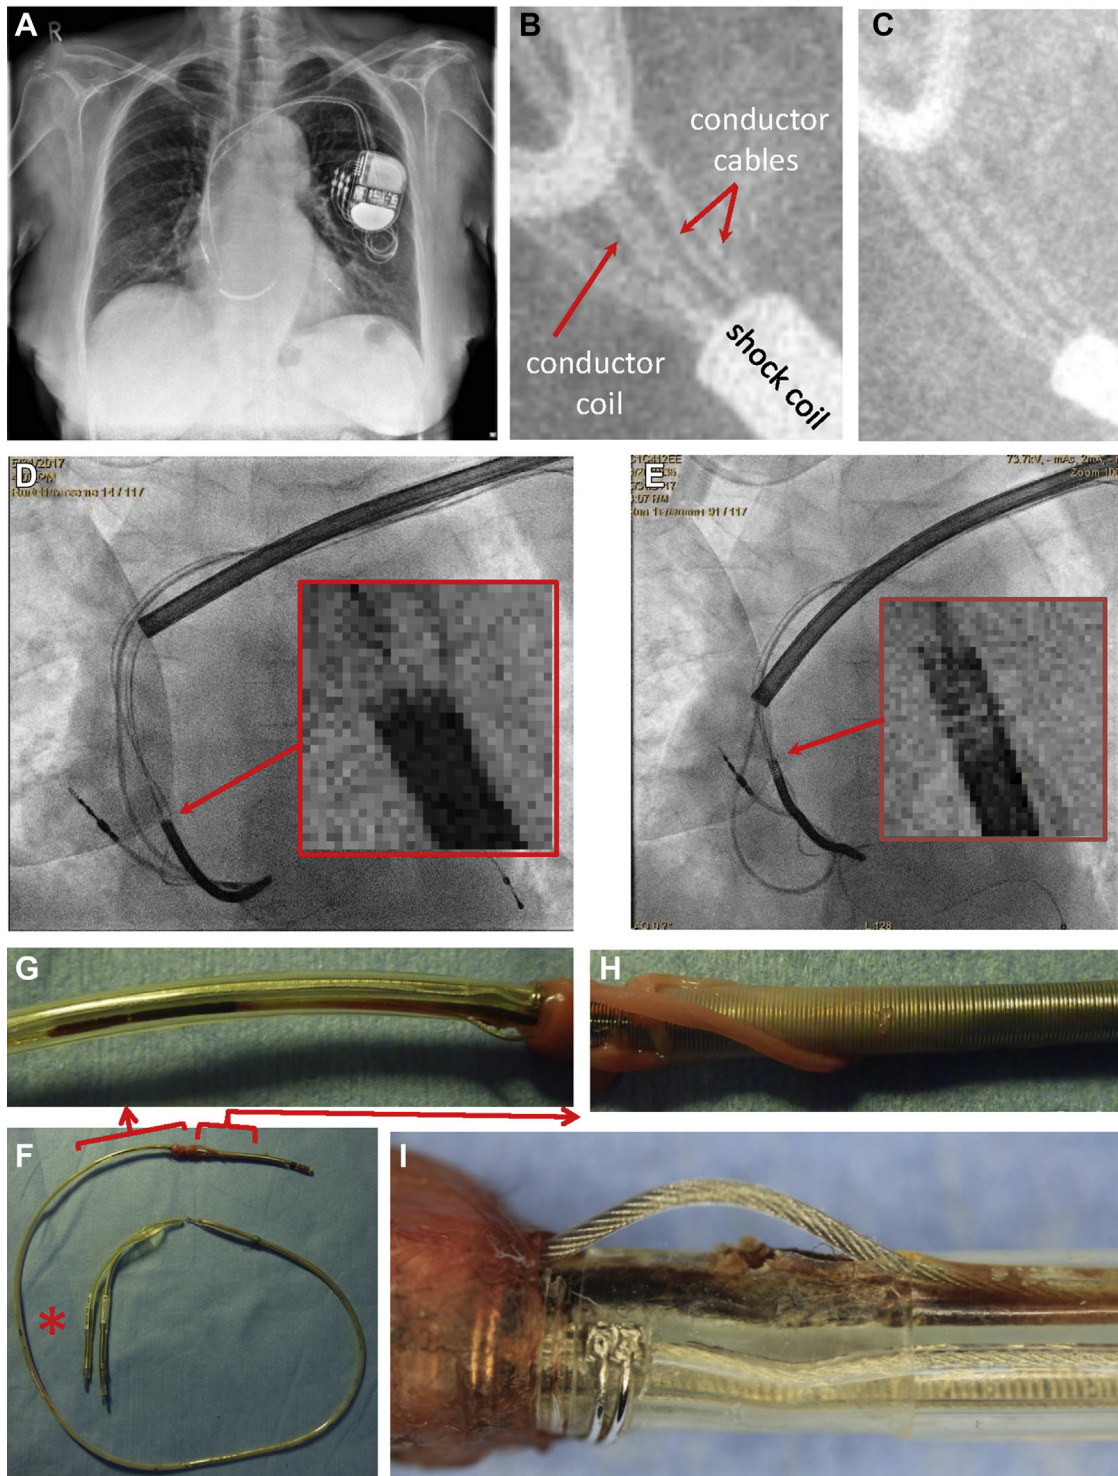
DF lead failure was diagnosed and the patient was admitted for lead extraction and replacement. Pre-extraction, the tip of the DF lead was on the mid RV septum and the proximal end of the shock coil formed the “nadir” of its intracardiac course (Figure 2A). A kink existed in 1 of the 2 conductor cables just proximal to the shock coil (Figure 2B) and was not present when the lead was first implanted (Figure 2C). The turns of the shock coil were tightly packed. The DF lead was extracted with a lead locking device (Spectranetics, Colorado Springs, CO) and a rotating dilator sheath (TightRail, Spectranetics) (Figure 2D). As traction was applied, the proximal turns of the shock coil separated and the lead suddenly broke free (Figure 2E). The tip of the rotating dilator sheath was approximately 2 cm ($\approx 6 \times$ lead body width) proximal to the shock coil at that point. The lead was pulled out of the body without further active cutting by the rotating dilator sheath. A new DF lead was implanted and the pre-existent device reused. The revised CRTD system was functioning normally at 3 months follow-up.

adhesions only around the proximal end of the shock coil (close to the “nadir” of the lead’s intracardiac course, [Figure 2A](#)) but not elsewhere, and very little damage to the lead by the extraction process ([Figure 2F](#)). A conductor cable protruded through a breach in the silicone insulation between the shock coil and the polyurethane overlay. Old, dark blood was seen in the lead body both close to and distant from the insulation breach. Fresh, lighter blood was seen closer to the insulation breach than old dark blood in the adjacent proximal lead body ([Figure 2G](#)). The fibrous adhesions were thicker over the proximal than toward the distal end of the shock coil ([Figure 2H](#)). The insulation breach had ragged edges and was filled with biologic debris and altered blood ([Figure 2I](#)). The conductor cable welded to the shock coil had a kink proximal to it and was distinct from the ring electrode cable protruding through the insulation breach. The proximal turns of the shock coil were displaced distally relative to their grooves in the medical adhesive.

The proximal end of the shock coil was fixed to the endocardial surface by fibrous adhesions ([Figure 2A, F, and H](#)). The adhesions were thinly and evenly spread over the proximal end of the shock coil, suggesting that they formed in vivo and were not displaced there from more proximal parts of the lead body during extraction. When traction was applied to the lead during extraction, the proximal end of the shock coil extended (and the turns of the coil separated, [Figure 2D and E](#)), but to a lesser degree than the underlying silicone insulation, owing to fibrous adhesions. When tension was suddenly released as the lead broke free, the turns of the proximal end of the shock coil did not return to their original positions and remained more widely spaced and displaced distally relative to the underlying silicone insulation ([Figures 2I and 3B, C, and D](#)).

The breach in the silicone insulation in the gap between the shock coil and the polyurethane overlay is consistent with abrupt rupture, with its ragged edges and little loss of material ([Figures 2I and 3B, C, and D](#)). The juxtaposition of fresh, lighter blood closer to the insulation breach than old, dark blood suggests that the tear formed during

Figure 2 Failed Sprint Quattro Secure lead before, during, and after extraction. **A:** Pre-extraction chest radiograph. **B:** Kink in a conductor cable. **C:** No kink in conductor cables immediately post lead implantation. **D:** Beginning of extraction. **E:** The lead broke free. **F:** Fibrous adhesions were seen only around the proximal end of the shock coil along the entire extracted lead. A conductor cable protruded through a breach in the insulation. Old, dark blood was seen in the lead body, both close to and distant from (*red asterisk*) the insulation breach. **G:** Old, dark blood was further away than fresh, lighter blood from the insulation breach and conductor cable protrusion. **H:** The fibrous adhesions were thicker around the proximal than toward the distal end of the shock coil. **I:** The breach in the silicone insulation between the shock coil and the polyurethane overlay had ragged edges and was filled with biologic debris and altered blood. The conductor cable protruding through the insulation breach was connected to the ring electrode. The shock coil cable had a kink just proximal to its weld to the coil. The proximal turns of the shock coil were separated and displaced distally.

extraction (Figure 2G). The silicone insulation already had a breach over the ring electrode cable under the proximal end of the shock coil pre-extraction (Figure 3B, C, and D). When tension was applied to the cut-and-tied proximal end of the lead during extraction, the silicone insulation (and the conductor coil to the tip electrode) at the lead’s fixation to the RV endocardial surface by fibrous adhesions (which coincided with a bend in its anatomic course in vivo) extended in response (Figure 2D and E), but the conductor cables could not. The ring electrode cable was forced to adopt a shorter course with a lesser curvature than the lead body by protruding out of the insulation breach under the shock coil, which gave it a mechanical advantage in tearing through the immediately proximal silicone insulation. A short segment of

the ring electrode cable became externalized through the tear and formed a loop outside the lead body after tension was released, as it was longer than the tear in the silicone insulation in its unstressed state (Figure 2I).

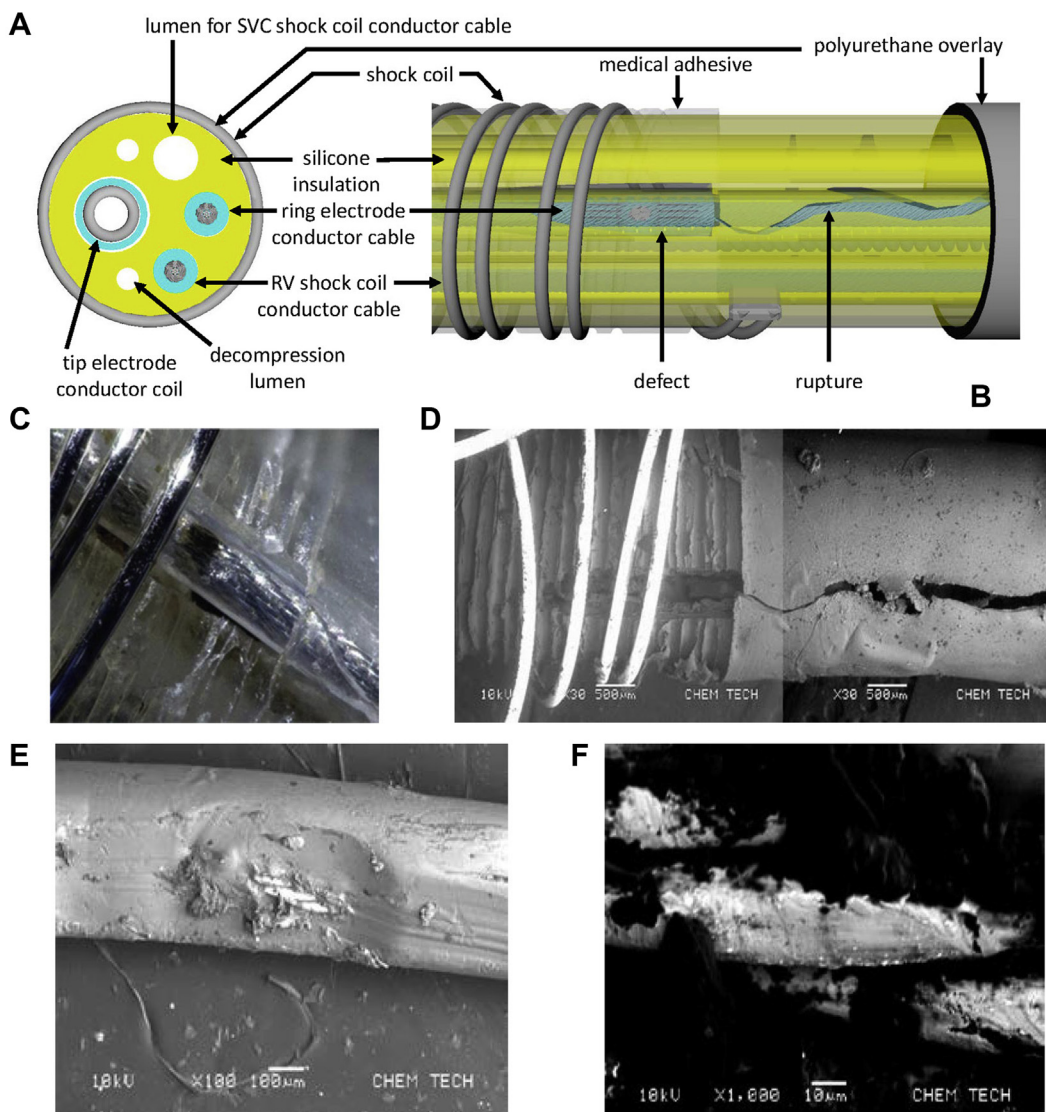
The extracted Sprint Quattro Secure lead, which has asymmetric conductor cable lumen distribution ([Figure 3A](#)), was returned to the manufacturer for analysis. The silicone insulation had a broad linear defect approximately 5 mm long and as wide as the conductor cable under the shock coil, and a narrow irregular tear in the gap between the shock coil and the polyurethane overlay ([Figure 3B, C, and D](#)). The ethylene tetrafluoroethylene (ETFE) coating of the exposed ring electrode cable segment had a scaphoid defect with loss of material and linear scratch marks at both

ends ([Figure 3E](#)) and exposed metal (sprinkled with spalls of platinum transferred from the shock coil) in the center ([Figure 3F](#)). The manufacturer reported no issues with the lead’s production.

Figure 3 Structure and defects of the failed Sprint Quattro Secure lead. **A:** Cross section of the lead. SVC = superior vena cava; RV = right ventricle. **B:** Diagram of the lead damages. **C:** The externalized conductor cable loop had been pulled back inside the lead body. The proximal turns of shock coil were displaced distally from their grooves in the medical adhesive. The silicone insulation breach was a broad linear defect (loss of material) under the coil and a narrow irregular tear (ragged edges; little loss of material) between the coil and the polyurethane overlay. **D:** The ring electrode cable had been removed. The silicone insulation defect under the shock coil was “undermined” (more extensive inside than outside) and tapered toward the lead tip. **E:** The ring electrode cable segment exposed in the silicone insulation defect under the shock coil had a scaphoid defect with loss of material and linear scratch marks at both ends in its ethylene tetrafluoroethylene coating. **F:** The exposed metal strands of the conductor cable were flattened and sprinkled with spalls of platinum (bright spots) transferred from the shock coil. The dark materials were biologic debris. (Images C, D, E, and F used with permission of Medtronic, Inc.)

The breach in the silicone insulation under the proximal end of the shock coil was a broad linear defect with significant loss of material (Figure 3B, C, and D). The ring electrode cable had a scaphoid defect in its ETFE coating, with loss of material, adjacent linear scratch marks (Figure 3E), and an exposed metal center sprinkled with spalls of platinum transferred from the shock coil (Figure 3F). These features strongly suggest IOA of the silicone insulation and the shock coil by the ring electrode cable: the silicone insulation was first worn through by the cable; the ETFE coating of the cable

was then scraped away by the shock coil; and finally, the shock coil and the metal conductor of the cable rubbed against each other, giving rise to nonphysiologic noises on both the near-field (tip-to-ring) and far-field (coil-to-can) channels (Figure 1C and D). The insulation breach was unlikely to have been caused by outside-in abrasion¹⁰ because of cover by fibrous adhesions and the shock coil.
