Article Structural Factors Inducing Cracking of Brass Fittings

Lenka Kunčická *, Michal Jambor 🗅, Adam Weiser and Jiří Dvořák

Institute of Physics of Materials, Czech Academy of Sciences, 61662 Brno, Czech Republic; jambor@ipm.cz (M.J.); aweiser@ipm.cz (A.W.); dvorak@ipm.cz (J.D.)

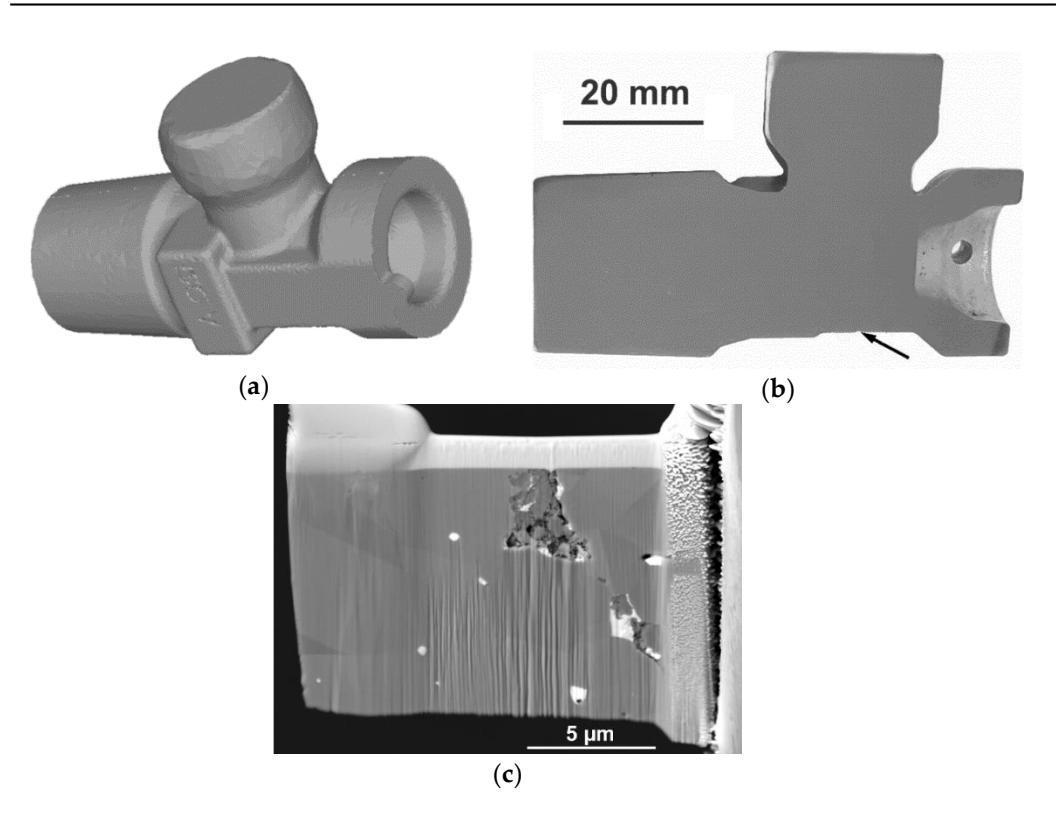
The aim of the work was to carry out detailed characterization of the structure of a brass fitting, with the focus on a specific location that exhibited cracking after hot deformation processing. The fitting was produced by Gas Control Equipment (GCE) (Chotěboř, Czech Republic) from the CuZn40Pb2 alloy. Figure 1a shows a model of the entire fitting created by the finite element method (FEM), using Forge NxT[®] software, whereas Figure 1b depicts the longitudinal axial cut through the real fitting, with the location of cracking

Figure 1. Numerical model of the investigated brass fitting (**a**); real cut through the brass fitting, with the location of cracking marked (**b**); lamella of the cracked region (before final milling), acquired using FIB (**c**).

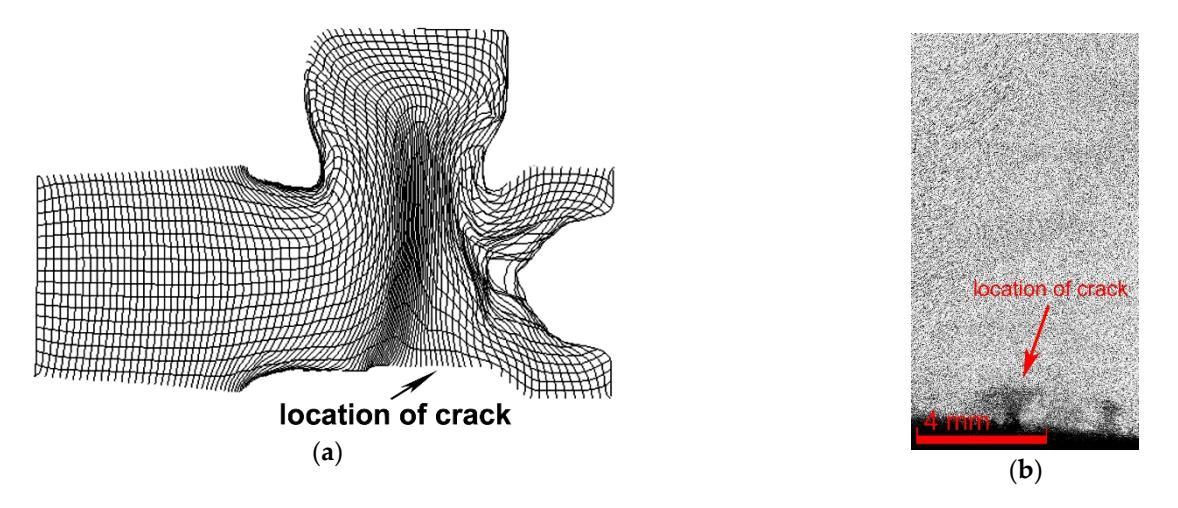
Numerical predictions and optical microscopy (OM) were the primary instruments used to analyse the plastic flow of the brass rod during the die forging of the fitting. Figure 2a shows a mesh superimposed through the axial longitudinal cut through the brass fitting, depicting the plastic flow of the material during the hot die-forging process. The supplementary detailed OM view of the flow of the grains along the axial longitudinal cut through the component (the crack can be seen in the bottom right corner) is depicted in Figure 2b. Both the figure from the simulation and the one from real forged part show that the plastic flow was aggravated in the area in which the crack occurred and in its vicinity, as the grains of the forged brass rod—the axis of which was parallel to the longitudinal axis of the fitting—primarily flew into the upper socket of the fitting, i.e., in the very opposite direction to the bottom horizontal area of the fitting in which the cracking finally occurred. The plastic flow also exhibited local instabilities, which manifested as a severely distorted grid in those particular locations (see Figure 2a).

Figure 2. Plastic flow along the axial longitudinal cut through the brass fitting acquired via numerical simulation (**a**); detailed OM view of plastic flow in the vicinity of the crack within the real component (**b**).

The numerical analysis of plastic flow revealed instability of material flow in the area in which the material flew into the upper socket of the fitting (see Figure 1b for the geometry of the fitting and the exact location of the crack, and Figure 2a for the predicted plastic flow), and also showed aggravation of the plastic flow in the location of the crack. This phenomenon was most likely induced by, among other factors, the increased friction of the forged brass with the die in this location [38]. Plastic flow instabilities also increase the risk of the occurrence of folds, as seen in Figure 3b,c. The experimental analysis of plastic flow performed via OM showed differences in the plastic flow in the individual locations of the fitting as well. The real material flow within the original extruded brass rod—the horizontal axis of which was parallel to the longitudinal axis of the brass fitting during die forging—was primarily towards the upper socket of the fitting. The aggravated flow of the material in the location of the crack most likely contributed to the observed defect, especially when considering its mutual effect with other factors—such as friction between the material and the die, or heat transfer through the die—which are important when evaluating the failure of materials, e.g., via computational simulations [38,39]. We also looked for any visible differences in the grain sizes between the internal and surface regions of the fitting. However, OM did not reveal any significant differences in this parameter throughout the structure of the component. The primary hypothesis was thus that the cracking occurred as a result of the mutual detrimental effects of aggravated plastic flow, local stress inhomogeneity, and local changes in the chemical or phase compositions.

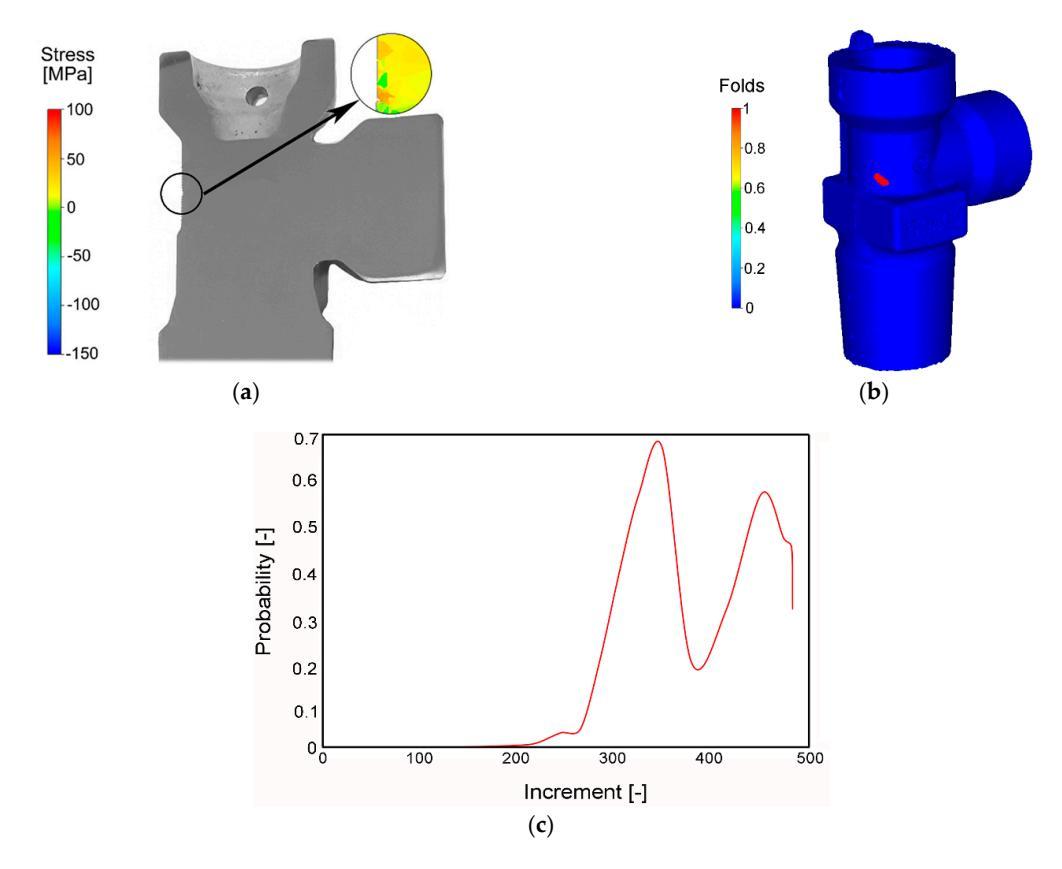
Figure 3a depicts the numerically predicted stress distribution in the location in which the crack occurred on the axial longitudinal cut through the fitting during hot forging. The prevailing stress in the cylindrical part of the fitting was of a compressive character. However, the part of the fitting featuring complex geometry exhibited the majority of the tensile stress, the value of which generally increased towards the shaped areas of the brass component. Nevertheless, certain locations on the fitting featured local stress inhomogeneities and combinations of compressive and tensile stresses, as can be seen in the circle in Figure 3a.

Figure 3. Stress distribution during hot forging in the location of the crack (**a**); predicted probability of the occurrence of folds in scale from 0 (0%) to 1 (100%) (**b**); Cockroft–Latham criterion during the die-forging processing step (**c**).

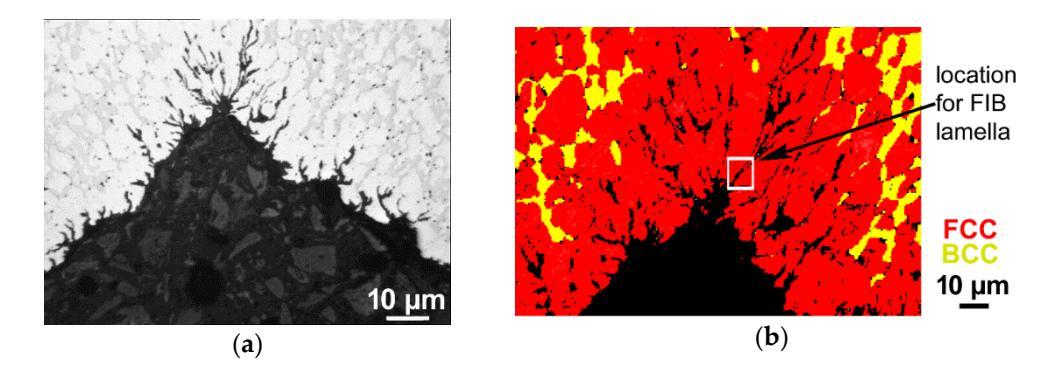
Subsequent analyses primarily focused on the structural factors in the vicinity of the crack, which could have contributed to the observed failure of the brass fitting. Figure 4a depicts a detailed optical microscopy image of the cracked area. As can be seen, the defect consisted of a stem-like branched crack, which developed at the surface of the brass component and proceeded towards its internal region in a direction more or less perpendicular to the longitudinal axis of the fitting.

Figure 4b shows an SEM-EBSD scan depicting the phases present in the cracked area of the fitting; the FCC (face-centred cubic) alpha phase is depicted in red, whereas the BCC (body-centred cubic) beta phase is depicted in yellow. The figure clearly shows that the surface of the fitting, as well as the entire cracked area, were depleted of the beta phase, as only the alpha phase was detected at the surface of the die-forged component.

Figure 4. OM image of the cracked area (**a**); SEM-EBSD scan of the cracked area, with a map of phase composition (**b**).

As evident from Figure 4b—which depicts the phase composition in the area in the vicinity of the crack, as acquired by the SEM-EBSD method—the surface of the fitting exhibited beta phase depletion. As the beta phase is the high-temperature brass phase [40], this finding is consistent with the previously discussed results. The locally aggravated motion of the material in the die, together with the continuous heat transfer between the die and hot brass during forging, contributed to accelerated cooling of the surface of the forged product, which facilitated the formation of the alpha phase on the surface of the fitting. In biphasic brasses, the beta phase ensures the plasticity and ductility of the material, while the alpha phase provides greater hardness and strength [40]. Therefore, the prevailing presence of the alpha phase decreased the ductility of the material in the location of cracking. This factor consequently also influenced the microhardness, which was

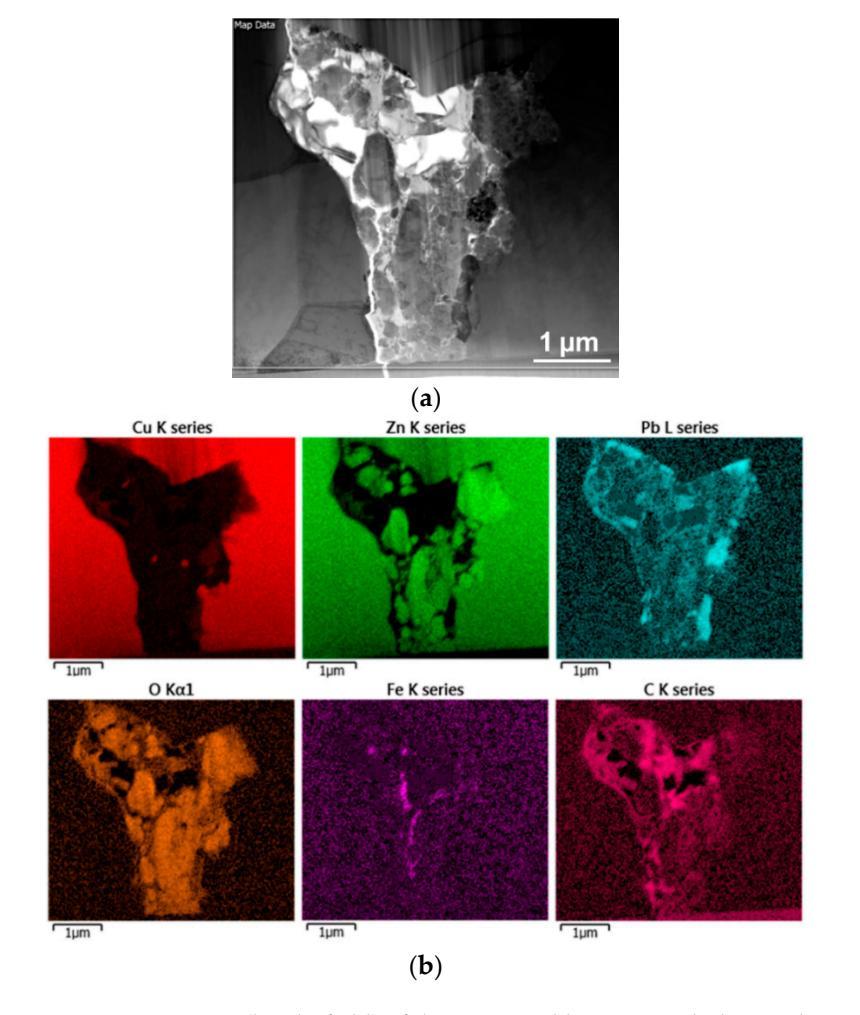
The structure analyses performed via SEM showed differences in the phase composition (see Figure 4b). Nevertheless, they did not reveal detailed information about the presence of possible precipitates or intermetallic phases in the vicinity of the crack. For this purpose, we prepared a lamella via FIB (see Figure 1c for the lamella and Figure 4b for the location from which the lamella was collected) and applied TEM. Firstly, we used TEM-EDS mapping to characterize the overall presence and distribution of the individual elements in the vicinity of the crack. The scanned area is depicted in Figure 5a, and the corresponding EDS maps for the individual elements are depicted in Figure 5b. As can be seen from the maps, the area surrounding the crack consisted mostly of Cu, with additional Zn and Pb, as expected. The area of the crack then exhibited negligible Cu content, but

increased concentrations of Zn, Pb, O, C and, locally, Fe. Subsequent investigations were focused on detailed examinations of the locations (particles) of interest.

Figure 5. TEM scan (bright field) of the examined location with depicted area of EDS mapping (**a**); EDS maps for individual elements for the scanned area (**b**).

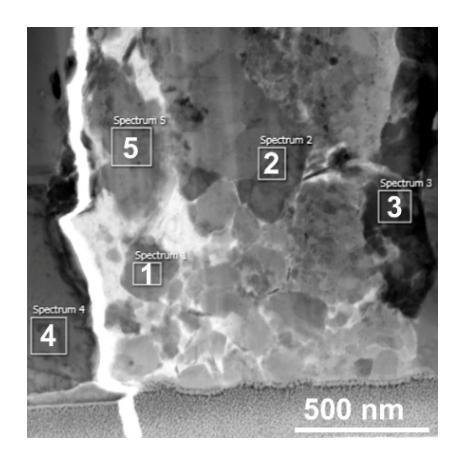
Figure 6 depicts a more detailed view on the area of the crack, in which subsequent analyses of the locations of interest were performed. The figure shows five individual locations (spectra) that were scanned for their detailed chemical compositions. The results of the scanning are summarized in Table 2. As can be seen from the table, the scan acquired from the location next to the crack—i.e., scan 4—exhibited only the presence of the brass elements characterized in Table 1—i.e., Cu, Zn, Pb, and Si. Scan 3—i.e., the location in very close proximity to the crack—also exhibited the presence of the basic brass elements, but together with quite a high amount of oxygen. The scans acquired from the particles present in the crack—i.e., scans 1, 2, and 5—all exhibited very little presence of Cu, but high content of Zn and/or Pb and Fe, together with oxygen (the presence of Na was most likely a remnant from the preparation of the samples).

Figure 6. TEM scan (bright field) of the detailed view of the cracked location, with depicted areas of local EDS scanning.

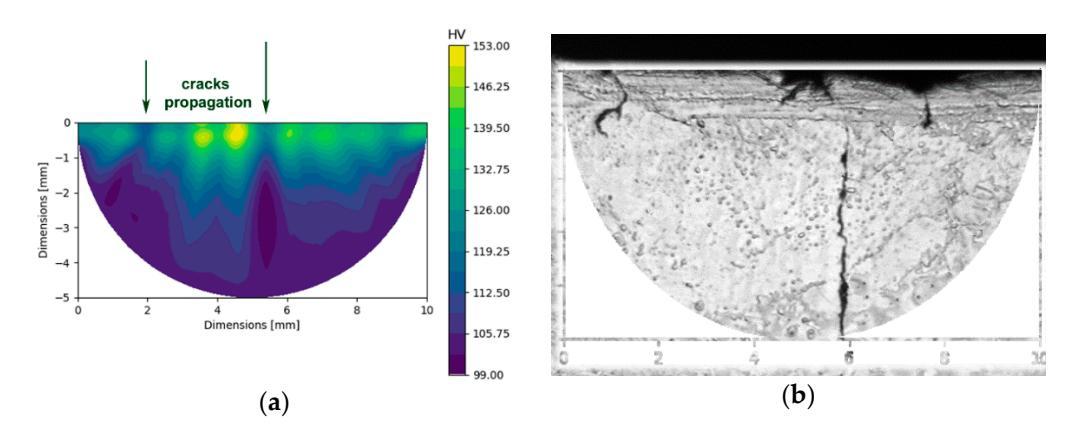
Figure 7. Map of experimentally measured microhardness in the cracked area (a); the corresponding cracked location, with depiction of the mapped area (b).

The images demonstrate that the microhardness was increased along the cracked surface, which resulted in decreased ductility, local brittleness, and eventual development of cracks. The map also shows that the occurrence of cracks consequently decreased the microhardness values along the cracks (see the local decreases in the HV values in the directions of the arrows depicted in Figure 7a, corresponding to the actual cracks in Figure 7b).

highest at the surface where the cracking occurred. On the other hand, crack propagation consequently weakened the material, which resulted in decreased microhardness values in the exact locations of the cracks (see Figure 7a,b). The detailed TEM characterization revealed that the area of the crack contained particles with increased oxygen contents, which points to the presence of oxides. Oxidic particles, especially when they are coarse and behave like interstitials, tend to be brittle and decrease the cohesive toughness of the material [41]. This phenomenon was demonstrated by the microhardness values, which were the highest along the surface on which the crack propagated.
