Inadvertent Intraoperative Defibrillation Secondary to Electrocautery Grounding Pad Placement

McGuire J A, Hayanga J, Barry C, et al. (September 21, 2022) Inadvertent Intraoperative Defibrillation Secondary to Electrocautery Grounding Pad Placement. *Cureus* 14(9): e29391. DOI 10.7759/cureus.29391

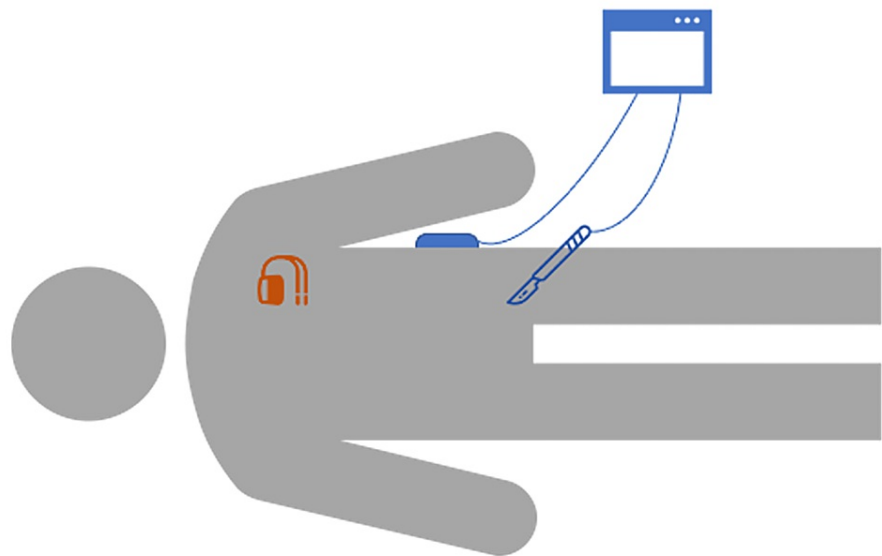
On the day of surgery, a spinal block with monitored anesthesia care was planned for anesthetic management. The spinal block was completed using 2mL of 0.75% hyperbaric bupivacaine injected intrathecally. The patient was placed in a supine position and the EDP was placed on the patient's left flank (Figure 1). After induction of anesthesia with a propofol infusion, both a nasal and oral airway was inserted to allow for adequate patency of airways, considering the patient's obstructive sleep apnea history. During the operation, the patient's AICD defibrillated on two separate occasions that were both concurrent with monopolar electrocautery usage. The surgical procedure was paused, and the EDP was repositioned from the left flank to the right flank. A magnet was placed over the AICD generator to inhibit its antitachycardia therapy functionality. The procedure was then resumed and completed with no additional complications. Postoperatively, a 12-lead ECG was ordered, and the electrophysiology team was consulted. The consultants found that the AICD had no abnormalities or malfunctions, and the inadvertent intraoperative defibrillations were confirmed. The patient recovered well postoperatively and suffered no clinically detectable myocardial damage.

FIGURE 1: Electrodispersive Pad Placement in Patient with Automatic Implantable Cardioverter Defibrillator.
