Images in
Cardiovascular Medicine

Optical Coherence Tomography-guided Treatment of Multiple Stent Fracture in Patients with Overlapping Drug-eluting Stents

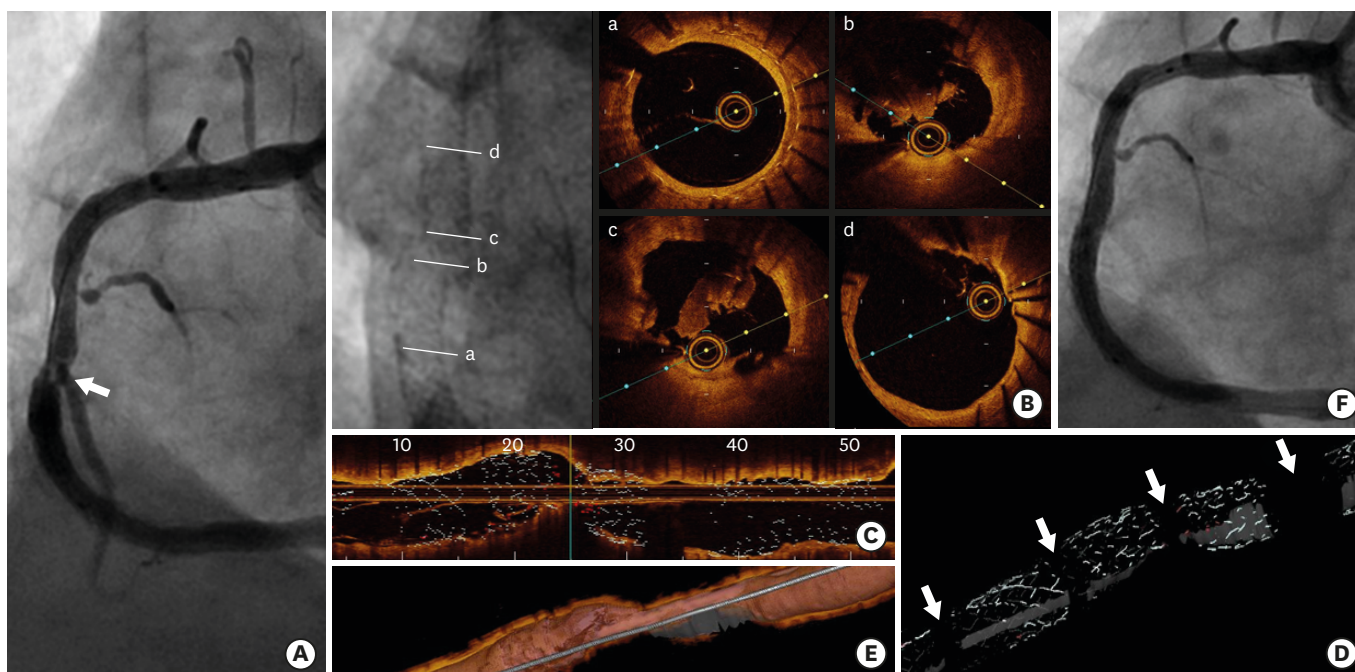
A 71-year-old man presented with exertional angina. Ten years ago, he had undergone treatment for myocardial infarction with two heterogeneous drug-eluting stents (DESs) in the right coronary artery (RCA): 4.0×30-mm Endeavor™ (Medtronic, Minneapolis, MN, USA) and 3.5×32-mm Taxus™ (Boston Scientific, Natick, MA, USA). Coronary angiography revealed intraluminal haziness in the middle of the previous RCA stent without significant in-stent restenosis (**Figure 1A**). However, magnified fluoroscopic images showed suspicious complete separation with displacement of the DES overlapping site (**Figure 1B**). Optical coherence tomographic (OCT) images showed multiple stent fractures with four gaps, confirmed on 3-dimensional (3D) reconstructed strut images (**Figure 1C and D**). The first gap was located at the Taxus™, the second gap with displacement was at overlapping site, and the third / fourth gaps were at the Endeavor™. Cross-sectional OCT images revealed tight stenosis with false lumen at the stent displacement point (**Figure 1, a-d**); the minimal lumen area was 1.68 mm². Before percutaneous coronary intervention, the concern was guide-wire position, which might be out of the fractured stent. However, the OCT images showed that the guide-wire was located clearly within the fractured stents (**Figure 1E**). The distance between the first gap and the fourth gap was more than 35 mm, as confirmed by longitudinal OCT images (**Figure 1C**). However, the purpose of a newer stent implantation was not the whole coverage of the pervious stent fracture, but treatment of the tight stenosis at the stent displacement point. Therefore, the lesions including both fracture sites were treated with implantation of 4.0×18-mm Resolute Onyx™ (Medtronic, Minneapolis, MN, USA), corresponding to the length of the tight stenotic lesion. Unfortunately, we could not perform a post-stent OCT imaging because of the risk of contrast-induced nephropathy. However, the final angiogram revealed good distal flow without any residual stenosis or dissection (**Figure 1F**).

Multiple stent fracture after DES implantation is extremely rare, associated with a higher rate of adverse clinical outcomes.¹⁾ The risk factors of stent fracture are stenting in the RCA, longer and overlapped stents, hinge movement and vessel angulation; our case showed all these findings.^{2,3)} This case shows that the OCT-guided procedure easily identified multiple fracture, whereas conventional angiography could not.

Figure 1. (A) Coronary angiography shows intraluminal haziness (arrow) at the mid portion of the previous right coronary artery stent without significant in-stent restenosis. (B) Magnified fluoroscopic images showed suspicious complete separation with displacement of the previous drug-eluting stent overlapping site. (a-d) show each site of axial optical coherence images. (C) Longitudinal optical coherence tomographic images showed multiple stent fractures with 4 gaps. (D) 3D reconstructed stent strut images clearly demonstrated multiple stent fracture with 4 gaps (arrows). (E) 3D reconstructed images showed that the guide-wire was clearly inside the whole fractured stents. (F) After 4.0×18-mm Onyx (Medtronic, Minneapolis, MN, USA) implantation, the final angiogram revealed good distal flow without any residual stenosis or dissection. 3D = 3-dimensional.
