## Case Report

# A Case of Loss of Ventricular Pacing Due to Inappropriate Hysteresis Function Programming After AV Node Ablation

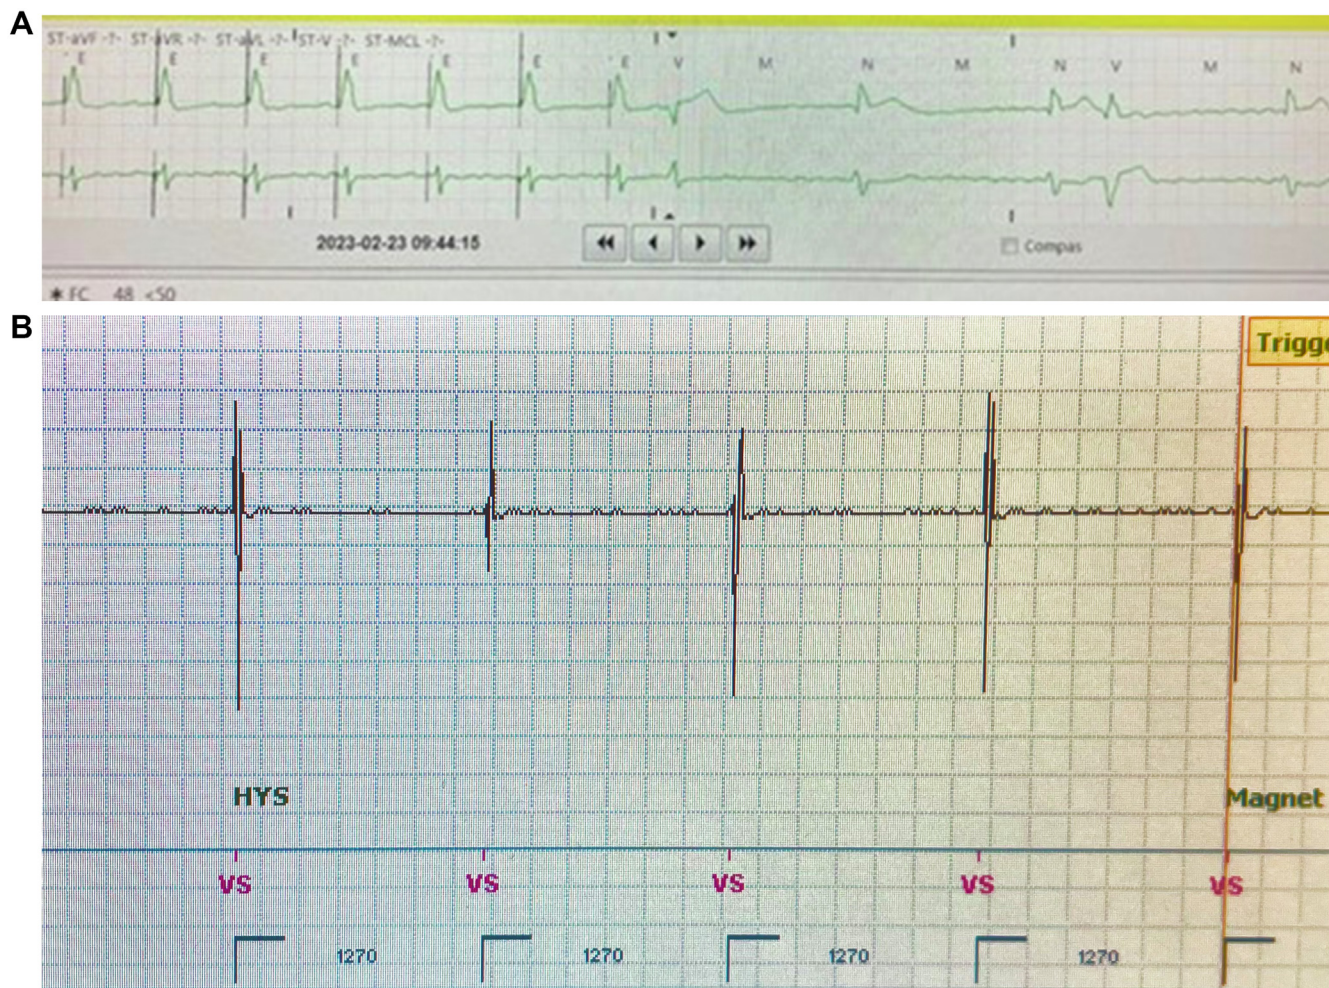
In our case, we had clear documentation of symptomatic bradycardia in a patient with a pacemaker. On an ECG tracing, pacemaker spikes were missing (Fig. 1A). In such a situation, the term “failure to pace” usually applies, and differential diagnosis includes the following:

**Figure 1.** (A) Telemetry recording of bradycardia episode due to suddenly interrupted pacing. (B) Intracardiac recording during bradycardia episode that demonstrates intrinsic rhythm at 47-50 beats per minute with hysteresis marker.

rate, and the pacemaker determines its escape rate from the hysteresis rate instead. As long as the intrinsic rate remains above the hysteresis rate, pacing is inhibited. The first occurrence of an escape pace at the hysteresis rate suspends hysteresis operations and reestablishes the lower rate as the minimal rate. In this case, the hysteresis rate was programmed unintentionally to 30 bpm.

In our case, after atrioventricular node ablation, the patient became partially pacemaker dependent, with an underlying slow ventricular escape rhythm. Premature ventricular contraction activated the inappropriately programmed undesirable hysteresis function and allowed the pulse to drop down to 37 bpm. “Pseudo malfunctions” are unusual and unexpected ECG findings that appear to be caused by pacemaker malfunctions but actually indicate normal pacemaker behavior under specific programmed parameters. We suspect that hysteresis was inadvertently programmed to the “on” setting during programming in preparation for the AV node ablation (with the LRL decreased to 40 bpm during ablation). A point worth noting is that certain St. Jude/Abbott pacemakers will automatically turn on hysteresis at 10 beats below the programmed LRL when either the sensor (rate response) or autocapture feature is enabled. Important to note is that when this occurs, the hysteresis remains programmed at the same rate, even if these features are disabled or the programmed lower rate is increased. In our case, if hysteresis was automatically programmed to 30 bpm when the lower rate was programmed to 40 bpm, the hysteresis rate remained at 30 bpm when reprogrammed to VVI 80 bpm. To rectify the problem, we turned the hysteresis function off.
