Case Report

Humeral plate failure following trauma – A case report

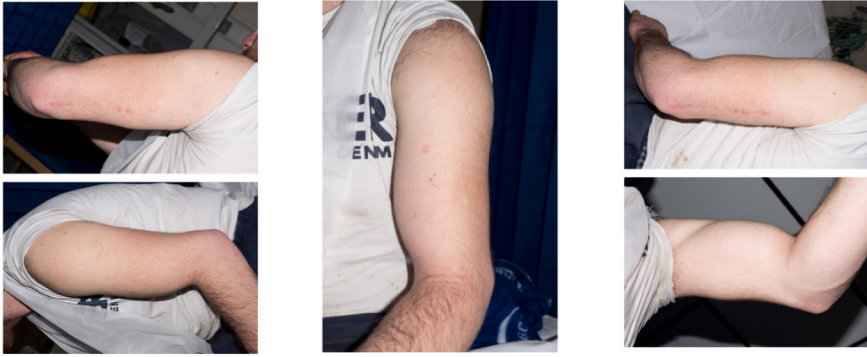
Fig. A. Medical Photography: injury to left upper limb.

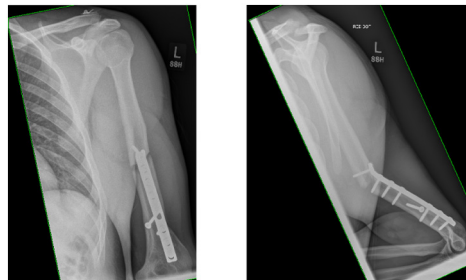
His radiographs demonstrated a short oblique fracture of his humeral diaphysis proximal to the previous site of fracture (Figs. B and C). Apex anterior angulation of 31.7 degrees was noted with the fracture sited between the two most proximal screws. The imaging suggested that all metalwork remained intact but the plate had undergone plastic deformation.

Fig. B. Radiographs: peri-prosthetic fracture of Left humerus shaft, plastic deformation of plate.

Following review of the presentation and imaging in the departmental trauma meeting the patient underwent surgical fixation two days after the injury. A posterior approach to the fracture was performed, all initial fixation except for the interfragmentary compression screw was removed and found to be intact. The fracture was reduced and fixation achieved with a Synthes Titanium 9-hole LC-DCP. Satisfactory fixation was achieved and the fracture well aligned on image intensifier (Fig. D). There were no *peri* or

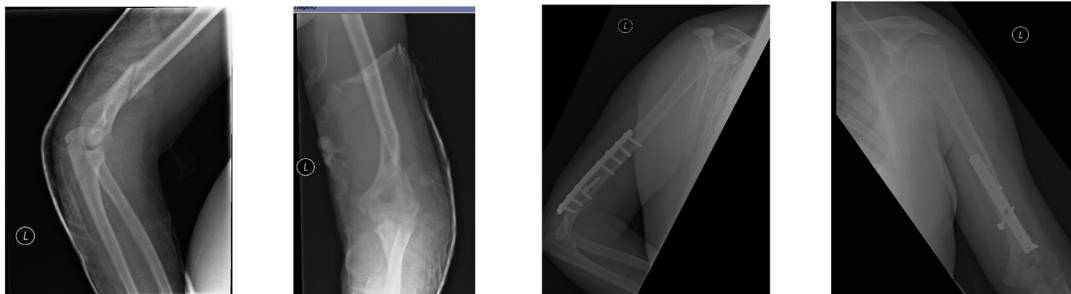
Almost eight years prior to this injury and before skeletal maturity, the patient had sustained a fracture to the left distal humerus, following a fall off a bicycle. Open reduction internal fixation was performed using a single interfragmentary compression screw and a nine-hole titanium Synthes plate (Fig. C). Post-operative recovery was uneventful, bony union was confirmed on follow-up imaging and the patient regained full function allowing discharge from follow up.

Fig. C. Radiographs: Humeral shaft fracture, pre and post open reduction and internal fixation.
