# Effect of X-ray dose rates higher than 8 Gy/min on the functioning of cardiac implantable electronic devices

**Keywords:** cardiac implantable electronic devices; malfunction; radiotherapy; dose rate

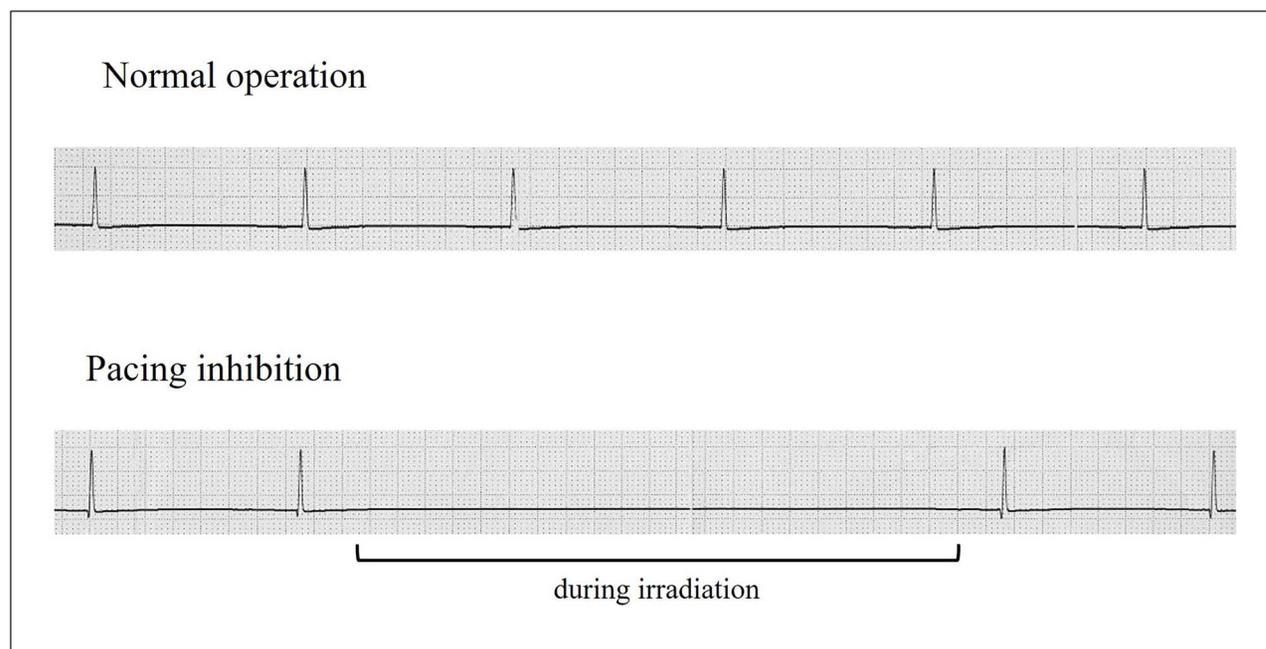
The results of the inhibition tests of 6 MV FFF and 10 MV FFF are depicted in Tables 2 and 3, respectively. In the 6 MV FFF condition, pacing inhibition was observed in three of four CIEDs and in all four CIEDs, when the dose rates were 4–12 Gy/min and  $\geq 14$  Gy/min, respectively. In the 10 MV FFF condition, pacing inhibition was observed in three of four CIEDs and in all four CIEDs, when the dose rates were 4 Gy/min and 8–24 Gy/min, respectively. Fig. 2 shows an example of an ECG in normal function and pacing inhibition. Pacing inhibition occurred simultaneously with irradiation and returned to normal function simultaneously on stopping the irradiation.

is close to the CIED [8, 17, 19]. However, sudden intrafractional movement of the patient may cause direct radiation exposure to the CIED. Malfunction was observed simultaneously with irradiation in this study (Figs 2 and 3). Hence, even temporary exposure of the CIED to radiation due to a sudden intrafractional patient movement, may cause interference. Interference can cause pacing inhibition in patients with pacemakers and inappropriate shock in patients with implantable cardioverter defibrillators. These patients with CIED may experience palpitations, dizziness, loss of consciousness etc.,

**Fig. 2. ECG output recording of CIEDs during irradiation in an inhibition test. In normal operation only the pacing pulse was recorded. If pacing inhibition occurred, pacing pulse was not recorded only during radiation exposure to the CIED.**

although there have been few reports of clinical accidents caused by interference [23]. Interference occurred only with irradiation and returned to normal function immediately when radiation was stopped. The patient's movement is constantly monitored during radiotherapy, and irradiation should be suspended immediately if abnormal patient movement is detected, thus the possibility that the malfunction is permanent is low [24]. Therefore, CIED malfunction due to interference, as observed in this study, is considered to have a low impact on patients.

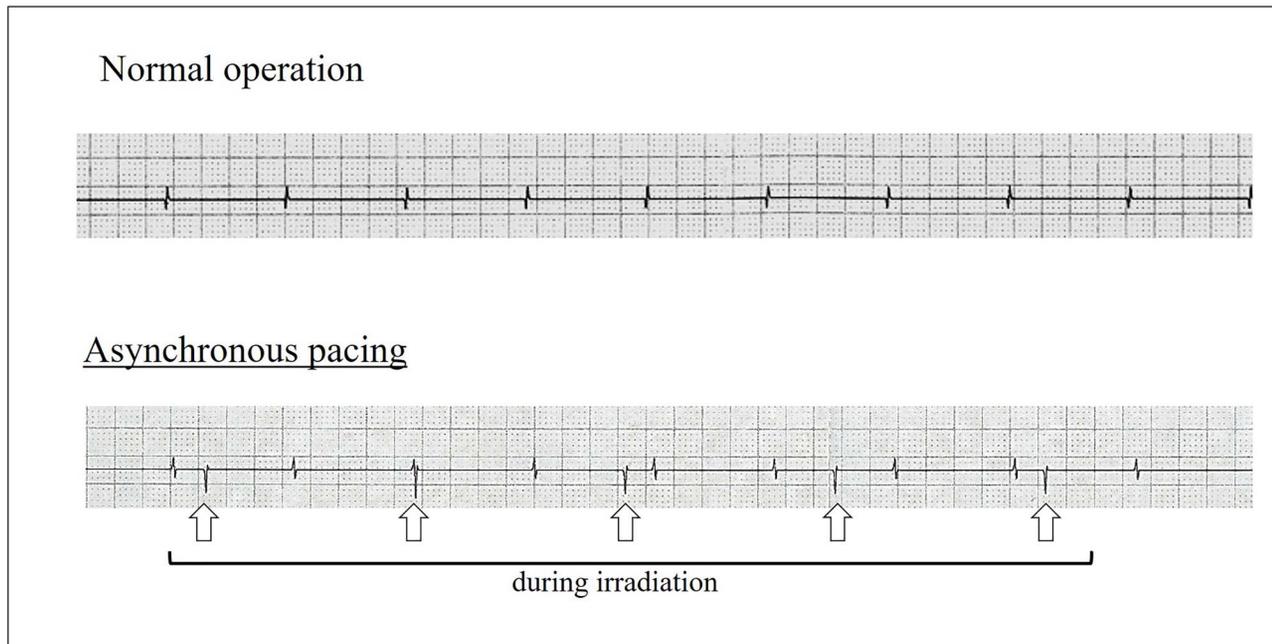
The results of the asynchronous tests of the 6 MV FFF and 10 MV FFF are depicted in Tables 4 and 5, respectively. In the 6 MV FFF condition, asynchronous pacing was observed in one of four CIEDs and two of four CIEDs, when the dose rate was 4–8 Gy/min and  $\geq 10$  Gy/min, respectively. In the 10 MV FFF condition, asynchronous pacing was observed in two of four CIEDs, when the dose rate was 4–24 Gy/min. Fig. 3 shows an example of an ECG in normal function and asynchronous pacing. The asynchronous pacing occurred simultaneously with irradiation and returned to the normal function simultaneously on stopping the irradiation.

**Fig. 3.** ECG output recording of CIEDs during irradiation during asynchronous testing. In normal operation, only the pseudo beat was recorded. If asynchronous pacing occurred, the pacing that was unrelated to the pseudo beat was recorded only during radiation exposure to the CIED.
