Metallosis: CT findings in a total hip arthroplasty

Jared R. Kirkham, Jonelle M. Petscavage, MD, and Michael L. Richardson, MD

We report a case of a 50-year-old man with extensive metallosis 20 years after right total hip arthroplasty. CT demonstrated osteolysis and radiodense debris surrounding the right hip joint. Although the radiographic appearance of metallosis has been well documented in the literature, the CT appearance of metallosis after total hip arthroplasty has been only sparsely described.

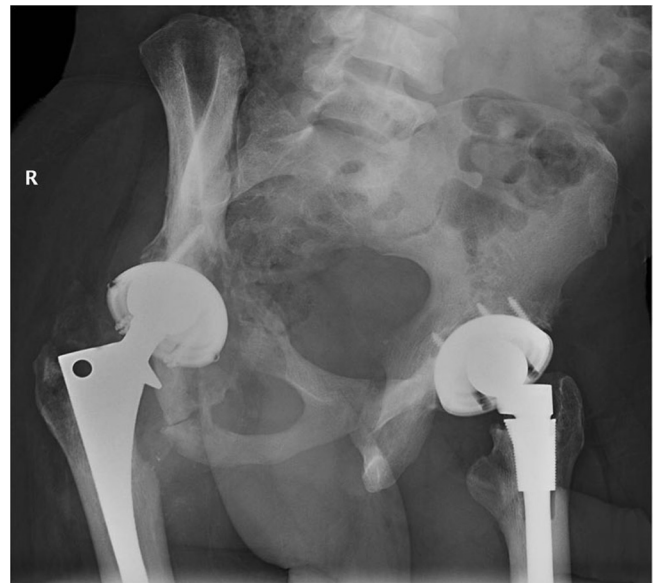
At that time, radiographs of the pelvis demonstrated complete wear of the polyethylene acetabular liner of the right hip arthroplasty, with extensive osteolysis. There were also fractures of the greater trochanter, lesser trochanter, and right superior and inferior pubic rami (Fig. 1). Noncontrast CT of the pelvis further demonstrated the extent of the osteolysis and fractures. CT also showed non-x-ray-apparent fluid-attenuation collections with high-density-material rims along the synovial margins of the right hip joint (Figs. 2 and 3).

Figure 1. 50-year-old man with extensive metallosis. Judet view of the pelvis shows bilateral total hip arthroplasties. There is osteolysis of the right greater and lesser trochanters and acetabulum. Also seen are fractures of the right superior and inferior pubic rami.

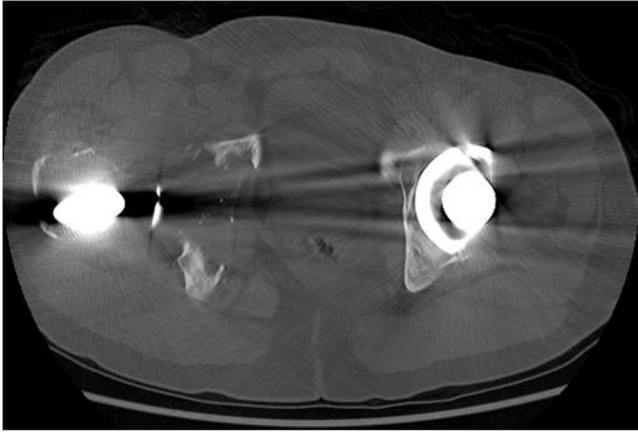
Figure 2. 50-year-old man with extensive metallosis. Axial CT of the pelvis in bone windows shows osteolysis of the right acetabulum with foci of small metallic debris. The medial acetabular wall is completely destroyed.

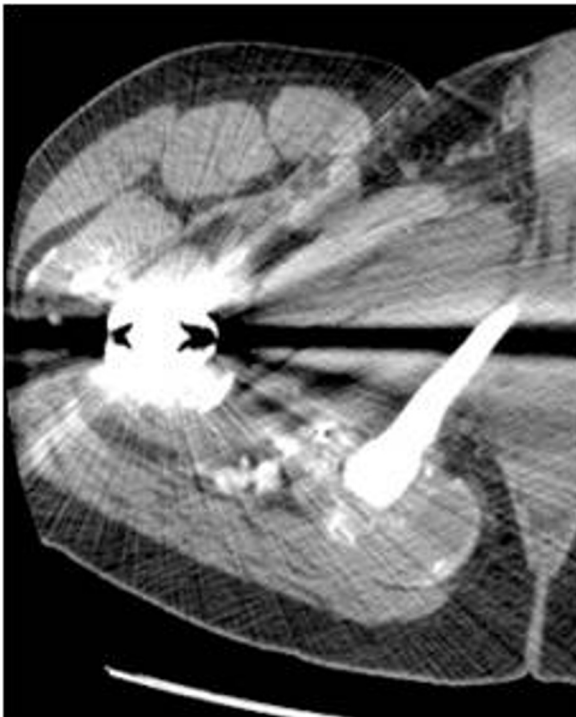
Figure 3. 50-year-old man with extensive metallosis. Non-contrast CT of the right hip joint, at the level of the inferior pubic ramus, shows several round, fluid-density collections with high-density peripheral rims, which are located both anterolaterally and posteromedially along the capsule of the right hip joint. Artifact from right hip prostheses is also present.

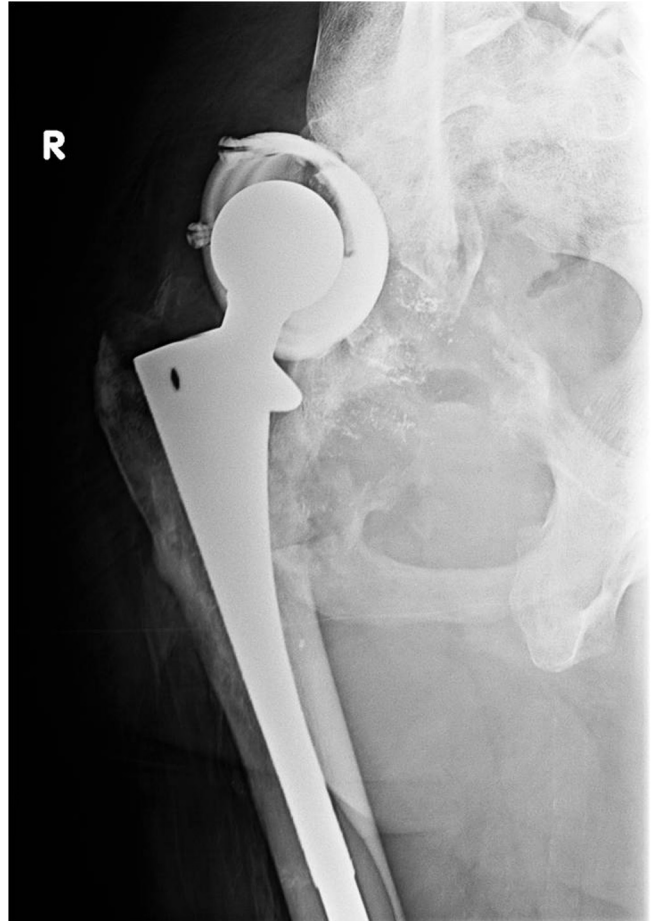
revealed a new fracture of the right acetabulum with significant superior subluxation of the hip and extensive surrounding osteolysis (Fig. 4). Numerous round, soft-tissue

Figure 4. 50-year-old man with extensive metallosis. Radiograph of the right hip shows further osteolysis of the greater and lesser trochanters and right acetabulum. A new fracture of the superior acetabular wall is present with superior migration of the femur. Small metallic particles are now seen on radiographs surrounding the hip prosthesis.

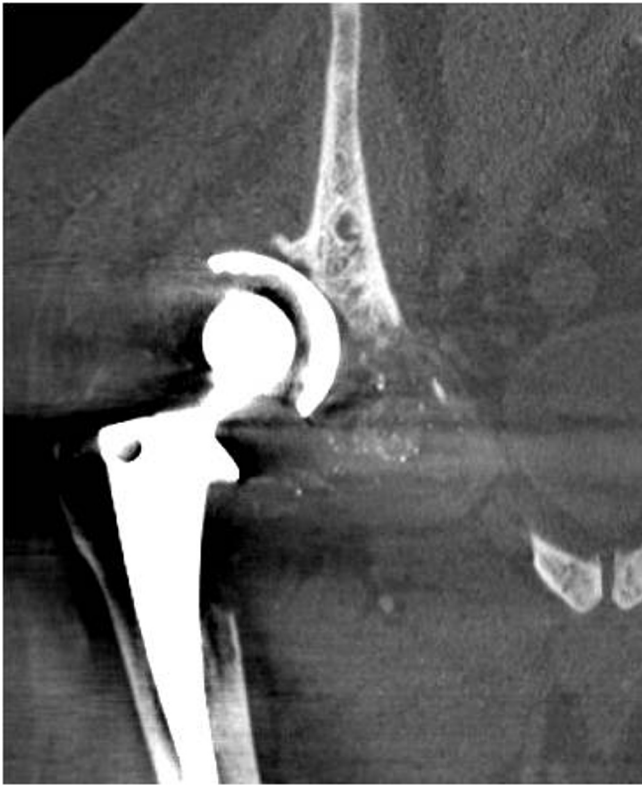
metallic-rimmed fluid collections. Findings were consistent with advanced metallosis (Figs. 5, 6, and 7).

Figure 5. 50-year-old man with extensive metallosis. Coronal reformatted CT of the pelvis without contrast in bone algorithm shows complete osteolysis of the right acetabulum with the space replaced by soft-tissue density and multiple foci of metallic debris, suggestive of advanced metallosis. The right femur is superiorly subluxated.

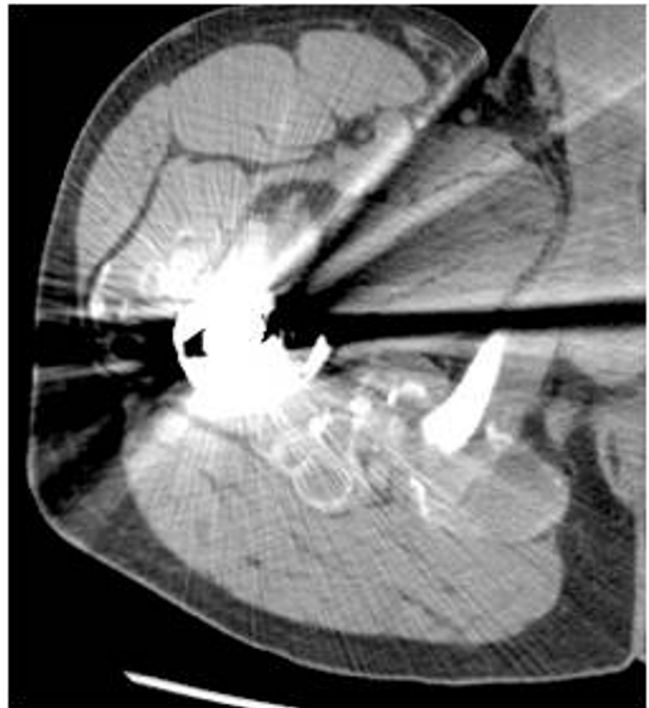
Figure 6. 50-year-old man with extensive metallosis. Axial image from noncontrast CT of the pelvis shows more round, fluid-density lesions with metallic-density peripheral rims. The lesions are anteromedial and posterolateral to the prosthesis, along the hip joint capsule.

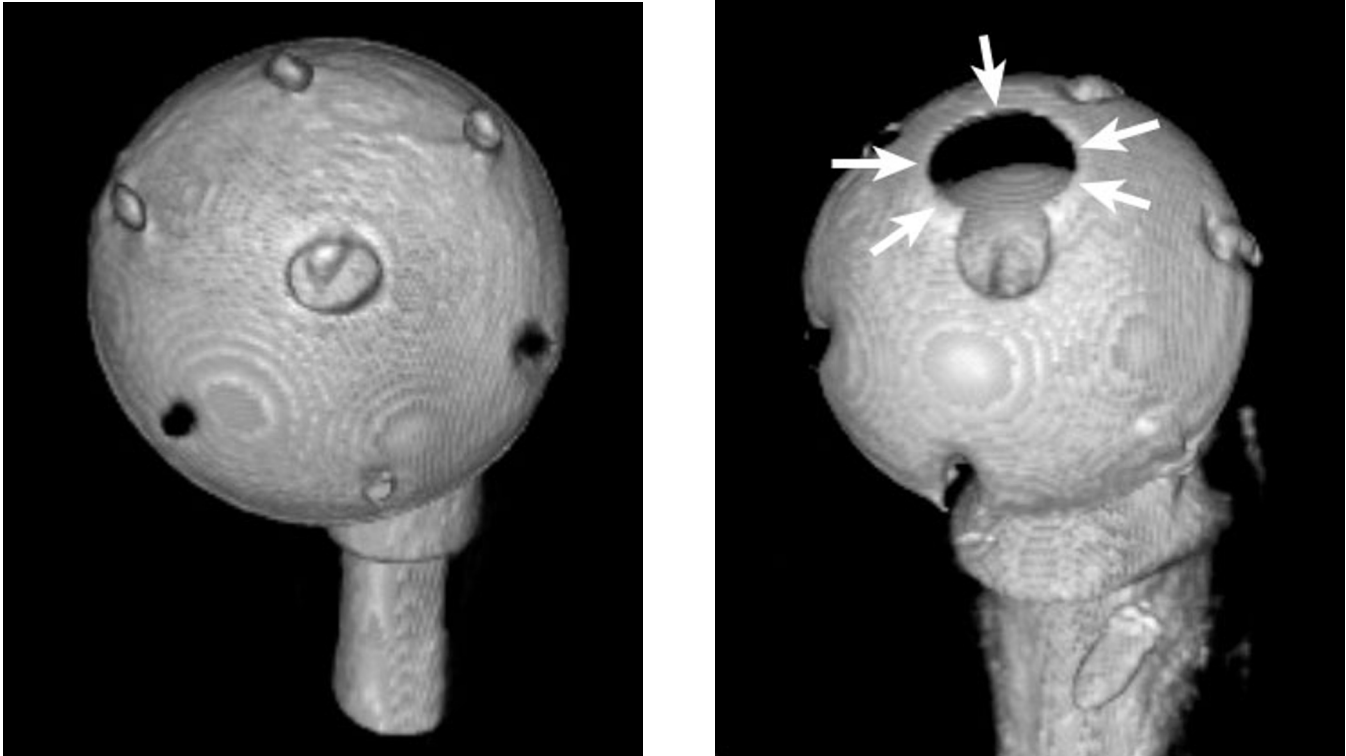
Figure 7. Volume-rendered 3D reformation of CT of prostheses. Left: Medial surface of left acetabular component. Right: Medial surface of the displaced right acetabular component. The abnormal articulation between this component and the ilium has worn a circular hole (arrows) in the component. In addition: [QuickTime 3D movie](#) (893 kB) of both prostheses.
