CASE IMAGE

An inappropriately–appropriate ICD therapy: What is the mechanism and what interventions can be done?

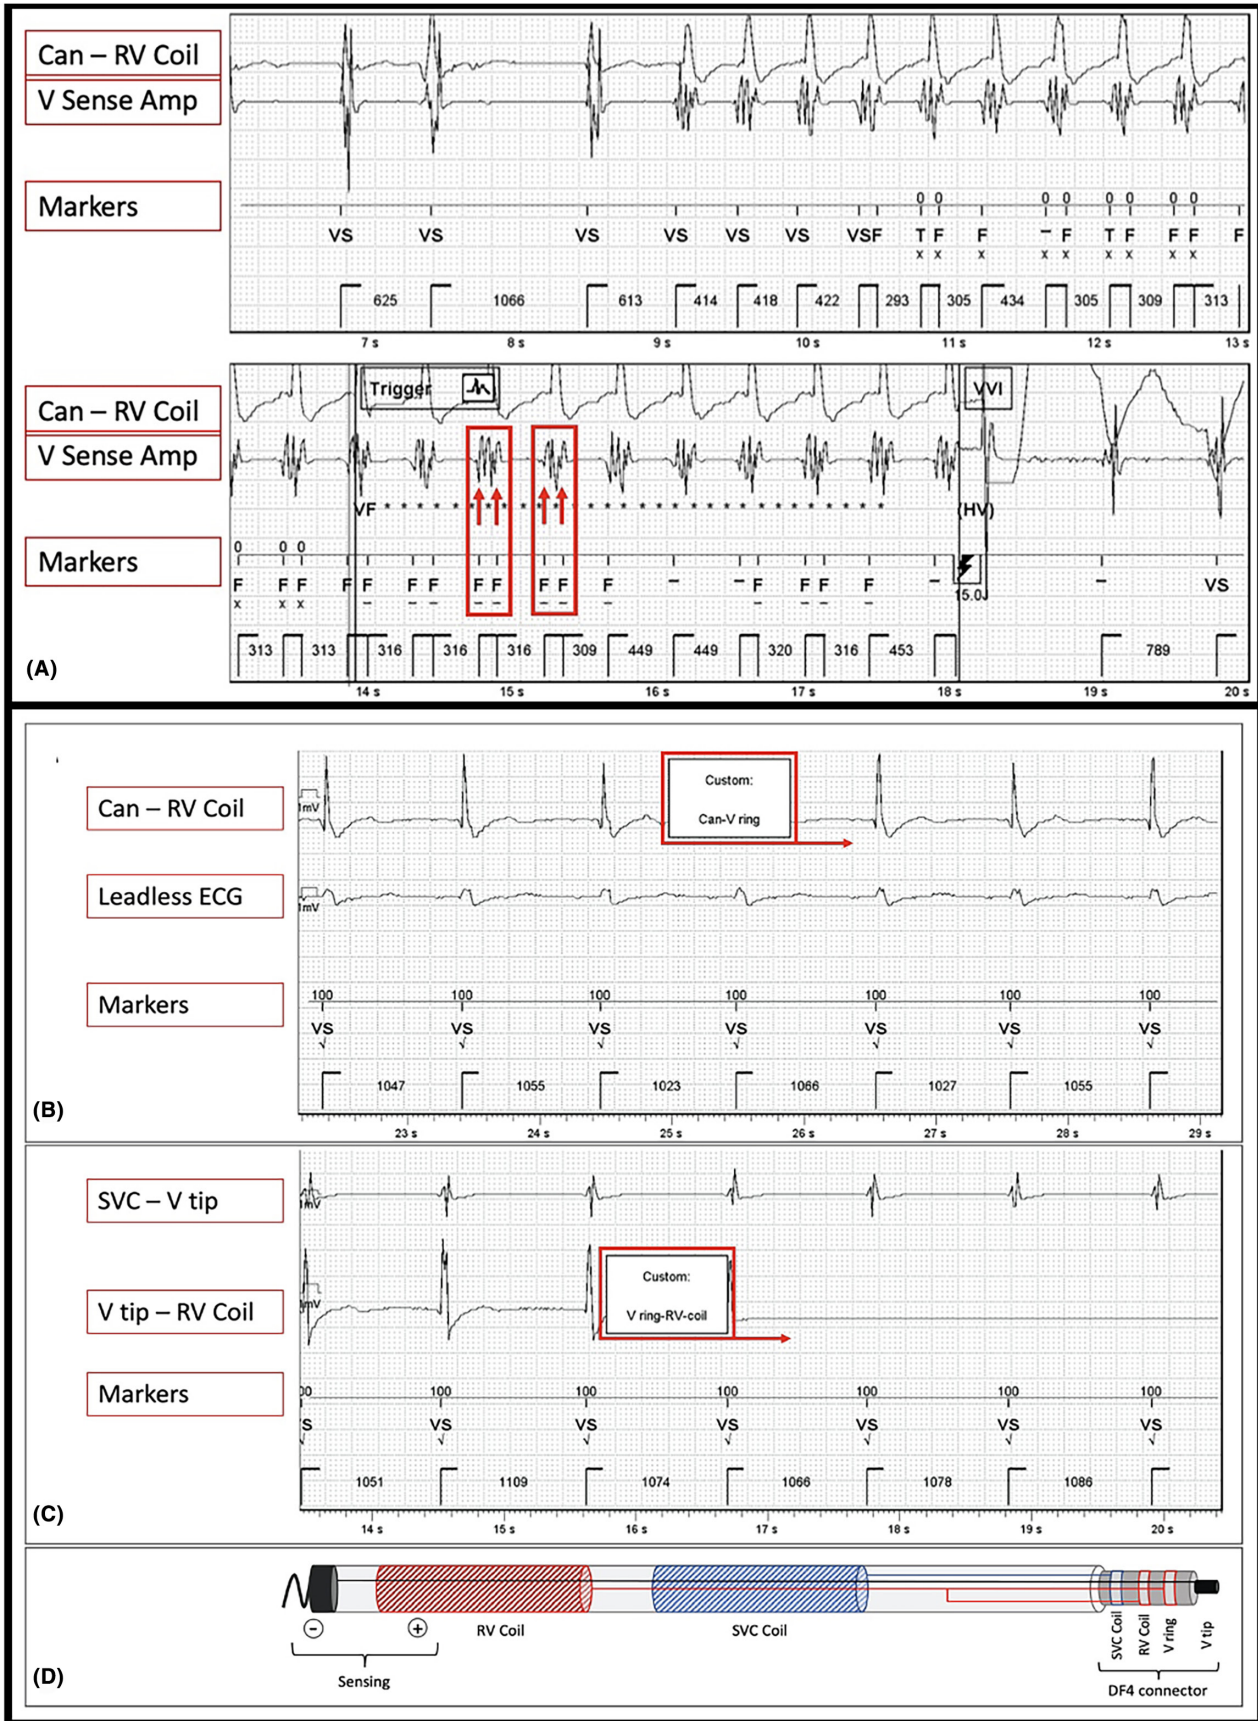
Cardiac device interrogation revealed ventricular tachycardia (VT) with a cycle length of 420 ms that was misclassified in the ventricular fibrillation (VF) zone owing to R-wave double counting, leading to shock and termination of the VT. The device baseline tachycardia configuration was as follows: A monitor-only zone commencing at 496 ms, a VT treatment zone at the cycle length of 351 ms,

FIGURE 1 (A) A ventricular tachycardia event was misclassified in the ventricular fibrillation zone owing to R-wave double counting and finally leading to shock and termination of the ventricular tachycardia. (B) “Can to RV-coil” electrogram configuration results in a similar electrogram to the “Can to V-ring” configuration. (C) “V-ring to RV-coil” configuration results in flat-line electrogram, as RV-coil also has the role of sensing anode (ring). (D) Schematic representation of an integrated dual-coil bipolar lead.

and VF zone detection at 270 ms. The lead manufacturer and model were unknown due to prior device replacements. The lead integrity was evaluated, and no issues were found. As the lead type was unknown (true or integrated bipolar), different electrogram (EGM) configurations were used for differential diagnosis. The existence of an integrated bipolar lead was established since the EGM recording of “Can to RV-coil” was identical to the one demonstrated by changing to “Can to V-ring” and the configuration “V-ring to RV-coil” showed a flat-line EGM, as expected in an integrated bipolar lead where the RV-coil also has the role of sensing anode (ring). (Figure 1 B,C)

R-wave oversensing can be eliminated most of the time by extending the ventricular blanking duration from the nominal value. This modification will affect the fastest frequency at which the device can detect VF and should be applied with caution. This was the intervention of our choice, being aware that true VF under-sensing can occur when the blanking interval is overextended. Subsequently, additional testing regarding the ability of the device to detect appropriately VT/VF following the new device programming was conducted before patient discharge. In devices that permit manual changes in the sensing algorithm, as in Abbott/SJM-manufactured ICDs, additional interventions can be applied. We can delay the sensitivity decay and/or affect the maximum amplitude of the sensed signal before the decay initiation to the programming sensitivity begins. This modification is highly effective in solving the problem of R-wave double counting.¹ Altering the sensitivity value may be considered as another therapeutic option. However, in R-wave oversensing, it is rarely useful. R-wave double counting remains a rare cause of ventricular oversensing, occurring mainly due to a marked ventricular conduction delay between the sensing bipole of the lead.² It is reported to be up to five times more frequent in integrated bipolar ventricular leads than dedicated bipolar leads, an observation that may be justified by their design properties (Figure 1D).³
