Reconsidering the “MR Unsafe” breast tissue expander with magnetic infusion port: A case report and literature review

Case Report

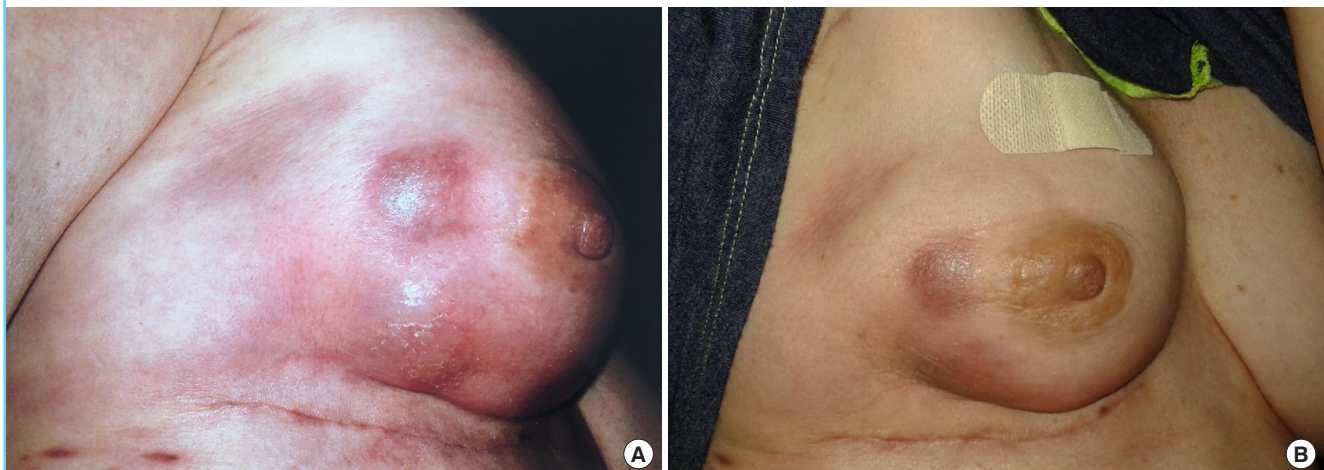
Fig. 1. Expander loss following vehicular accident and MRI

Five days later, the patient presented to the emergency department with right breast pain. On physical exam, the breast had two lesions, 2 cm in diameter, and associated erythema and swelling. She was diagnosed with cellulitis and was prescribed clindamycin. The cause of the cellulitis was likely associated with the trauma sustained from the traffic accident. The patient presented to her plastic surgeon the following day who also noted right inframammary fold erythema and the small lesions (Fig. 1). The saline in the TE was removed. Despite these maneuvers, the right breast continued to worsen and by 3 weeks post-MRI, the patient had impending TE exposure and required

(A, B) Clinical photographs showing inframammary fold erythema and blistering of the patient’s right breast following motor vehicle collision with the patient as a pedestrian and subsequent magnetic resonance imaging (MRI).
