Case Report

Refractory Impella Suction Alarms in the Setting of Extracorporeal Membrane Oxygenation

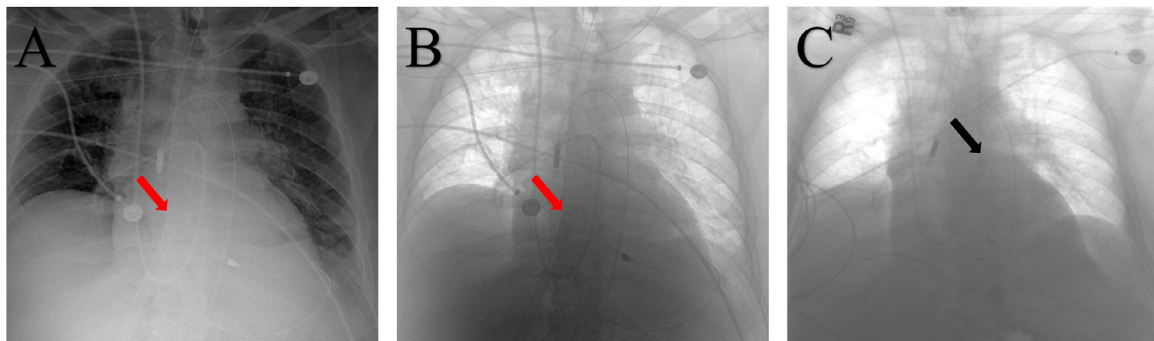
repositioned multiple times under direct echocardiographic guidance to try to stop the alarm, to no avail. His echocardiogram also showed an LV end-diastolic diameter of 5.6 cm, and an LV ejection fraction of < 20%. There was no evidence of cardiac tamponade, and fluid administration did not resolve the alarms. Furthermore, the alarms persisted despite decreasing the P-level (to P-2) of the Impella. The pulmonary artery catheter demonstrated the following hemodynamics: right atrium 15 mm Hg, pulmonary artery 24/17 mm Hg (mean: 19 mm Hg), pulmonary capillary wedge pressure 17 mm Hg, central venous pressure/pulmonary capillary wedge pressure ratio 0.88, and pulmonary artery pulsatility index 0.6. Inhaled nitric oxide was initiated with the goal of reducing right ventricular (RV) afterload; however, this did not resolve the alarms. A repeat chest radiograph noted that the venous canula of the ECMO circuit had migrated to the left atrium (Fig. 1). The venous cannula was promptly repositioned, with resolution of all Impella alarms. A transesophageal echocardiogram confirmed the presence of a patent foramen ovale (Video 1

Again, in our case, the migration of the venous cannula of the ECMO circuit through a patent foramen ovale led to a decrease in LV inflow with a subsequent smaller LV cavity, acting like a tandem heart LV support system. In other words, the EC-PELLA system had incidentally shifted from a biventricular support system to primarily LV-only support (much like an LV assist device), which can be detrimental in some patients, especially if they have advanced RV failure. Review of serial chest radiographs confirmed the diagnosis. The venous cannula was repositioned with resolution of all alarms. In conclusion, appropriate venous cannula position should be confirmed, with real-time echocardiography and/or chest radiography, at the time of veno-arterial ECMO

Figure 1. (A, B) Chest radiograph (normal and inverted) confirming the extracorporeal membrane oxygenation venous canula position shows slight migration from the superior vena cava–right atrium junction to the middle of the right atrium. (C) Inverted chest radiograph shows the migration of the venous cannula to the left atrium. **Arrows** indicate the tip of the extracorporeal membrane oxygenation venous cannula. The pulmonary artery catheter shown is deep, and the position was adjusted.

, view video online). The Impella CP was later upgraded to an axillary Impella 5.5 device with decannulation of the ECMO on day 8. Unfortunately, the patient died a few weeks later due to significant competing risks and comorbidities that were most likely related to the late presentation of his ST-elevation myocardial infarction.
