# Indian Pacing and Electrophysiology Journal

## Occurrence of Torsade de Pointes prior to complete lead connection during pacemaker implantation

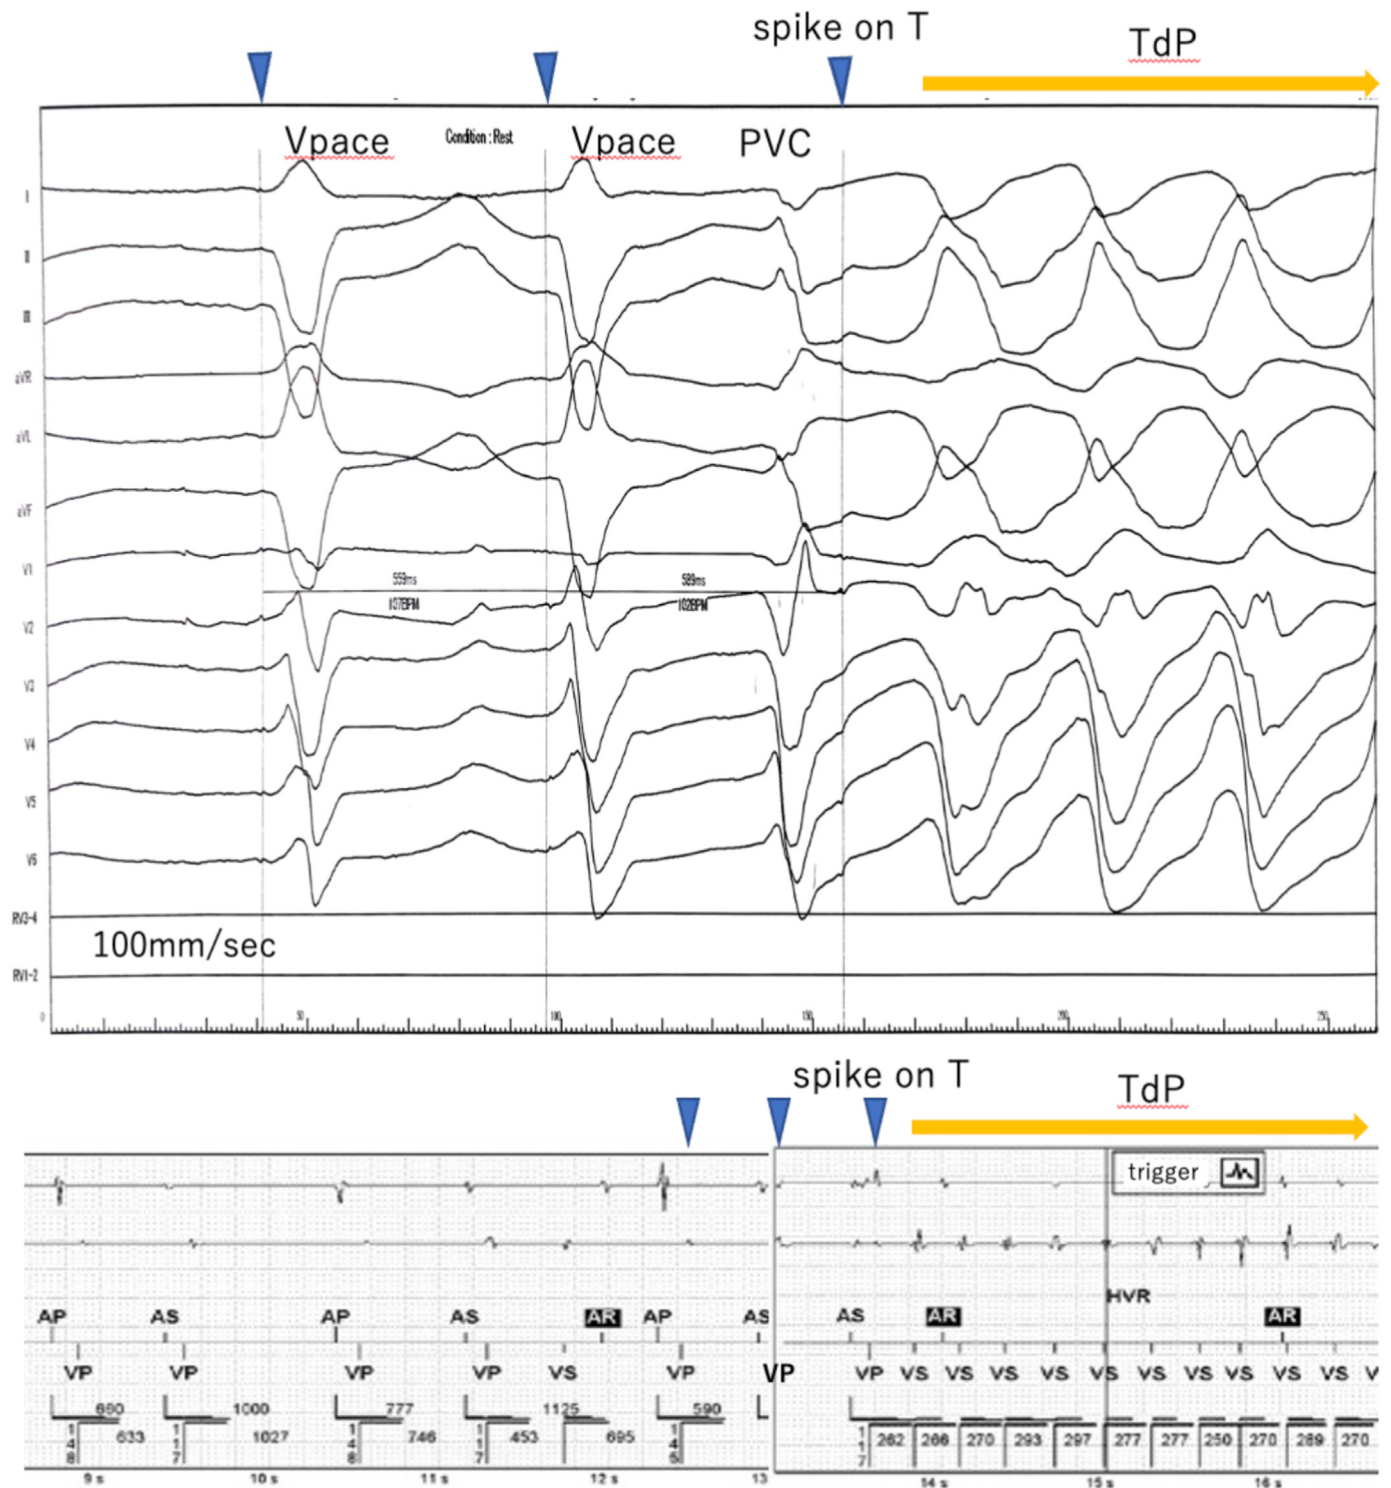
**Fig. 3.** Programmer records  
Programmer records and enlarged ECG revealed that ventricular pacing (arrowhead) and undersensing of premature ventricular contraction (PVC) caused a spike on the T-wave, which resulted in Torsade de Pointes (TdP).

with QT prolongation. In this case with prolonged QT, T-waves associated with undersensed PVCs and ventricular pacing occurred simultaneously, resulting in a spike on the T-wave and TdP.

Several possible measures can prevent this. First, pre-operative

insertion of a temporary pacing wire will help maintain a normal heart rate and reduce the occurrence of PVCs. Second, prior to connection, the device's pacing mode can be set to VVI or DDI, and the lower rate can be set at 30 bpm. In this case, the atrial lead was

first connected during DDD mode. Therefore, upon atrial wave detection, ventricular pacing occurred with a preset AV delay. If the VVI had been set even lower at 30 bpm, it would have minimized ventricular pacing while the patient was unstable before torque wrench tightening. However, an unexpected ventricular pace can occur when the device's pacing mode is set to VVI or ventricular lead is connected first, because of undersensed PVC under unstable conditions before the lead is completely connected. Third, the output of the ventricular lead should be set to a minimum value before device connection in order to inhibit effective pacing. The initial setting should be the lowest output at 0.2 V, thereby preventing unexpected pacing. Following torque wrench tightening and stabilization of sensing and pacing, the output may be increased upon reassessing the threshold. The last step is to lower the sensitivity threshold to avoid undersensing. However, excessively lowering the sensitivity is associated with oversensing due to abundant noise upon pacemaker implantation. In this case, a default setting of 2 mV was used, and this setting was reasonable.
