A Sticky Situation: The Unfortunate Consequence of Chewing Gum

Christopher Lee, MD, Sam Dow, MD, Stanislav Henkin, MD, MPH, Benjamin D. Morley, MD, Athos J. Rassias, MD, Cynthia Taub, MD, MBA, MS, and Salvatore P. Costa, MD, *New Hampshire, Lebanon*

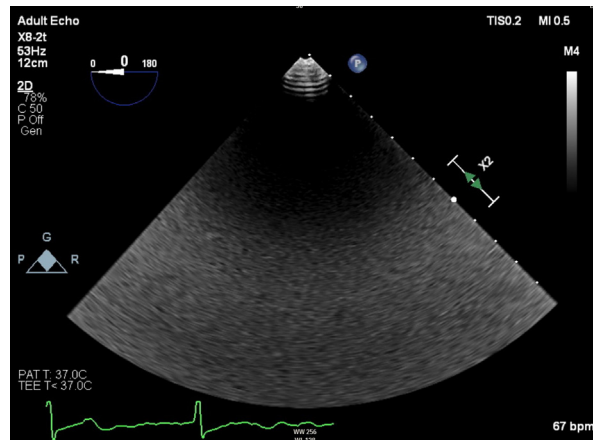
The patient was subsequently intubated without difficulty for the procedure, and a TEE probe was placed without resistance or difficulty in the midesophageal position. Initial midesophageal TEE views at a depth of between 30 and 35 cm were notable for diffuse anechoic images without any identifiable cardiac structures (Figure 1, Video 1). Given the relatively common occurrence of swallowed trapped air

leading to poor TEE image quality, different troubleshooting mechanisms involved manipulation of TEE probe depth or flexion. However, there was no difference in TEE image quality with TEE probe manipulation or with changes in multiple echocardiographic machine settings (i.e., adjusting the gain, depth).

Figure 1 Initial midesophageal TEE view at a depth of between 30 and 35 cm showing diffuse anechoic images.

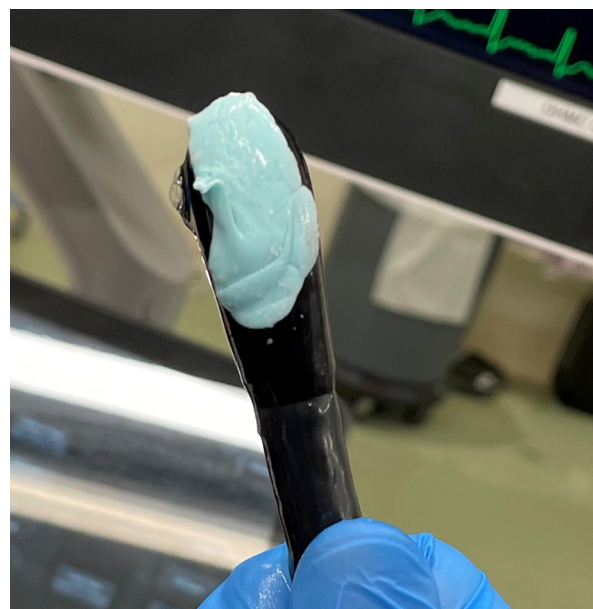
The patient remained on minimal ventilator settings without evidence of respiratory compromise throughout the initial attempted TEE image acquisition. Suspecting a TEE probe malfunction, the TEE probe was subsequently removed, with the plan to switch to a new TEE probe. However, upon removal, we were surprised to find a piece of chewing gum stuck to the tip of the TEE probe, covering the piezoelectric crystal (Figure 2). At that point, the anesthesia team noted that the patient had been chewing gum preprocedurally and when they were asked to spit out the gum, they refused and had proceeded to swallow it. The piece of gum was removed from the tip of the probe, and upon subsequent replacement of the TEE probe in the midesophagus, the patient’s left atrial appendage was well visualized without evidence of thrombus (Figure 3, Video 2). The patient’s LAAO device procedure was ultimately successful.

This was the first time in our clinical practice that the cause of a TEE artifact was proven to be caused inadvertently by a piece of chewing gum that coated the piezoelectric crystal of the TEE probe, creating a diffusely anechoic, uninterpretable image. Although the patient claimed to have swallowed their gum prior to the procedure, against medical advice, the likelihood is that the piece of gum was still in either their oral cavity or posterior oropharynx and subsequently coated and stuck to the tip of the TEE probe as it was being placed in the esophagus. Although this led to a small procedural delay, the patient was still able to have the LAAO device successfully implanted with TEE imaging guidance.

Figure 2 Transesophageal probe with the patient's chewing gum covering the tip of the probe.

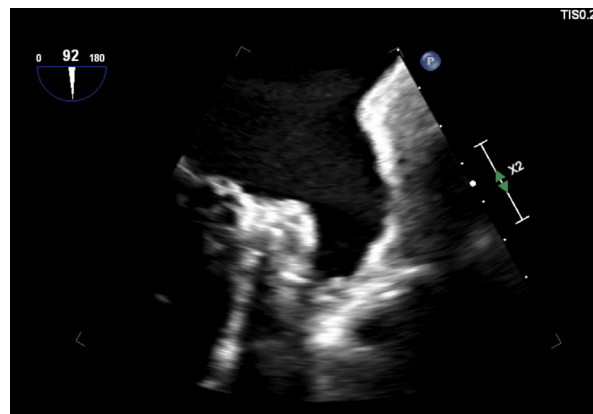
Figure 3 Well-visualized left atrial appendage without evidence of thrombus with midesophageal TEE views at 90°.
