Inappropriate defibrillator shock during gynecologic electro-surgery

KEYWORDS Electromagnetic interference; Electro-surgery; Implantable cardioverter-defibrillator; Left ventricular assist device (Heart Rhythm Case Reports 2018;4:267–269)

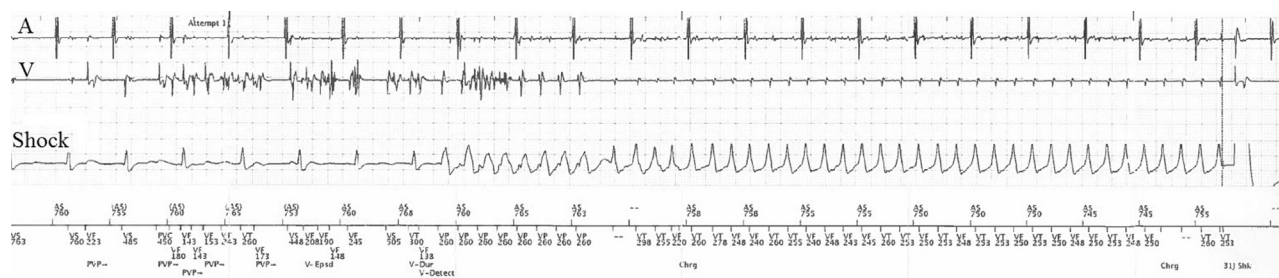
IN) and placement of iCAST stents (Atrial Medical Corporation, Hudson, NH) in the bilateral renal arteries 2 years earlier. She also had a dual-chamber ICD (Boston Scientific, Inc, Marlborough, MA) implanted 12 years prior for primary prevention (lead model numbers 4086 and 0158 from 12 years prior and pulse generator model E110 [Teligen] from 8 years prior) and was followed at an outside institution for device management. At baseline, the patient's device was programmed DDI with lower rate limit of 50 beats per minute (bpm) with 2 therapy zones and therapies—a ventricular fibrillation (VF) zone: 250 bpm, detection duration 1.0 second, and therapy: antitachycardia pacing (ATP) before charging, a 31-joule shock followed by 7 41-joule shocks; and a ventricular tachycardia (VT) zone: 200 bpm, detection duration 2.5 seconds, and therapy: ATP with scan scheme, followed by ramp scheme, then a 21-joule shock, and 5 41-joule shocks. Given that the planned surgery was to occur remotely from the ICD, the device was not interrogated prior to the procedure, no programming changes were made, and no magnet was applied. For the procedure, the patient was in the lithotomy position with a grounding pad for monopolar electro-surgery on her right thigh and the LVAD controller resting on her abdomen at the level of the umbilicus. Electro-surgery on the cervix was first performed with blended cut output at 40 watts, without incident. At the end of the case, coagulation output was applied at 50 watts, at which time EMI was sensed by the patient's ICD as a VF event. This led to delivery of ATP, which induced true VT, which was detected in the VF zone and successfully terminated with a 31-joule shock (Figure 1). Much lower-amplitude EMI was also visible on the right atrial lead and, interestingly, only very subtle noise was seen on the shock electrogram (EGM). Of note, sensing on the right ventricular (RV) lead was set to an integrated-bipolar configuration (RV tip to RV coil) while the shock EGM was sensed from the pulse generator to the RV coil. Subsequently, a magnet was placed over the ICD as more electro-surgery was applied at the same settings. EMI occurred again, causing oversensing categorized as a VT event, but no therapies were delivered (Figure 2) owing to the presence of the magnet. Interrogation of the ICD after the procedure revealed normal

Figure 1 Electrograms (EGMs) showing electromagnetic interference (EMI) detected as ventricular fibrillation (VF) by the implantable cardioverter-defibrillator. A = right atrial lead EGMs, true bipolar sensing; V = right ventricular (RV) lead EGMs, integrated-bipolar sensing from the tip electrode to the RV coil; Shock = “shock” EGM, a far-field signal recorded from the pulse generator to the RV coil. Note the only very subtle noise on the shock EGM, in contrast to the large-amplitude EMI seen on the RV EGM.

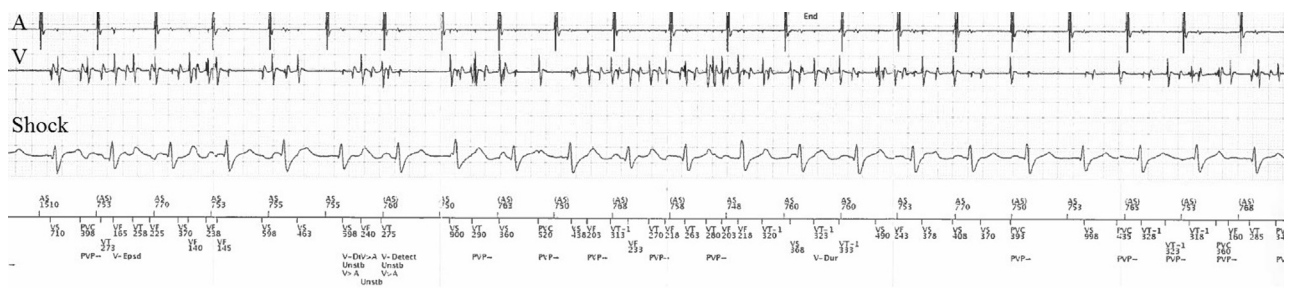
Figure 2 Electrograms (EGMs) showing electromagnetic interference (EMI) that was sensed as ventricular tachycardia / ventricular fibrillation but not treated owing to presence of a magnet. A = right atrial lead EGMs, true bipolar sensing; V = right ventricular (RV) lead EGMs, integrated-bipolar sensing from the tip electrode to the RV coil; Shock = “shock” EGM, a far-field signal recorded from the pulse generator to the RV coil. Again, note the only very subtle noise on the shock EGM, in contrast to the large-amplitude EMI seen on the RV EGM.

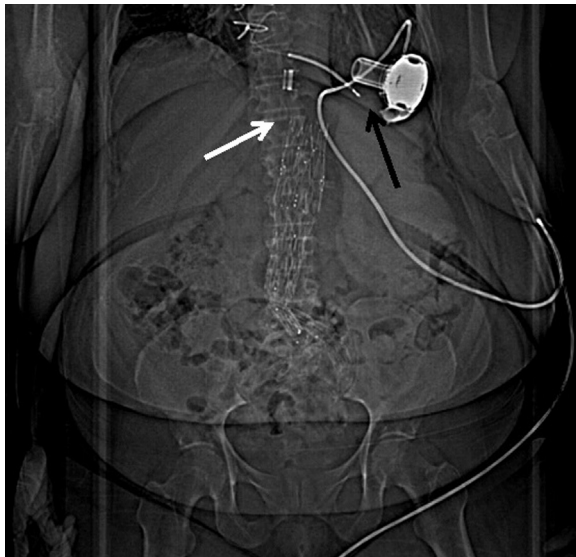
monopolar electrosurgery signal, resulting in EMI on an ICD lead.^{5–7} While bipolar electrosurgery may have been less likely to result in EMI, the nature of the LEEP necessitates the use of single loop and roller ball electrode, which are only available as monopolar units.⁸ Given that the patient had no prior history of oversensing or ICD therapy until the time that electrosurgery was delivered, the lead malfunction alone was not likely the sole cause of oversensing but may have predisposed the patient to oversensing from external EMI.

Figure 3 Computed tomography scout film demonstrating proximity of the left ventricular assist device (LVAD) to the right ventricular (RV) lead and the location of aortic graft. Note that the caudal end of the aortic graft extends well below the iliac crest. Black arrow indicates the RV lead tip. Note proximity to the LVAD pump. White arrow indicates the top of the aortic graft.
