## CASE REPORT

## A worn Björk–Shiley prosthetic valve without valve dysfunction observed during ascending aortic replacement

*Clinical Case Reports* 2014; 2(5): 180–182

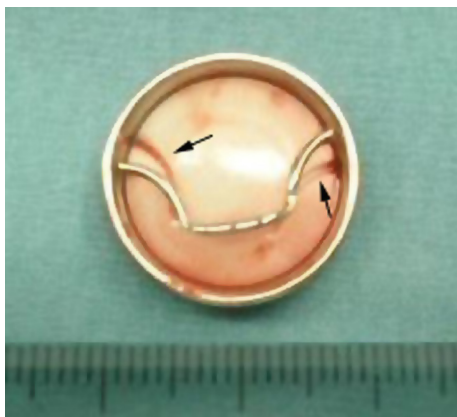
and right femoral vein cannulation. After the additional superior vena cava cannulation, the heart was arrested with antegrade cardioplegic solution followed by intermittent retrograde cardioplegic solution. We observed that the implanted Björk–Shiley valve disc was worn and concave at the site meeting the strut on the ventricular surface (Fig. 2). The intimal flap was recognized in the ascending aorta. We judged that the implanted valve was Björk–Shiley Delrin one, and that it was no longer capable of maintaining the patient's life. The worn Björk–Shiley valve was removed, and a valved conduit with a mechanical valve was implanted. The bilateral coronary artery orifices were reconstructed in an ordinary fashion. The distal anastomosis of the ascending aorta was just below the brachiocephalic artery. The brain was protected during aortic reconstruction by systemic moderate hypothermia and retrograde cerebral perfusion.

**Figure 2.** Explanted Björk–Shiley Delrin valve. The explanted Björk–Shiley valve disc was worn and concave at the site meeting the strut on the ventricular surface.

The implanted valve in our patient was functioning well before aortic surgery, but we replaced the valve because we confirmed disc erosion 39 years after implantation. This report may be the first describing a Björk–Shiley valve with disc erosion before the appearance of structural dysfunction. A patient with the first-generation Björk–Shiley valve may undergo repeated cardiac surgeries. In these patients, we should consider replacing the implanted valve.
