## IMAGING VIGNETTE

## CLINICAL VIGNETTE

# Impaction of a Percutaneous Heart Pump in Iliac Artery and Its Removal Using Snare

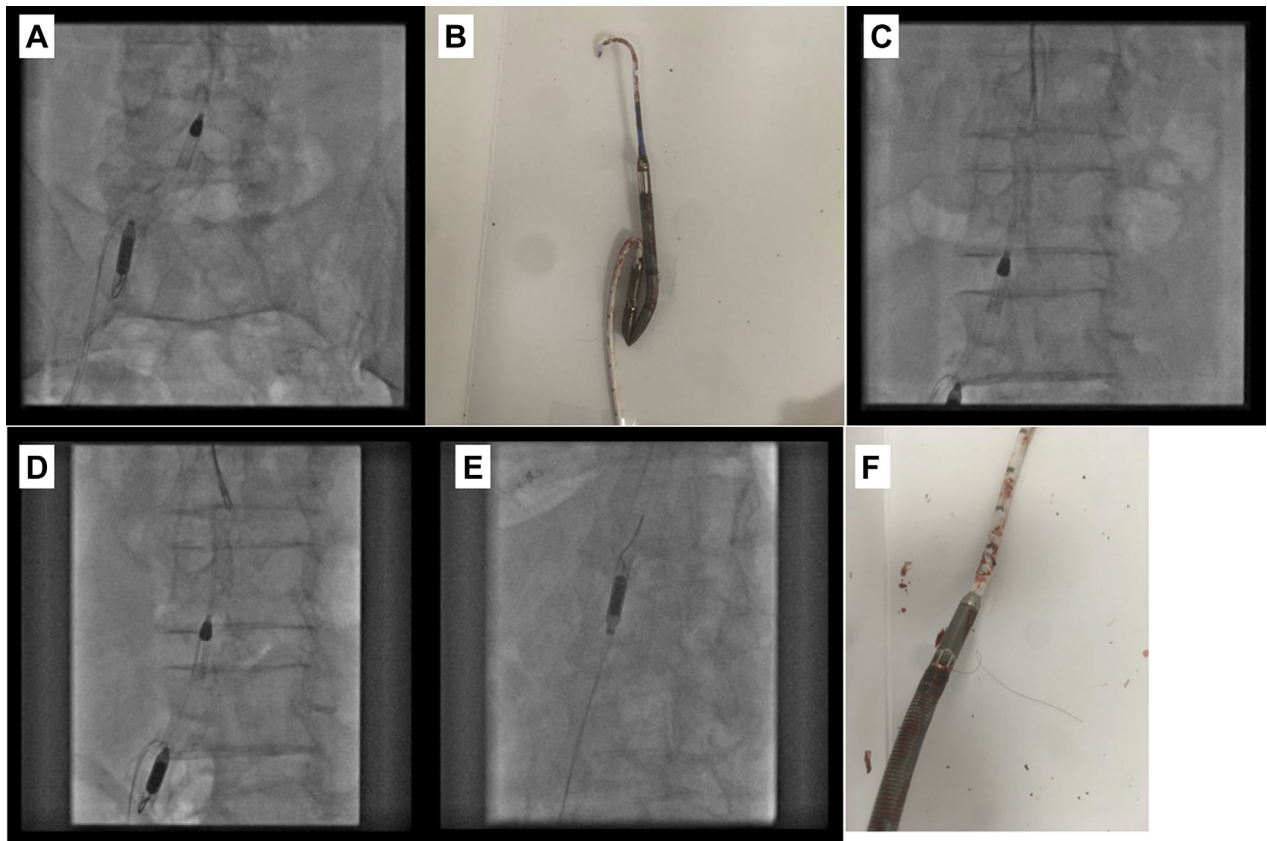
**FIGURE 1** Impaction and Removal of a Percutaneous Heart Pump

After positioning of the 0.018-inch diameter, 260-cm placement guidewire in the left ventricle, we advanced the Impella CP catheter (Abiomed) into the LV chamber. On pulling out the guidewire, we felt undue resistance. More forceful pulling led to a sudden snapping movement as the wire became severed near the spring end. Fluoroscopy revealed a twisted catheter in the descending aorta, folded in on itself distal to the motor housing with the entangled radiopaque broken end of the placement wire jutting out in the outlet area. On pulling the catheter down farther, it bent again at the cannula region and became impacted in the right common iliac artery (**Figures 1A and 1B, Video 1**).

**(A)** The impacted percutaneous heart pump catheter in the right common iliac artery. **(B)** The extracted catheter folded to simulate the manner in which it became impacted in the iliac artery. **(C)** Placement of snare at the pigtail. **(D)** The snared heart pump pigtail being pulled upward. **(E)** The straightened heart pump catheter. The detached radiopaque spring end of the placement guidewire is seen entangled at the outlet area near the motor housing. **(F)** The extracted heart pump catheter.

The only way to unfold and straighten the catheter was to untangle it from the iliac artery by snaring the pigtail and pulling it back millimeter by millimeter into the aorta (which could offer more space) and then unfold it by pulling the pigtail upward while fixing the catheter shaft outside the introducer sheath. This we did by using an EN Snare (Merit Medical Systems) 18- to 30-mm snare in a 7-F multipurpose guide catheter through right brachial access (**Figures 1C to 1E, Videos 2, 3, and 4**). We then removed the straightened catheter through the introducer sheath. The extracted catheter revealed the detached spring end of the placement wire projecting out of the catheter at the outlet area near the motor housing and a kink in the white shaft just distal to the motor housing (**Figure 1F**). Our backup plan in case of failure to extract the catheter interventionally was surgery.

To conclude, never pull the placement guidewire blindly if inexplicable resistance is encountered. Fluoroscopic guidance should be used liberally during the entire introduction and removal of the device. Avoid
