Can water lacerate a tendon? A car-wash accident: A lacerated extensor hallucis longus tendon

Senol Ardic ^{a, *}, Ibrahim Altun ^b, Gokhan Peker ^b, Bestami Kose ^a

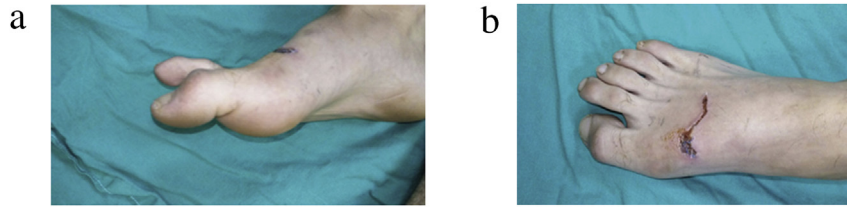
A 21-year-old man presented to our ED due to looseness in the hallux (Fig. 1a and b). His history revealed that while operating a pressurized water spray machine for car-washing one week before, he had inadvertently sprayed his foot, and despite wearing protective plastic boots this had resulted in a laceration at the level of the hallux, which had been sutured in an other hospital (Fig. 2). The initial partial looseness in the toe worsened, and he subsequently presented to our hospital. Physical examination revealed a 3-cm-

Fig. 1. First examination.

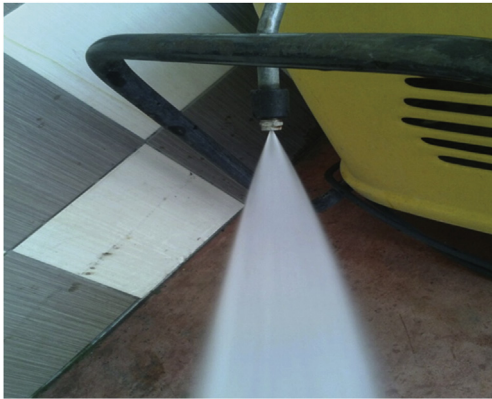
Fig. 2. Water pressure machine.

Cleaning equipment using pressurized water may be dangerous if sufficient safety measures are not taken. We think that such occupational accidents with serious outcomes can be prevented through simple protective measures.

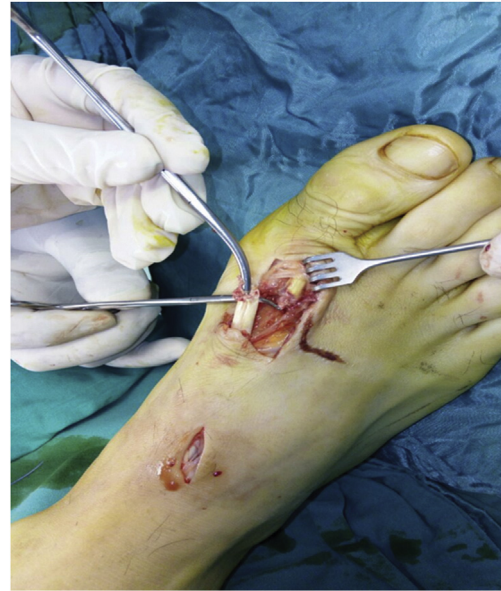
long partially healed incision proximal to the dorsal part of the metatarsophalangeal joint, with limited dorsiflexion, in the right hallux. Therefore, laceration of the EHL tendon was suspected (Fig. 3). Surgery was performed one week later, a splint was applied for 3 weeks and complete healing was observed after a short-term physiotherapy.

Fig. 3. EHL tendon rupture.
