## Images in Cardiovascular Disease

# More Is Not Always More: A Timely Reminder Why Not to Use Too Much Hardware

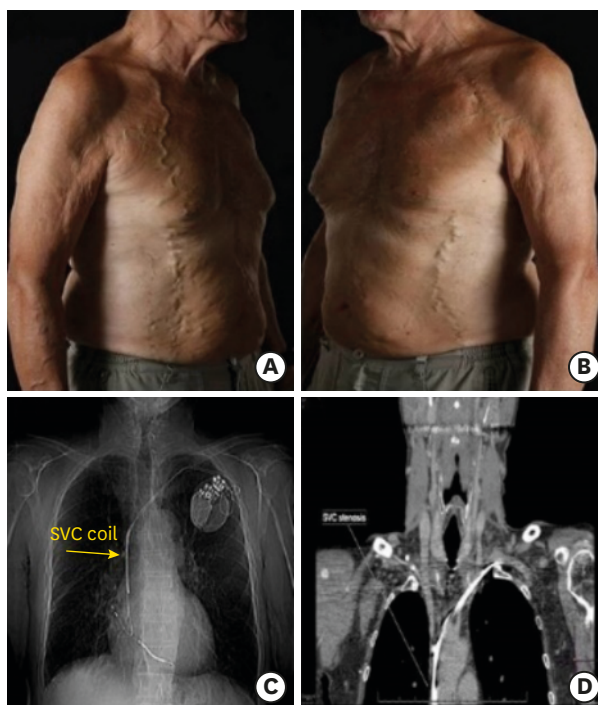
A healthy 79-year-old male with non-ischaeamic cardiomyopathy underwent an implantable cardioverter defibrillator (ICD) insertion 7 years ago following presentation with a haemodynamically significant ventricular tachycardia. A 9 French dual coil ventricular and a 6 French atrial lead were inserted transvenously. While considering an upgrade to a biventricular device due to symptomatic heart failure, striking bilateral symmetrical varicosities over the chest and abdomen (**Figure 1A and B**), suggestive of superior vena cava (SVC) obstruction, were noted. Echocardiography showed severely impaired left ventricular systolic function. On questioning, he admitted to having a fuzzy head and dizziness when bending over. Chest X-ray showed normally positioned dual coil ICD from a left

**Figure 1.** Striking bilateral symmetrical varicosities over the chest and abdomen (A, B), suggestive of SVC obstruction. Chest X-ray showed normally positioned dual coil ICD (C). Computed tomography venogram confirmed stenosis of the SVC (D).  
ICD: implantable cardioverter defibrillator, SVC: superior vena cava.

infraclavicular approach (**Figure 1C**). Computed tomography venogram confirmed stenosis of the SVC (**Figure 1D**). SVC obstruction is a known entity (in up to 30% cases) in the context of bulky ICD leads. However, it remains asymptomatic and thus often goes unnoticed until the need for device upgrade with a new lead or extraction arises.<sup>1)</sup> Having said that, venous engorgement such as in our case is very rare. One of the common causes of stenosis at the right atrium (RA) - SVC junction is the SVC coil of a dual coil ICD. Superiority of dual, versus single coil leads, in terms of defibrillation efficacy remains to be proven.<sup>2)</sup> Moreover, the SVC coil increases lead complexity, cost, risk of lead failure, and lead removal.<sup>3)</sup> Also, in the absence of a bradycardia indication, the potential of an additional atrial lead to enhance arrhythmia discrimination, reduce inappropriate shocks, rate of hospitalization and mortality has not been borne out by scientific studies.<sup>4)</sup> A SVC coil induces not only wall adhesions, but also sclerotic reorganisation of the venous wall resulting in stenosis and obstruction.<sup>1)</sup>

In our patient, we are managing his heart failure with optimal medical therapy including angiotensin receptor antagonist and neprilysin inhibitor and sodium glucose transporter 2 inhibitor. We anticipate the need for a venoplasty of the SVC-RA junction if we do ever consider upgrading his ICD with a new left ventricular lead. In retrospect, the SVC obstruction may have been prevented if a single coil ICD was implanted in the first place. In contemporary practice of ICD implantation, an SVC coil can cause more trouble than be of benefit to a patient.
