## Letter to the Editor

# Pacemaker mimicking a tunnel digger

J Geriatr Cardiol 2020; 17: 528-529. doi:10.11909/j.issn.1671-5411.2020.08.010

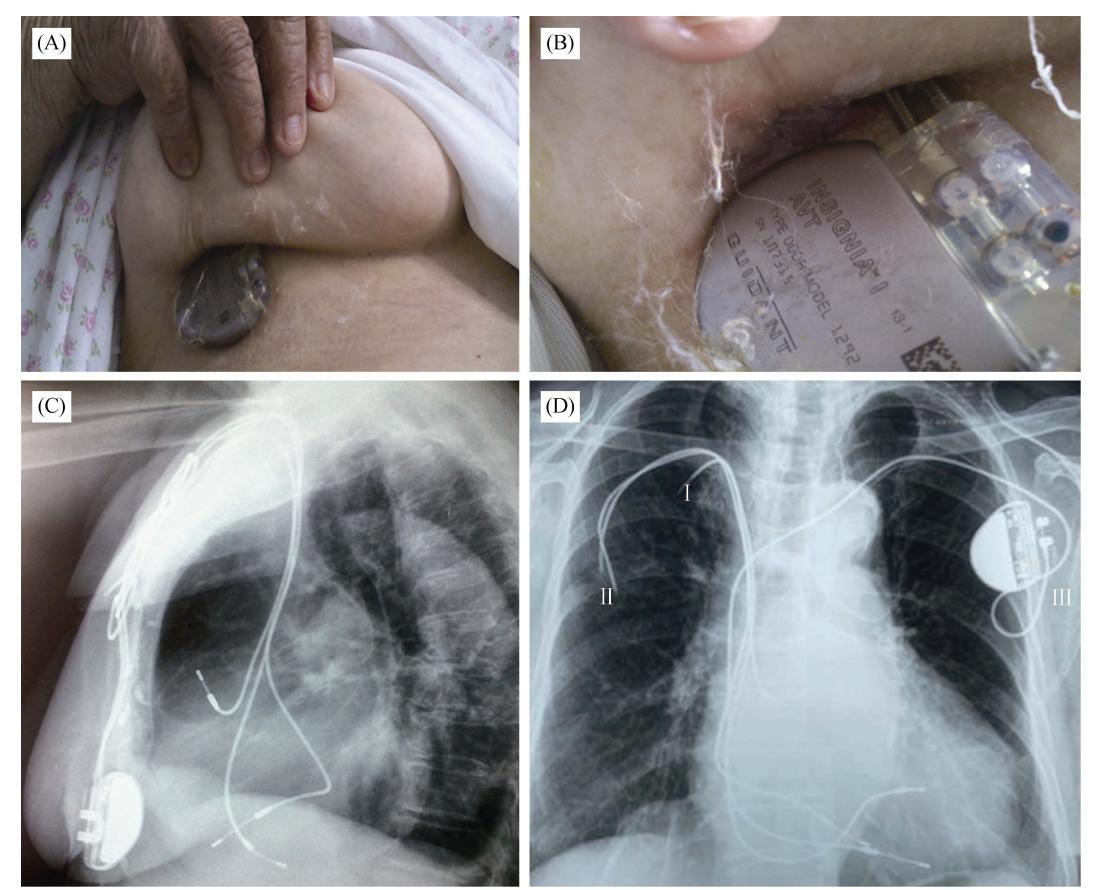
**Figure 1.** Clinical images and X-rays. (A): Display of pacemaker's generator upon the elevation of the right breast; (B): detailed view of the skin tunnel's entrance. Note the cotton flakes that the patient used to cover the opening; (C): X-ray chest film, lateral view showing the external position of the device; and (D): X-ray chest film poster anterior view, ten days after the re-installment of the pacemaker. I presented as initial pocket of the VVIR pacemaker. II presented as re-implantation pocket of the DDDR device leading to tunnel formation and complete generator extrusion. III presented as final re-implantation on the left side.

On physical examination, she revealed to us a tunnelhole beneath the right breast which she used to hide and cover with cotton pads. To our surprise, a complete pacemaker generator extrusion was observed (Figure 1A–C). Pacemaker testing revealed that the device's functional values were completely within normal ranges. Neither fever nor other manifestations of systemic infection were noted upon admission. However, wound swab cultures were positive for Proteus mirabilis and Klebsiella pneumoniae and intravenous antibiotic treatment, according to antibiogram results, was initiated for two weeks. Explantation, without lead removal and replacement with a new VVIR unit, placed subpectoral (under the pectoralis major muscle) on the left side was accomplished without complications at one-year follow-up (Figure 1DIII).

Skin erosion as the most common late complication of pacemaker implants is widely documented with an estimated incidence of around 0.8%, but the complete extrusion of the device from the subcutaneous pocket is very rare.<sup>[1-4]</sup> Tissue vulnerability in elderly patients, the presence of a thin subcutaneous layer, erosive action (especially the scratching of an itch), small pocket size, depressed level of immunity, poor hygiene, poverty and cognitive impairment are the most important causal factors.<sup>[1,2]</sup> In our case, the large breast size with plenty of loose fatty tissue in the retromammary space, may have predisposed to this extremely unusual, invisible, longitudinal downward displacement of the generator, leading to its complete extrusion below the woman's right breast, forming a tunnel of about 20 cm onto the pectoralis major muscle. Early diagnosis at the period of preerosion is crucial, in order to avoid more serious complications that may require the removal of the hardware. Careful

examination of the skin at the expected site of the pocket and subpectoral implantation of the device, as performed the second time in our patient, should be considered in order to prevent this rare complication. The removal of the generator and leads is recommended if erosion occurs, as the system is considered contaminated.<sup>[3]</sup> In our patient, no lead removal was attempted because she was considered high-risk in case an open heart surgery was needed and she had no signs of systemic infection. An alternative and feasible approach includes permanent pacemaker implantation via the femoral vein, especially in cases with recurrent erosion.<sup>[5]</sup>
