Allergic reaction to pacemaker compounds: Case reports

KEYWORDS Allergic reaction; Covered generator; Erythema; Exteriorization; Pacemaker; Polytetrafluoroethylene (Heart Rhythm Case Reports 2022;8:410–414)

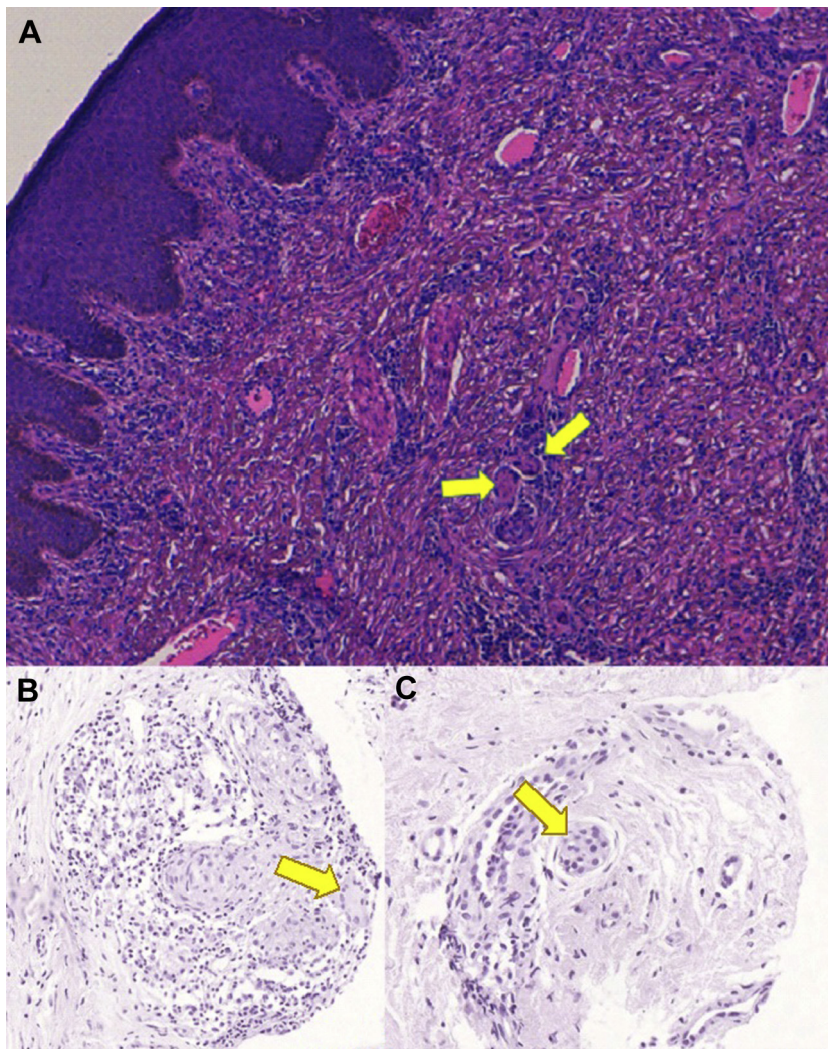
Skin tests were performed on all pacemaker components, including titanium, which reported negative at 72 hours. Biopsies of the lesions were also taken during the device removal procedure, showing giant Langerhans cells and chronic granulomatous inflammation due to foreign body (type IV reaction) (Figure 1A).

Figure 1 Pacemaker pocket tissue biopsy. Classic type IV reaction is shown, characterized by chronic granulomatous inflammation and Langerhans cells (yellow arrows). Pathology findings were consistent in the 3 reported cases. **A:** Case 1. **B:** Case 2. **C:** Case 3.

Dermal tests of the pacemaker components were negative. The biopsy of the pocket lesions demonstrated chronic granulomatous inflammation and multinucleated giant cells (Figure 1B). After analyzing the results, it was decided to implant an epicardial pacemaker covered with an expanded polytetrafluoroethylene (ePTFE) bag (Gore-Tex cardiovascular patch) made by the surgery team (Figure 2B). No complications or symptoms were reported after 2 years of follow-up.

adequately healed, with satisfactory outcomes. The pocket tissue biopsy reported findings consistent with the 2 previous cases (Figure 1C).

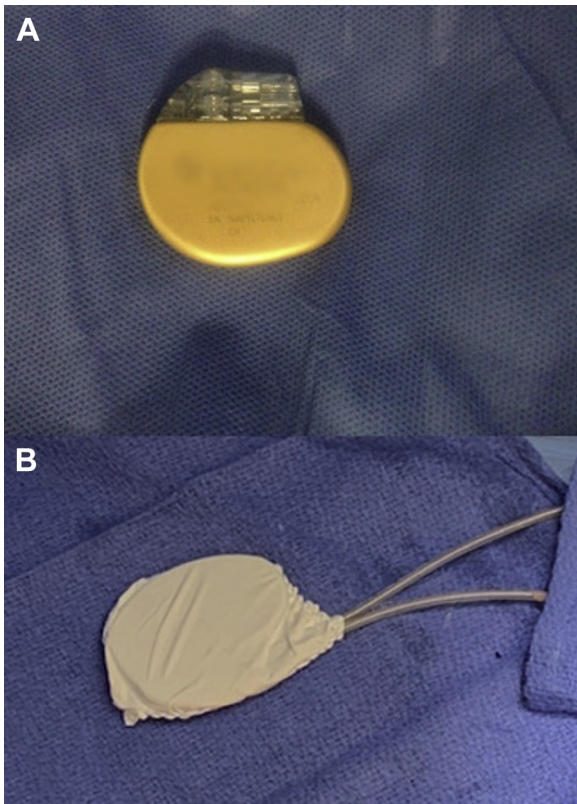
Figure 2 Pacemaker generators covered. **A:** The gold-coated pacemaker generator implanted in the first case (patient 1). **B:** The polytetrafluoroethylene-wrapped generator used in the second case (patient 2).

A new implant was successfully done in March 2012, an endocardial bicameral pacemaker (Medtronic Adapta DR PVV, 24 karat gold, 0.45 mm minimum coating thickness; Medtronic Inc) (Figure 2A) in the left subclavian region. No complications were reported after a 9-year follow-up.
