## Case Report

# Acute Failure of a Glenoid Component in Anatomic Shoulder Arthroplasty

**William E. Daner, III and Norman D. Boardman, III**

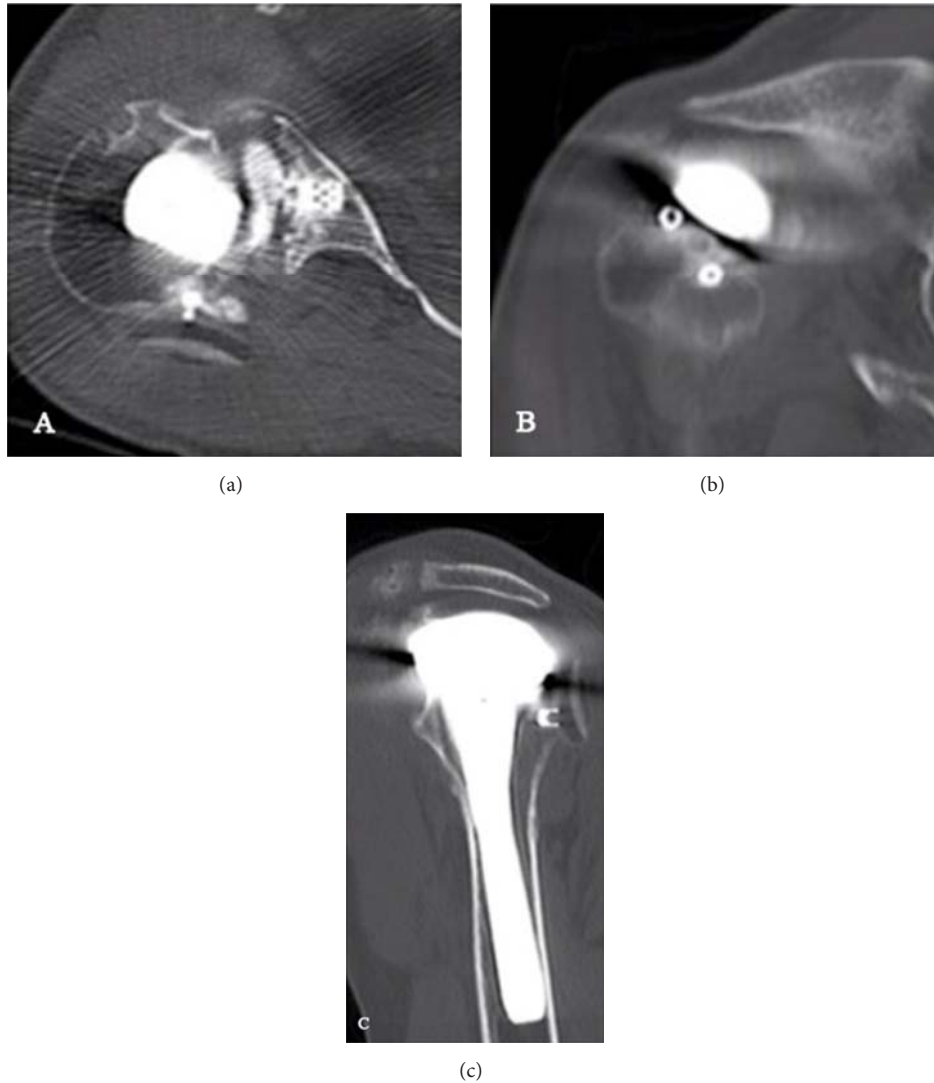
The patient is a 65-year-old man referred to the senior author's clinic with persistent right shoulder pain and severely restricted range of motion approximately 10 months after a primary anatomic TSA. The indication for the primary procedure was longstanding severe osteoarthritis with an intact cuff. The Exactech Equinox (Exactech Inc., Gainesville, FL) shoulder system was used for the index procedure, with a pegged, caged glenoid (model number 314-02-04). Utilizing a standard deltopectoral approach, a 15 mm press fit humeral stem with a 47 × 18 humeral head, offset with a 4.5 mm replicator plate and a large beta curvature, pegged glenoid with cage was implanted. No complications had been noted at the time of the primary procedure. The patient had an uneventful, atraumatic postoperative course, but he failed to progress. His range of motion was severely restricted to about 15 degrees in all planes 8 months after surgery. A CT arthrogram was ordered to evaluate if there was a rotator cuff tear but instead found that the glenoid component had dissociated and was sitting posterior to the humeral head (Figure 1). The polyethylene glenoid component had

FIGURE 1: Selected axial (a), coronal (b), and sagittal (c) cuts of CT demonstrating dissociated glenoid component with cage remaining seated in the glenoid.

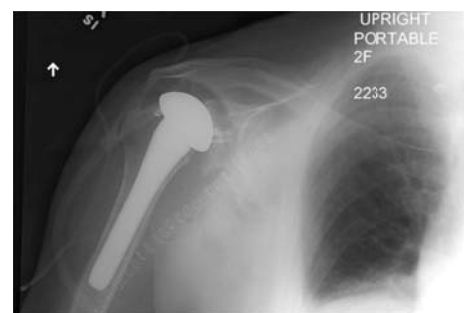
disengaged from its metallic cage and one of the three metallic peg caps, which remained seated in the glenoid. Close inspection of the postoperative films, as early as those immediately following surgery in the postanesthesia care unit, confirmed that the glenoid had in fact failed acutely (Figure 2).

FIGURE 2: Postoperative X-ray, day of primary TSA.

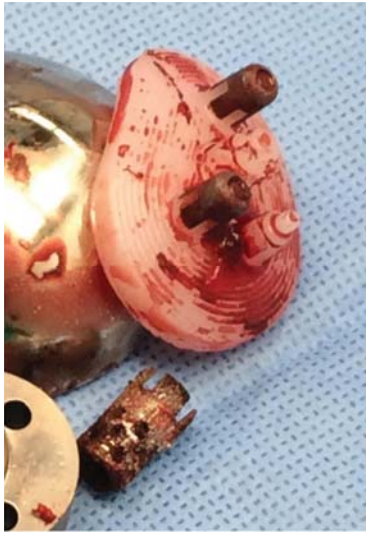
The patient was subsequently referred to the senior author and underwent revision TSA. The glenoid component was retrieved from the posterior capsule. The component failure occurred at the interface between one of the pegs and its metallic cap as well as at the cage component, which had disengaged from the polyethylene (Figure 3). Inspection of the native glenoid revealed a region of proud bone, consistent with inadequate reaming of the glenoid. The retained glenoid cage and peg were extracted and the glenoid was prepared for the new implant. A new pegged glenoid was cemented into place and the humeral head was downsized.

FIGURE 3: Explanted glenoid component. Note that one of the pegs and the cage have dissociated from the remainder of the glenoid component.

The cause of acute glenoid failure in the subject of this case report was likely multifactorial and in all likelihood related to inadequate glenoid exposure. The glenoid component failed through the cement-implant interface as well as within the implant itself. The metal cage and one of the three metal peg caps dissociated from the polyethylene and remained seated in the patient's glenoid, while the remainder of the component dissociated posteriorly. The cement mantle failed acutely, which may have been due to premature cement hardening before the glenoid was impacted or improper component positioning secondary to poor exposure. Less likely, the cement may not have adequately set when compression was released and the shoulder reduced. However, with this implant, it has been reported that holding compression while the cement sets is an unnecessary step.

The dissociation of the metallic peg caps and cage from the polyethylene is not without precedence. In the two revised failures of the Exactech Equinox system noted previously, the central cage locking mechanism failed as well. Especially for this implant, glenoid exposure is paramount. The component requires “straight line” glenoid impaction. It must be directly perpendicular to the face of the glenoid to prevent damage to the locking mechanism of the central peg as it engages the drilled hole. Failure to do so may disengage the central peg from the polyethylene [23]. This technical point is likely the cause of the failure in this patient.
