Rare complication of inadequate sealing caused by anchor slip through the fabric part in a left atrial appendage closure device

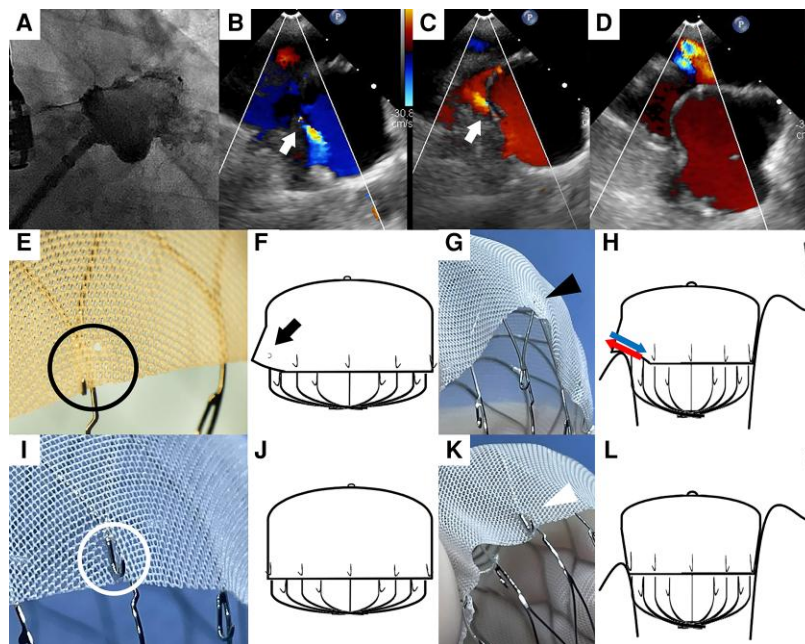
Figure 1 We attempted to place the WATCHMAN-FLX 31 mm device in the left atrial appendage (LAA) (A). The residual blue colour Doppler flow was observed inside the LAA (white arrow) identified by transoesophageal echocardiography (TEE) (B). The red colour jet flow was, in contrast, found outside the LAA (white arrow) (C). The new WATCHMAN-FLX device was redeployed in a similar position in the LAA, and the TEE showed no residual leak flow (D). Physical examination of the retrieved WATCHMAN-FLX device revealed the existence of a pinhole in the fabric area and the detachment of the anchor (black circle) (E). The schema of this phenomenon showed that the anchor slipped through the fabric area (black arrow) (F). The fabric part without anchoring was easily opened (black arrow head) when the device was compressed from the outside by a human hand (G); thus, we speculated that there was residual flow (bidirectional flow) in the LAA at the first attempt (H). The unused intact WATCHMAN-FLX shows that the anchor part is hooked (white circle) through the small pinhole inside the fabric area (I and J). The fabric area, without dislodgement of the anchor, was not opened (white arrow head) if the device was compressed by a human hand (K), resulting in no residual flow in the LAA (L).

The structure of the WATCHMAN-FLX device is designed to have dual-row anchor parts, and the proximal anchors are hooked into the fabric area. The recapture procedure of WATCHMAN-FLX may cause anchor dislodgement through the fabric area. The anchor slip phenomenon may be considered when unusual residual leak flow through the proximal fabric area is identified by transoesophageal echocardiography.

A 77-year-old man who had a history of stroke and major bleeding underwent percutaneous left atrial appendage (LAA) closure. After several device recapture attempts using the WATCHMAN-FLX 31 mm (Boston Scientific, Marlborough, MA, USA), the device was implanted in the correct position of the LAA (Figure 1A). However, transoesophageal echocardiography (TEE) identified an abnormal minor leak flow through the proximal body surface (Figure 1B and C). The leak flow appeared to have originated in the fabric area of the device. Therefore, we switched to a new device. Although the new WATCHMAN-FLX device was deployed in a similar position compared with the previous attempt, the residual leak inside the device had disappeared (Figure 1D). Visual and microscopic examination of the retrieved WATCHMAN-FLX device revealed the existence of a pinhole in the fabric area and the detachment of the anchor (Figure 1E). This phenomenon could be explained by anchor slippage through the fabric part of the device caused by frequent recapture attempts (Figure 1F), which caused the residual flow in the LAA (Figure 1G and H). The proximal

anchor parts of WATCHMAN-FLX were hooked without a strong connection through the small pinhole inside the fabric area (Figure 1I and J). We speculate that the anchor part was not dislodged in the second attempt of this case (Figure 1K), resulting in no residual flow in the LAA (Figure 1L).

In patients using the WATCHMAN-FLX device during the procedure, physicians should follow the traditional criteria that include the four important components of position, anchor, size, and sealing of the device. In this case, detailed and careful observation with intraoperative TEE allowed us to identify the existence of inadequate sealing with a small leak flow. Although rare, physicians should be aware of the potential risk for anchor dislodgement after the recapture procedure of the WATCHMAN-FLX device.
