## Case Report

## Impending Trunnion Failure: An Uncommon Radiographic Presentation of Total Hip Arthroplasty Failure

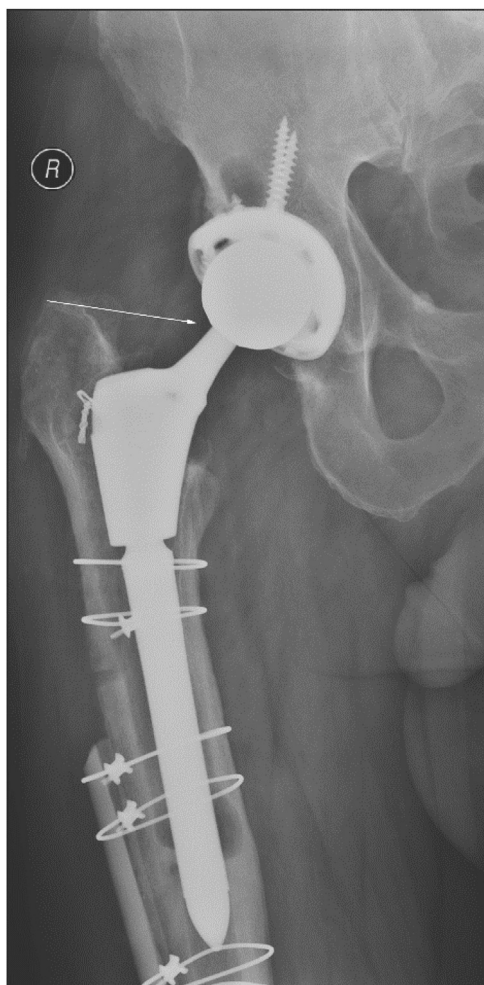
right THA in December of 2002, with revision in January 2006 for aseptic loosening, both occurring at an outside institution. In April 2012, he had a second revision, using a Zimmer Biomet hip replacement system including an Arcos Modular Femoral Revision system with a titanium stem and size 40 + 9-mm neck length (Zimmer Biomet, Warsaw, IN) [7]. A femoral cortical strut allograft was used because of significant osteolysis that had led to this revision. Postoperative imaging showed proper alignment of the femoral head-neck junction without any acute complication (Fig. 1).

**Figure 1.** Antero-posterior hip radiograph of a 64-y-old male with metal-on-polyethylene total hip arthroplasty (THA) demonstrating symmetric positioning of the neck within the femoral head (arrow). This routine postoperative follow-up radiograph was obtained 2 mo after his second THA revision for aseptic loosening.

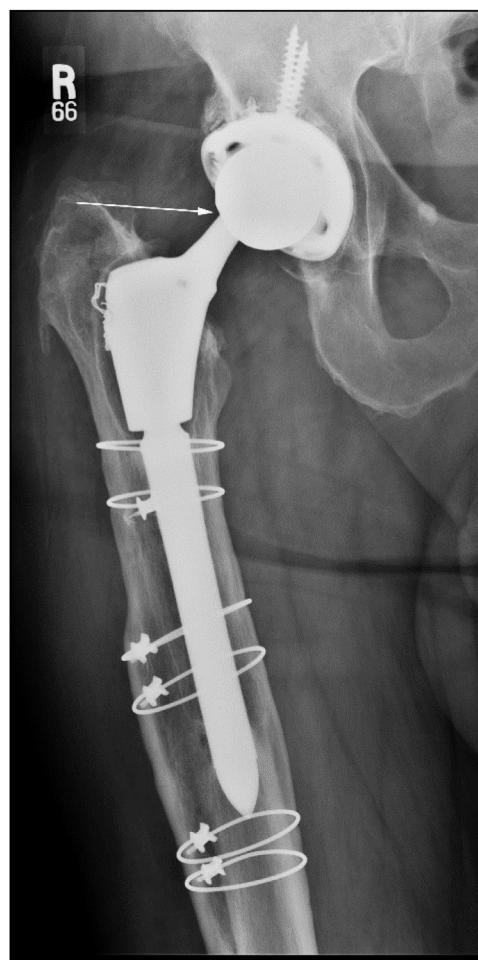
At his follow-up appointment in 2019, the patient reported that the clunking had worsened and was now associated with a sensation of instability. On examination, he had clear clicking with gentle internal and external rotation of his hip. Antero-posterior radiograph of the right hip at this visit demonstrated an abnormal oblique angle at the femoral head-neck junction when compared with his initial postoperative radiographs (Fig. 2). These radiographic findings were concerning for trunnion wear.

**Figure 2.** Antero-posterior hip radiograph of a 64-y-old male with 2 y of clunking, and a new-onset sensation of instability demonstrates an abnormal oblique angle between the head-neck taper of the femoral stem (arrow) concerning for trunnion damage and impending gross trunnion failure.

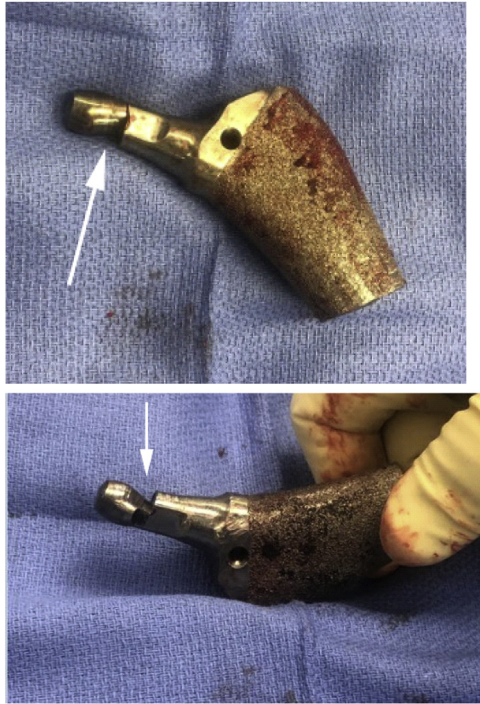
Informed consent was obtained from the patient, and 2 weeks later, he underwent a third revision of his right THA, revealing marked trunnion damage, a half-thickness crevice in the femoral neck, and a loose femoral head (Fig. 3). The degree of trunnion erosion necessitated revision of the femoral stem, requiring extended trochanteric osteotomy, in addition to exchange for a ceramic femoral head. At his recent 7-month follow-up visit, he was noted to be ambulating well with minimal pain and without the need for assistance.

**Figure 3.** Explanted femoral stem demonstrating erosion of the proximal portion of the taper and a half-thickness crevice (arrows) in the femoral neck.

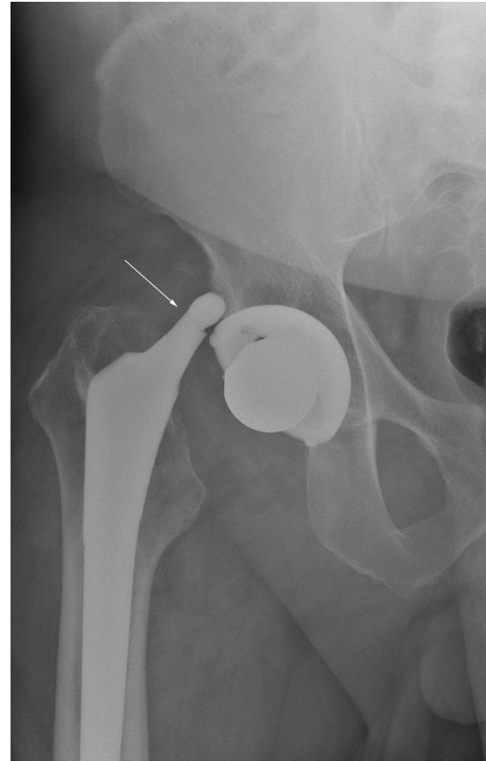
**Figure 4.** Antero-posterior hip radiograph of a 47-y-old male (different patient than the case report) with acute-onset right hip pain after sitting in a chair demonstrates gross trunnion failure with complete dissociation of the femoral head from the neck at the taper and notching of the trunnion (arrow). Black synovial fluid was aspirated from the joint before revision surgery. This case illustrates a potential complication of trunnion wear leading to catastrophic trunnion failure.
