New type of left ventricular rupture during redo mitral valve replacement. A case report

S.I. Sersar, A.M. Bassiouni, A.A. Jamjoom

Division of Cardiothoracic Surgery, Department of Cardiovascular Diseases, King Faisal Specialist Hospital and Research Center, Saudi Arabia

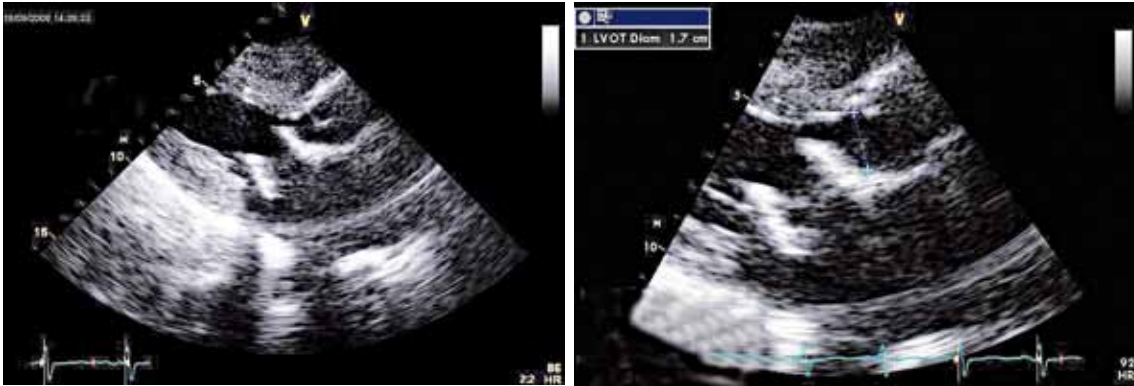
Figures 1 and 2

tral valve replacement (MVR) with a high profile bioprosthesis size 31 (we could not identify the type and or the manufacturer of the bioprosthesis). The echocardiography showed abnormal position of the bioprosthesis strut, with narrowing of the left ventricular outflow tract (LVOT) = 1.7 cm and a mean systolic gradient of 35 mmHg. (Figures 1 and 2).

Pre operative echocardiogram showing the bioprosthesis malpositioned with left ventricular outflow tract obstruction.

To the best of our knowledge, this is the first report of a posterior LVOT wall rupture after redo MVR. From our point of view, this new type of LV rupture may be due to the abnormal position of the previously implanted mitral valve bioprosthesis strut, causing significant thinning and weakness to the posterior wall of the LVOT (2).

We think that the cause of the mitral valve improper positioning may be due to over preservation of the posterior mitral valve leaflet leading to abnormal position of the bioprosthesis. New York University experience to reduce the LV tear during mitral

preserve the posterior leaflet at the expense of the position or size of the prosthesis and or the LVOT.
