Am J Med Case Rep. 2020 ; 8(7): 178–181.

Shift From Left to a Right Bundle Block on ECG Leading to the Diagnosis of a Malpositioned Lead in the Coronary Sinus: A Case Report

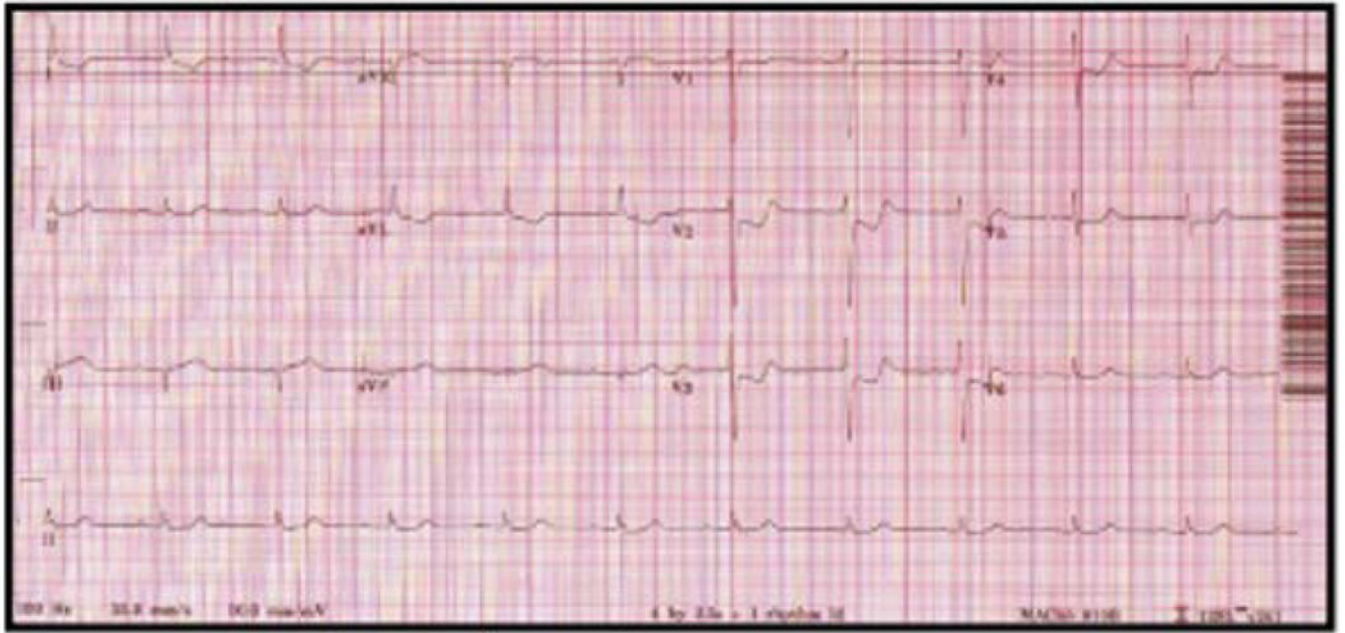
Figure 1.
Initial EKG showing normal sinus rhythm, note ST-Segment depression in lead V2- V3

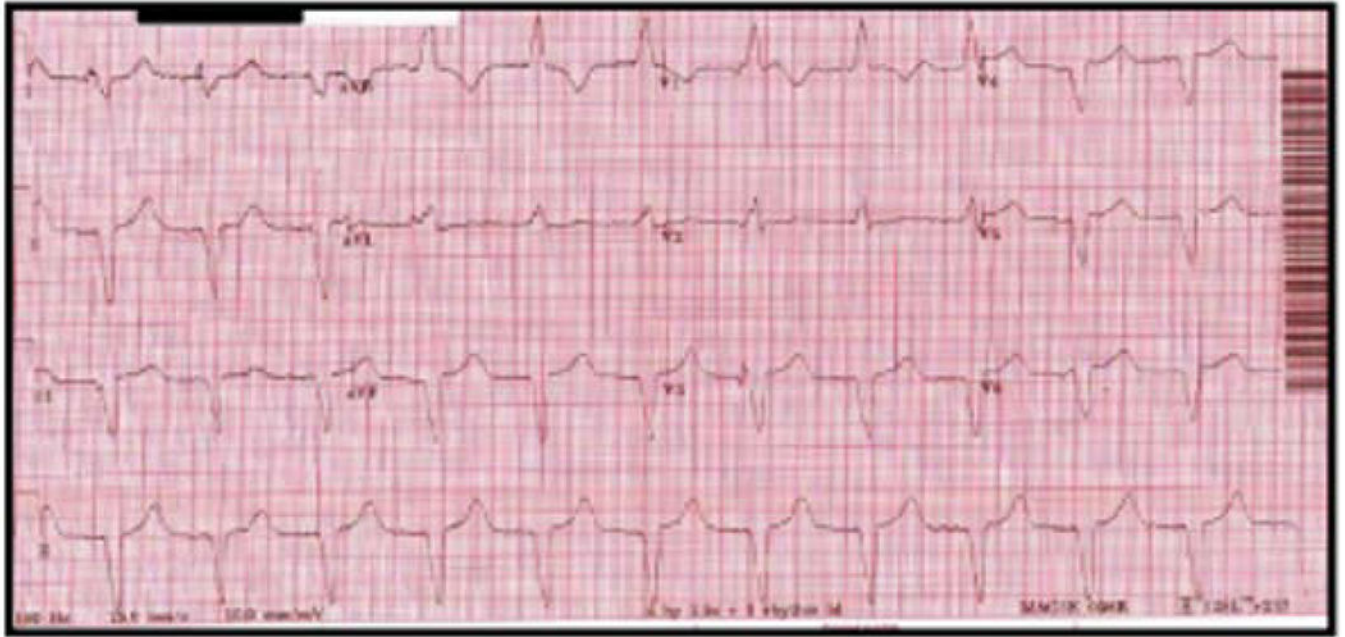
Figure 2.
EKG showing RBBB pattern with RV pacing

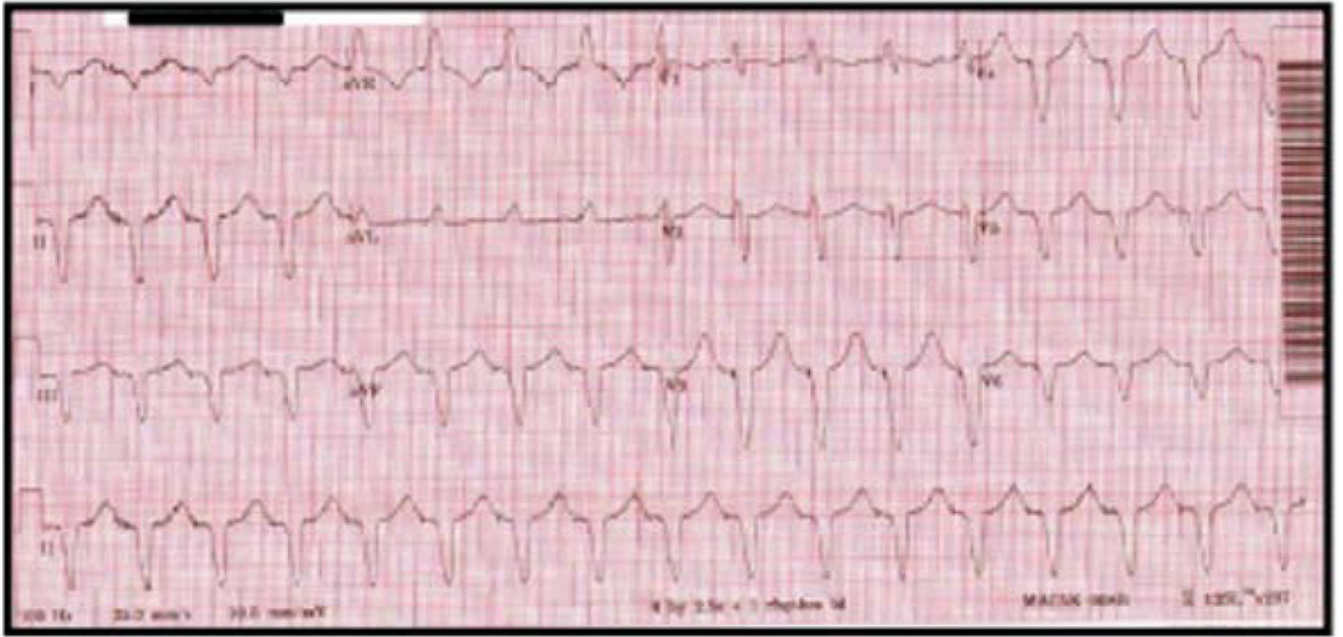
Figure 3.
EKG with asynchronous pacing (with magnet on the pacemaker) showing RBBB
