Determination and classification of intraoral phosphor storage plate artifacts and errors

Purpose: The aim of this study was to determine the reasons and solutions for intraoral phosphor storage plate (PSP) image artifacts and errors, and to develop an appropriate classification of the artifacts.

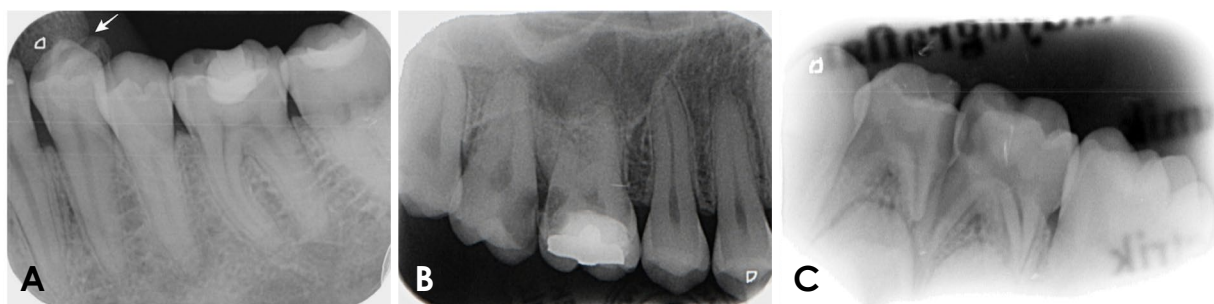
In the study, the next most common error was whitening (Table 1). When the PSP is exposed to visible light through a piece of paper with writing on it, more light passes through the area without writing, and the text on the paper appears on the latent image (Fig. 1).

**Fig. 1.** A. Phalangioma (arrow). B. The dental fillings (highest attenuation value areas) lost photons and had a shiny appearance when exposed to ambient light. C. A text pattern caused by exposure to visible light.

ery of the image because the photons that are exposed on the periphery of the plate have a lower intensity than those that are exposed on the center of the plate.⁴ Additionally, the highest attenuation value areas, such as fixed prostheses and metallic dental materials, lose photons and have a shiny appearance when exposed to ambient light (Fig. 1B).

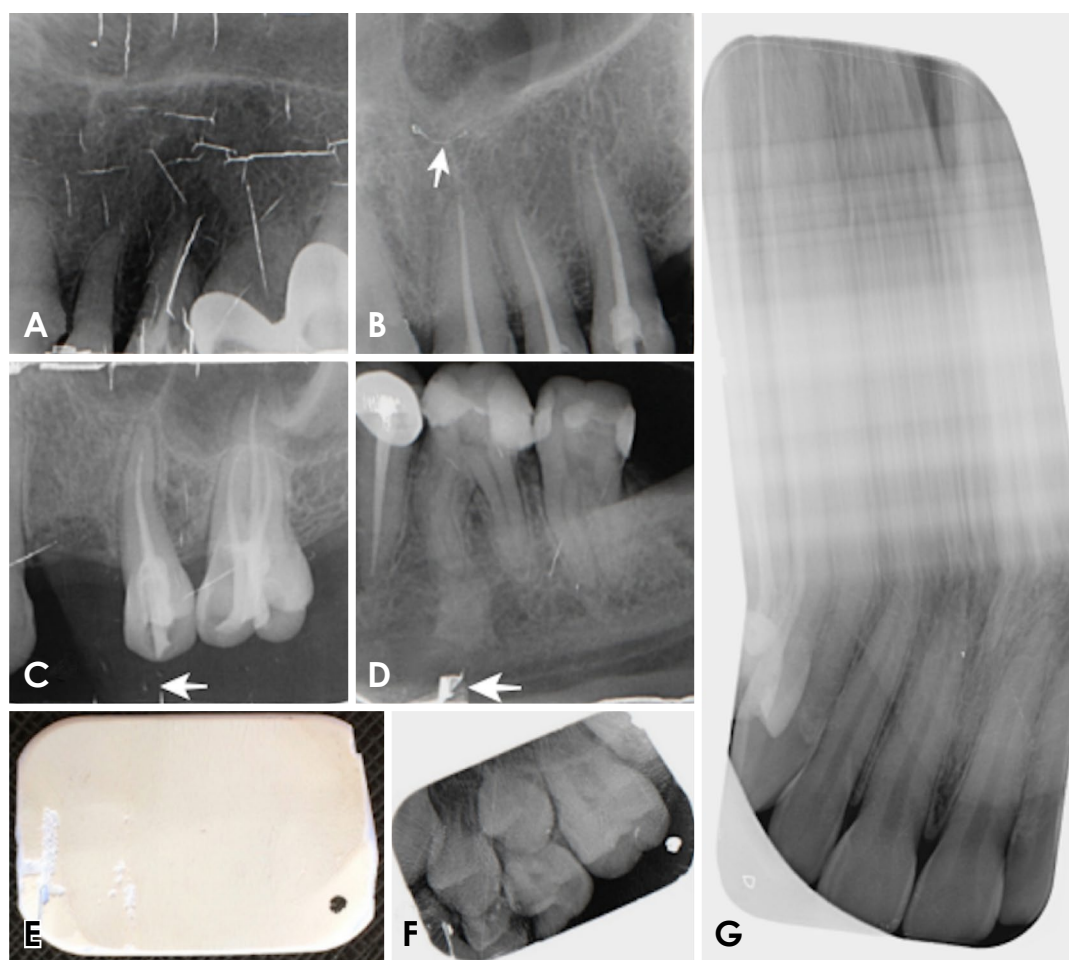
In the study, the third most common error involved short scratches (Table 1). These deformations are shown as irregular or straight radiopaque lines anywhere on the radiograph. Using a plate that is not properly matched with the scanner causes the image to elongate longitudinally and produces bright stripes (Table 2, Fig. 2).^{8,9}

Fig. 2. Phosphor storage plate (PSP) damage. A. Stretches. B. Crescent-shaped bending (arrow). C. Bite marks (arrow). D. Partial stripping (arrow). E. Peeled plate surface. F. Reticulation caused by a peeled PSP surface. G. Elongation of the image resulting from use of a mismatched plate.

Another common error came from short scratches caused by deformations in the plates. Damage to the photo-stimulating luminescence layer and cracking in the supporting polyester layer can occur for a variety of reasons, including careless manipulation when positioning the PSP in the mouth, excessive bending, unintentional biting by the patient, using force when placing the film into the scanner, and mechanical stresses of the rollers and holders during the scanning process. Manufacturers recommend using protective covers to minimize mechanical damage to the plates.^{8,9} Previous studies have suggested that plastic bar-

rier envelopes were not able to prevent bite marks.⁴ PSP damage can be handled using Roberts and Mol’s method,¹⁷ which involves placing double-sided pieces of tape around the sensor plate cover. It has also been reported that the use of both cardboard sheaths and disposable plastic envelopes prevents PSP damage; however, this also causes movement of the phosphor plates in the disposable packets.¹³ PSPs should be checked every day for scratches. If scratches are found on the surface, a test image should be taken and, if necessary, the PSP should be replaced. It was observed that the rate of physical damage to the PSPs was much higher than reported by Chiu et al.⁴ and Gülsahi et al.,⁵ but similar to that reported by Çalıřkan and Sümer.³ In this study, the high rate of the PSP damages was due to the fact that new PSPs could not be purchased when needed because of the hospital’s financial situation and the high costs of the PSPs.

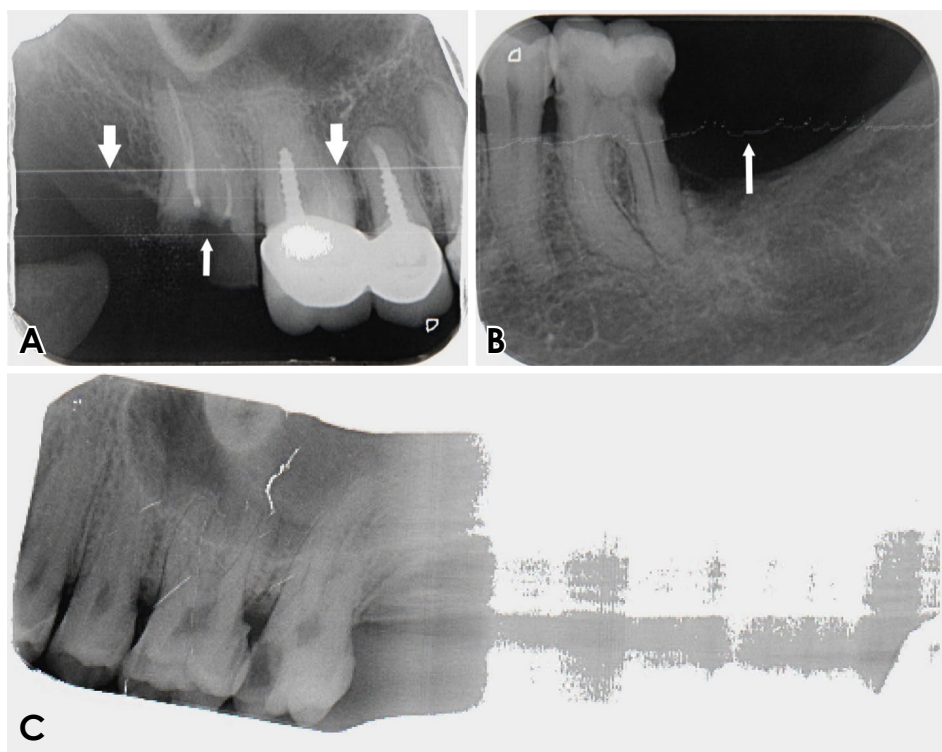
Errors related to the scanner were quite rare; the most common scanner error was horizontal white lines caused by the accumulation of dust and dirt on the narrow window of the scanner (Table 3, Figs. 3-6). In this study, errors related to the scanner were identified with the help of our technical support team and previous studies.^{3,4,6,8-11}

Fig. 3. Scanner artifacts. A. The gray lines extend in the fast scan direction (thick arrow) (caused by dust on the light guide) and dust particles (thin arrow). B. The gray line extends in the fast scan direction (arrow). C. Transport belt artifact (caused by the belt motor not moving at the correct speed, resulting in an abnormal elongation of the image).

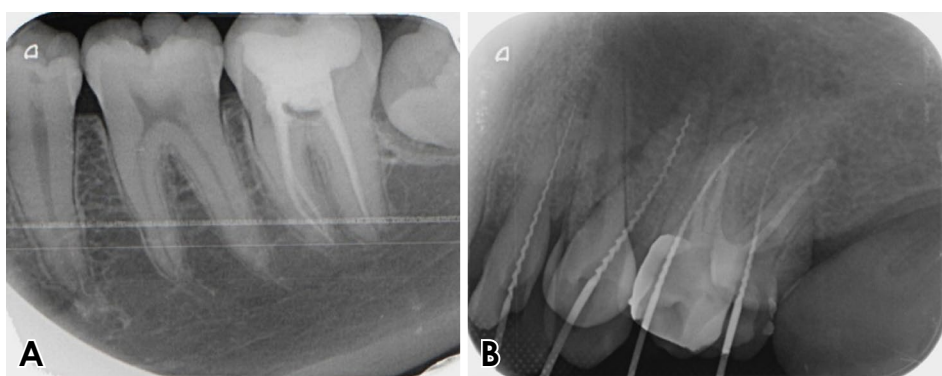
Fig. 4. Scanner artifacts. A. Laser slit dirt. B. Eraser unit artifact.

An inadequate erasing process causes a ghost image of the previous exposure to appear on the image. The solution is to check the setting. The eraser setting should be at the highest erasing power, while the scanning speed should be

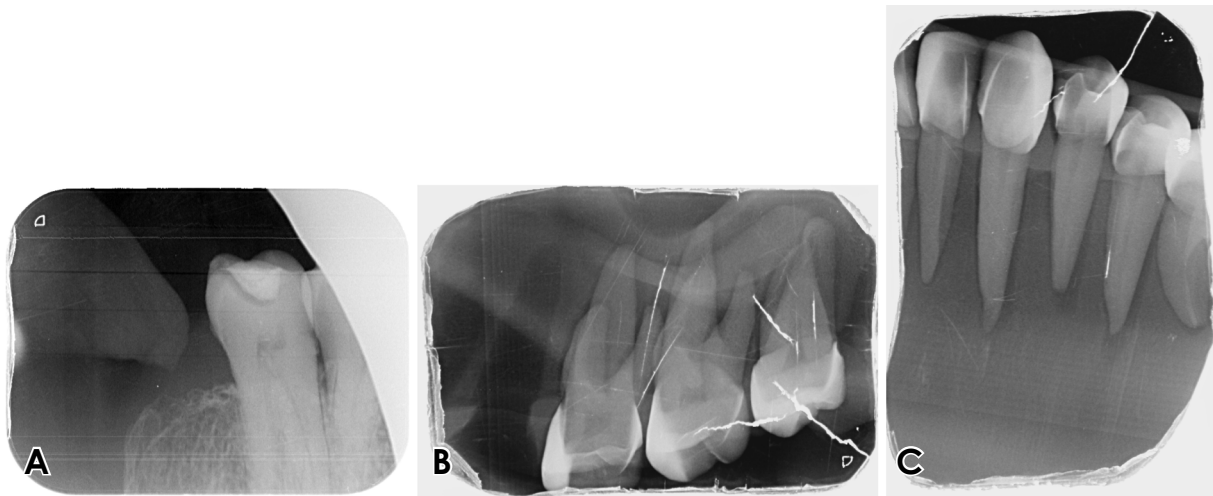
Fig. 6. Scanner artifacts. A. Straight radiolucent lines (with the likely cause being dust/dirt particles on the pickup light guide). B and C. Parallel multiple radiolucent lines images obtained from a phantom head. The likely cause was electromagnetic interference.

served and these artifacts appeared as 4 straight lines in the same image, equidistant from each other. It was reported that such scan lines were caused by dust/dirt particles on the pickup light guide.¹⁰ Shetty et al.⁶ reported that non-visualized areas and missing lines or pixels may be caused by sudden power failures. In addition to that, before this study was performed, radiolucent bands with different characteristics were observed in 4 consecutive images taken from a phantom jaw. These radiolucent bands in phantom images were seen as multiple radiolucent lines parallel to the fast scan direction (Fig. 6). After the device connections had been repeatedly put in place, the error was diminished. The manufacturers report that electromagnetic interference artifacts are caused by the existence of power lines in the immediate vicinity, which is a physical phenomenon that can affect electronic equipment in general.⁹ Manufacturers suggest adding appropriate electromagnetic shielding, and that the quality of the supply voltage should corresponded to a typical commercial or hospital environment. The device should also be powered from an uninterruptible power supply or from a battery.⁹ Çalışkan and Sumer³ referred to this as the ridging artifact, and suggested that these multiple radiolucent lines parallel to the fast scan direction are caused by momentary changes in the light intensity of the stimulating lasers and loss of synchronization between fast scan cycles and image plate transitions. A full consensus about radiolucent artifacts has not been achieved; further research is needed on this type of artifacts.

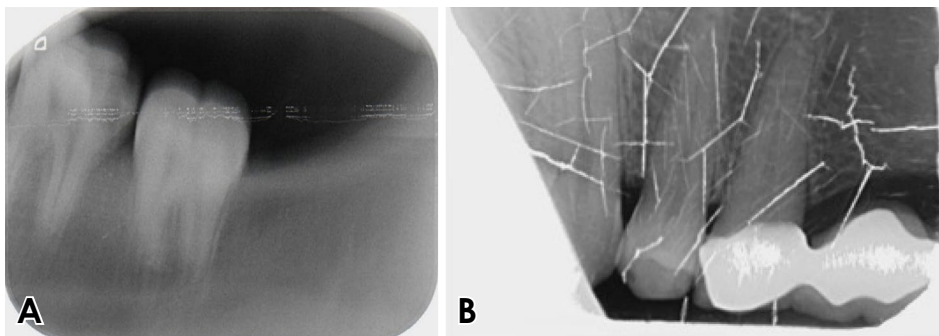
defects and bisection of images. Edge masking is designed to improve the quality of clinical images.^{8,9,11} Defective edge masking causes part of an image to be missing, so that it resembles a cone-cut image or a metal artifact.^{8,9} In addition, inadequate edge masking causes image blurring.¹¹ This study found 2 images with the artifact presenting as a blurred image. In this retrospective examination, we could not securely differentiate a defective edge masking artifact from cone-cut images. However, in the clinic, when we encountered this type of edge masking defect, the system gave the edge masking defect error for consecutive images that had a cone-cut appearance in the same region of images (Fig. 7). The solution was to update the software program. However, if the software program cannot be updated, the edge masking tool should be closed. Another software artifact is bisection of images. This error is caused by the image being divided into 2 parts, 1 of which is saved on the screen of the previous patient and the other part saved on the screen of the correct patient (Fig. 8).^{8,9} Software artifacts encountered in the clinic that have been reported pre-

Fig. 7. Software artifacts. A. An edge masking defect causing a noisy view. B. An edge masking defect simulating a cone-cut image.

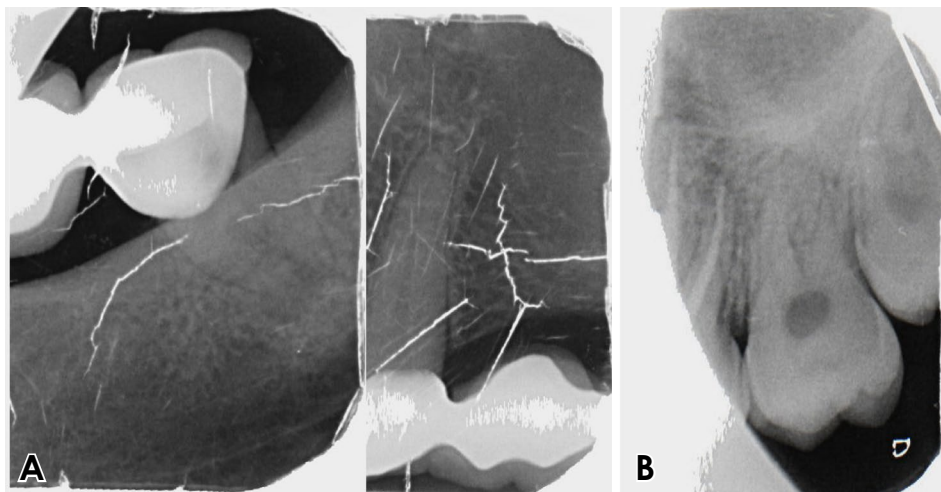
Fig. 8. Software artifacts. A. A bisection artifact (dividing the same image into two images). B. Plate size determination error. The reason for this artifact is that the scanner detected a different size from that of the scanned plate.

Plate size determination error most likely occurs when the scanner detects a different size from that of the scanned plate. The current study observed this artifact when the number 2 plate was detected as being the number 0 plate, causing half of the image to be missing. Çalışkan and
