Unusual Horizontal Root Fracture in a Mandibular Second Molar after Lower Wisdom Teeth Removal

Luiz Fernando Magacho Da Silva, Jonathan Ribeiro Da Silva, Fabrizio Albieri, Rodrigo Dos Santos Pereira

Department of Oral and Maxillofacial Surgery, General Hospital of Nova Iguaçu, Rio de Janeiro, Brazil

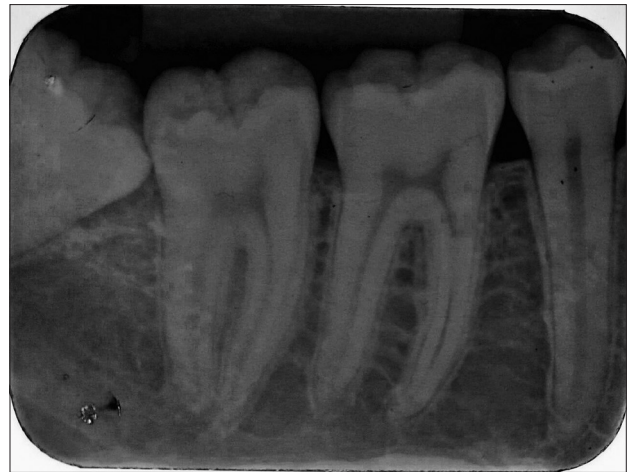
Figure 1: Preoperative X-ray demonstrating the third inferior molar with anterior angulation and the II-A Pell and Gregory classification

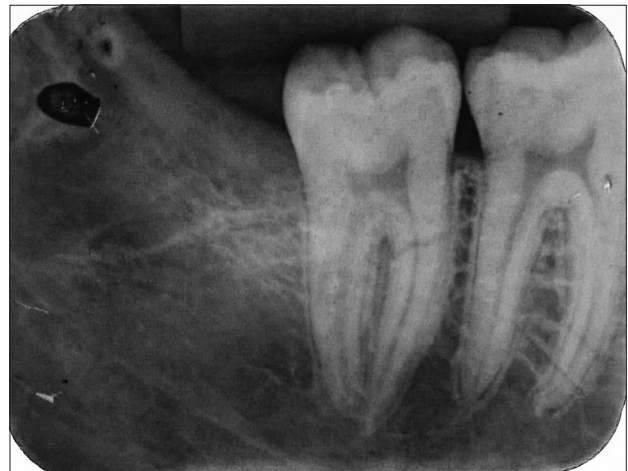
Posterior dental fractures commonly occur because of occlusal trauma during sports practice, physical injuries, or automobile accidents. Horizontal root fractures are especially rare.^[14] Cobankara and Ungör^[2] reported a horizontal root fracture involving a maxillary first molar caused by an automobile accident. Wang *et al.* reported a series of cases involving posterior teeth root fractures but with no fracture found on a mandibular second molar and with the main etiology being damaging masticatory habits and occlusal forces.^[4] In the present case, the etiology of the fracture was probably the force applied through dental elevators during removal of the wisdom teeth. There were no literature findings that connect wisdom teeth removal to a possible second molar root fracture by the time this article was written.

Figure 2: Immediate postoperative X-ray showed a horizontal fracture of the mesial root of the lower right inferior second molar

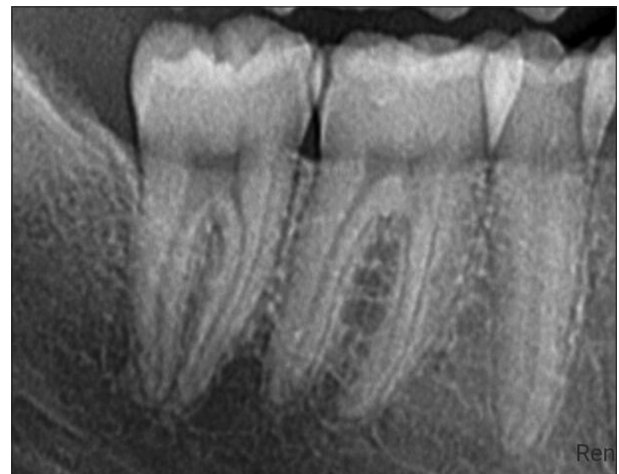
flap was performed to expose the tooth. After this, an osteotomy was performed in the vestibular region, followed by a dental section in the cementitious junction, a crown separation using a dental elevator, and the extraction of the 2 parts. No abnormal events were noticed during the surgical procedure. Sutures were done using 4-0 Vicryl resorbable thread (Ethicon, Johnson and Johnson, São José dos Campos, Brazil). An immediate postoperative X-ray showed a horizontal fracture of the mesial root of the lower right inferior second molar [Figure 2]. The clinical evaluation presented with no mobility, and because of this, no immobilization was done. After 1 week, the sutures were removed, and the patient reported no discomfort around the lower second molar. Clinical evaluations including pulp vitality tests and tooth mobility evaluation were performed weekly. Seven months later, another X-ray was taken that showed root healing with a small callus and without any trace of root fracture [Figure 3].

Horizontal root fractures, with or without initial treatment, tend to heal in 80% of the cases.^[2,3,12,15] This case demonstrates the potential of a nontreated tooth with a horizontal fracture to heal spontaneously. The pattern of healing observed was type 1 as described by Andreasen and Hjørtting-Hansen, where a hard-tissue callus is formed around the fracture, the root is reunited, and the tooth preserves its vitality.^[12] During all postoperative stages, in this case report, the tooth kept its sensibility.

Figure 3: Postoperative X-ray after 7 months showing the root healing
