Arthroplasty Today 1 (2015) 7-10

Case report

Acute, recurrent total knee dislocation: Polyethylene dislocation and malreduction

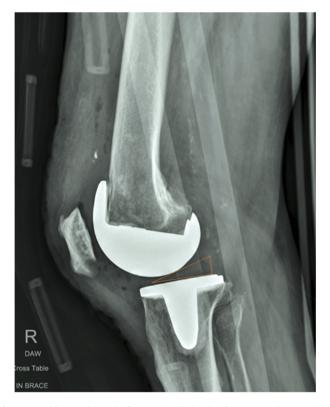
A 62-year-old man with a history of post-traumatic osteoarthritis and associated valgus deformity of the right knee underwent TKA at an outside hospital. Four days post-operatively the patient heard a loud "pop" while getting out of bed; radiographs confirmed posterior dislocation of the right knee. Fluoroscopy-assisted closed reduction was performed under general anesthesia. The patient was immobilized in a brace and made weight bearing as tolerated. Post-reduction radiographs were reviewed when he presented to our institution, which retrospectively showed persistent subluxation (Figure 1).

Fig. 1. Lateral knee radiograph after attempted closed reduction revealing persistent subluxation. Outline illustrates the posterior to anterior sloping of the polyethylene insert.

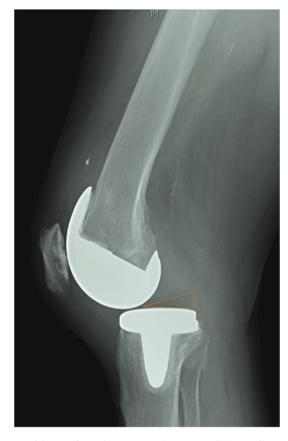
Four months afterward, the patient presented to this institution for a second opinion. The patient reported that he had right knee pain and daily dislocations of his right knee. The patient reduced his knee with the aid of traction using a rope tied to a bannister. Radiographs revealed a posteriorly dislocated tibia (Figure 2), and

Fig. 2. Lateral knee radiograph at presentation to our clinic revealing posterior dislocation of the tibia. Outline illustrates the posterior to anterior sloping of the polyethylene insert.

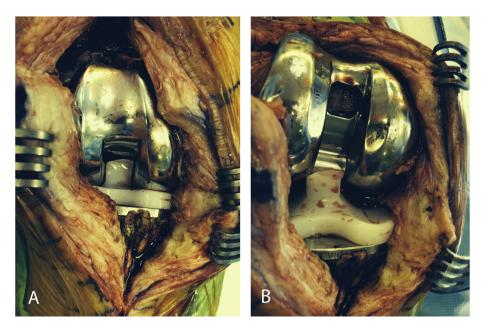
The first stage of the exchange involved total knee resection and the placement of an antibiotic spacer in the right knee. Upon surgical exploration, it was discovered that the polyethylene insert had spun completely to 180° with the anterior lip of the polyethylene insert lying posteriorly (Figure 3A and B). Figure 3B also exhibits gapping of the lateral compartment in flexion. Exploration revealed a severed popliteus. The patellar, femoral, and tibial components were removed without any bone loss, extensive synovectomy was performed, and the knee was irrigated. An articulating spacer was fixed on both the femur and tibia with antibiotic impregnated cement. The patient was made weight bearing as tolerated with a hinge brace (0°-30°) and placed on a six-week course of intravenous vancomycin. The patient was discharged four days postoperatively without complication.

Fig. 3. Intraoperative photos revealing 180° spinout of the polyethylene insert (A) as well as the lateral gapping in flexion (B).

In our case, we believe that flexion instability resulting from a severed popliteus caused posterior dislocation and resulted in 90° spinout of the polyethylene insert. We believe the closed reduction performed at the outside hospital rotated the insert an additional 90° to complete the 180° spinout. The first of three closed reduction attempts likely caused the complete spinout, as the lateral radiograph obtained prior to the second closed reduction at the outside hospital reveals a 180° spinout of the polyethylene insert (Figure 1). This spinout was presumably missed. Additionally, the patient had valgus deformity of the right knee, which is visible on the patient's original pre-operative radiograph prior to primary TKA. As discussed above, valgus deformity is a known risk factor for rotating platform dislocation, which likely predisposed this patient to dislocation. An

Eight weeks later, right total knee reimplantation was performed without complication. A highly constrained implant with a rotating platform was chosen. Even given the prior history of problems with a mobile bearing implant, the added benefits of reduced strain on the highly constrained polyethylene were felt to
