Case Report

Challenges in Removing the Essure[®] Device

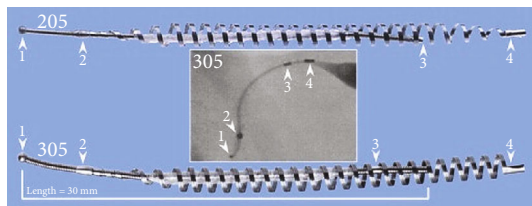
FIGURE 1: Essure[®] (Bayer AG, Leverkusen, Germany) with the four radiopaque markers (1). 1: distal end of the inner coil, 2: distal end of outer coil, 3: proximal end of the inner coil, and 4: proximal length of the outer coil [4].

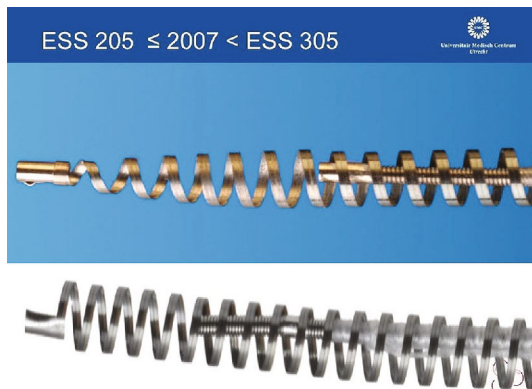
FIGURE 2: Difference of the third marker between ESS 205 and ESS 305.

Prior to removal surgery, it is important to understand the structure of the device. The inner coil consists of stainless steel and polyethylene terephthalate (PET) fibers running along the inner coil. The outer coil consists of nickel-titanium alloy (nitinol). [1, 10] The ESS205 and ESS305 are made from the same materials. Concerning the third marker, there is a difference between the two devices. The third marker of ESS205 is located at the proximal end of the inner coil. The third marker of ESS305 is situated a few millimeters more distal from the end. The third marker of ESS205 is prone to fragmentation after stretching the device during removal surgery, because of its position on the device, where this is less likely to happen with ESS305 because the marker is not terminal. The difference between the proximal part of the outer coil is that there is a little tube at the end of ESS205 that is placed over the nitinol coil. At ESS305 is a platinum plate attached at the end of the outer coil. In both models, the fourth marker is the biggest part of the device and prone to fragmentation. The PET fibers of the inner coil of Essure[®] react with the fallopian tube tissue which induces fibrosis. The outer coil becomes frail after some time, and traction may cause it to break. The most proximal part of the outer coil with the fourth marker is easily lost and can be hard to find. [6] In summary, not only the fourth marker but also the third marker of the ESS205 can tear off and can easily be lost during removal surgery.

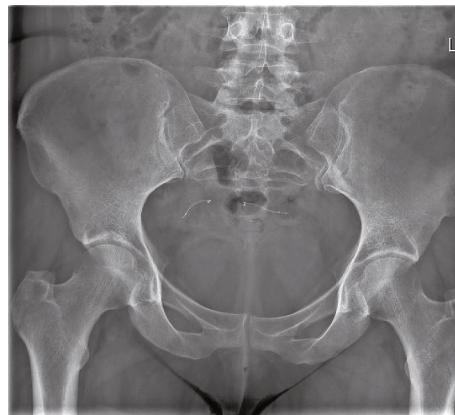
During gynecologic examination in May 2016, no abnormalities were found. Both devices seemed to be in the right position, assessed by transvaginal ultrasound imaging. She obtained a flat panel abdominal X-ray showing both implants with symmetrical deployment in the pelvic area and the proximal markers 25 mm apart (Figure 3). The woman requested surgical removal of the devices. Because of her

FIGURE 3: Flat panel abdominal X-ray (anterior posterior view) showing both implants (ESS 205) with symmetrical deployment in the pelvic area and the proximal markers are 25 mm apart.

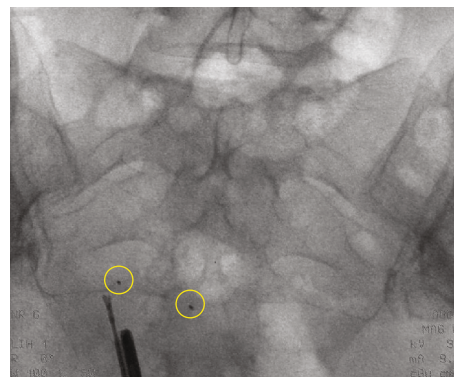
fragments. These were most likely to be parts of the removed Essure[®] devices. During initial laparoscopy, both fourth markers were visualized and removed, implying that these fragments were different parts of the device, supposedly the third markers (proximal marker of inner coil). The woman requested removal of these fragments. Six weeks later, hysteroscopy and laparoscopy were repeated. Hysteroscopically, no fragments of the devices were seen. During laparoscopy, intraoperative fluoroscopy was performed to visualize both remnants. The markers were bilaterally removed from the cornua, and this resulted in complete removal of the device remnants (Figures 4 and 5). The postoperative period was uncomplicated. Six week later, the woman continued to do well. Her symptoms were reduced; she only continued to experience symptoms of her left groin.

FIGURE 4: Fluoroscopy during surgery. Two markers are visible.

Intraoperative fluoroscopy is described in previous case reports to find lost fragments of the insert. [8, 11] It is a challenge to localize the exact localization of the fragment. Even with fluoroscopy, technical skills are needed for the removal. In view of the small size of the fragments and the limits of the human eye, this and other cases elaborate that there should be a low threshold for the use of intraoperative fluoroscopy. This technique can prevent the need for reoperation and eventually hysterectomy.

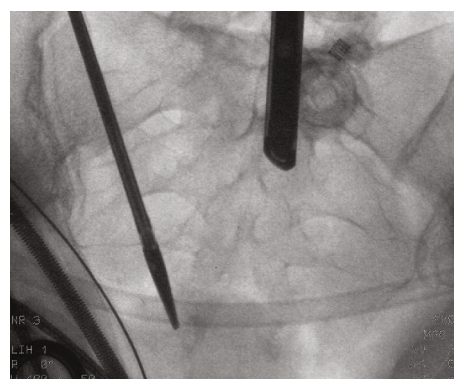
FIGURE 5: Fluoroscopy during surgery. The markers are removed.
