A national survey of MRI safety practices in Ghana

Cite as: Albert Dayor Piersson, Philip Nii Gorleku. A national survey of MRI safety practices in Ghana.

Heliyon 3 (2017) e00480.
doi: [10.1016/j.heliyon.2017.e00480](https://doi.org/10.1016/j.heliyon.2017.e00480)

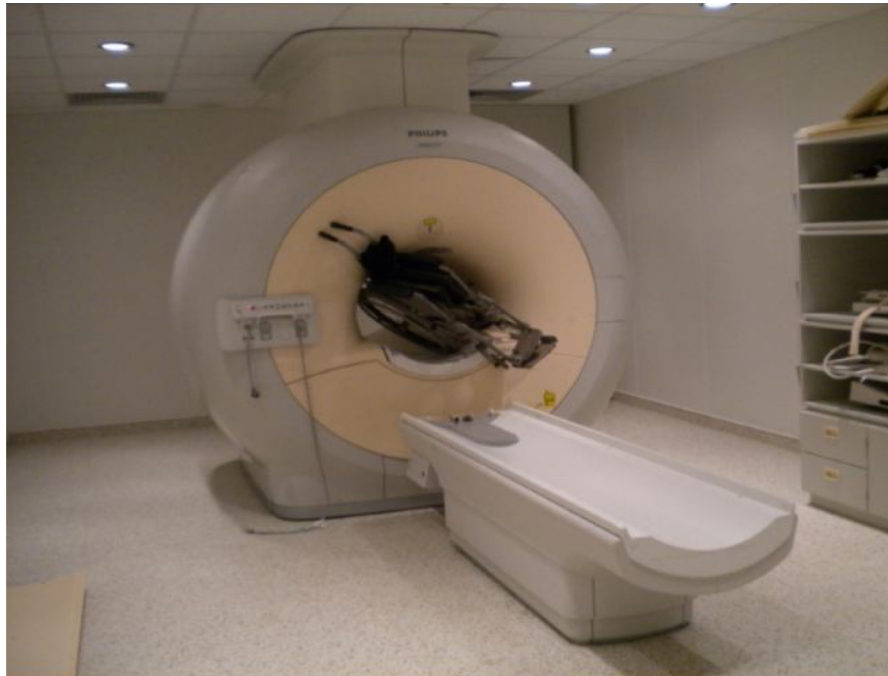
Fig. 1. Photograph shows a wheelchair pulled into the bore by the strong magnetic force of the MRI Scanner at the Korle Bu Teaching Hospital in Ghana, From “Assessment of Safety Standards of Magnetic Resonance Imaging at the Korle Bu Teaching Hospital (KBTH) in Accra, Ghana,” by Samuel Opoku, William Antwi and Stephanie Ruby Sarblah, 2013, in Faycal Kharfi (Ed.), *Imaging and Radioanalytical Techniques in Interdisciplinary Research – Fundamentals and Cutting Edge Applications*, InTech, CC BY 3.0 [6].

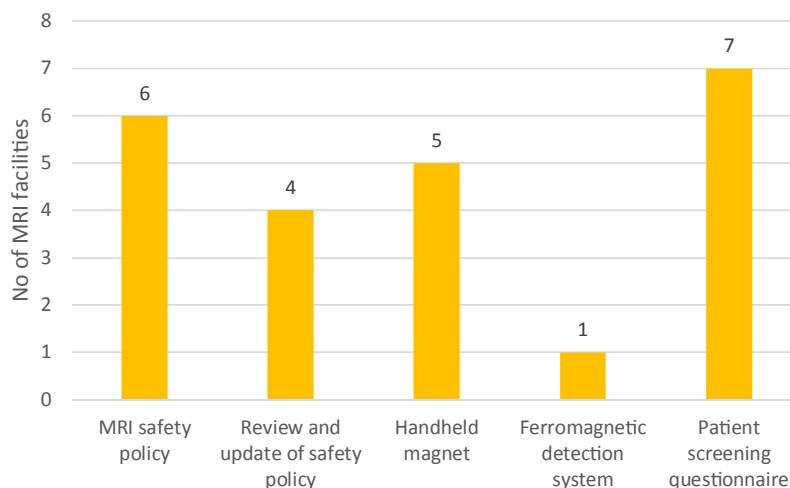
The finding that half of the respondents indicated they have MRI safety policy document, and only 4(33%) review and update it (Fig. 2) on regular basis is

**Fig. 2.** Summary of respondents' indication to availability of MRI safety policy, review and update of safety policy, and patient screening tools.

In our study, the use of patient screening questionnaire (Fig. 2) is most common, although not so encouraging. This result revealed that patients and non-MRI staff are likely to enter the MRI scanner room without undergoing any safety screening, thus putting them at the risk of the magnetic fields of the scanner. This was also observed by Opoku et al. [6] in their study that accompanying family members, and other clinical staff (i.e. nurses, anaesthetists, medical doctors) were not subjected to mandatory screening apart from taking out their metallic possessions on their own volition before entering the scanner room. In the same study, the authors [6] reported that apart from patients completing the MRI screening form, metal detector screening coupled with visual observation was the only form of screening that was done at the unit. It is also noted that the inappropriate design feature of an MRI suite can be a hindrance to effective safety screening practices [6]. It is well established that most MRI-related incidents have been due to deficiencies in screening methods and/or a lack of properly controlled access to the MRI suite [9]. The importance of employing standardized screening form, visual observation, and the use of ferromagnetic detection system are critical for the identification of materials that may be potentially harmful to patients and other individuals that may be within the environment of the static magnetic fields [10]. Even though handheld magnets are currently in use as an adjunct screening tool, their use is dissuaded in current practice as they are limited in differentiating between ferrous and non-ferrous materials, and their inability to detect very small ferromagnetic materials that may cause injury [2]. Currently, ferromagnetic detection systems are recommended as they are simple to operate, and capable of detecting small ferromagnetic objects external to the patient [5, 11]. In a review of the FDA's MAUDE (Manufacturer and User Facility Device Experience) database,

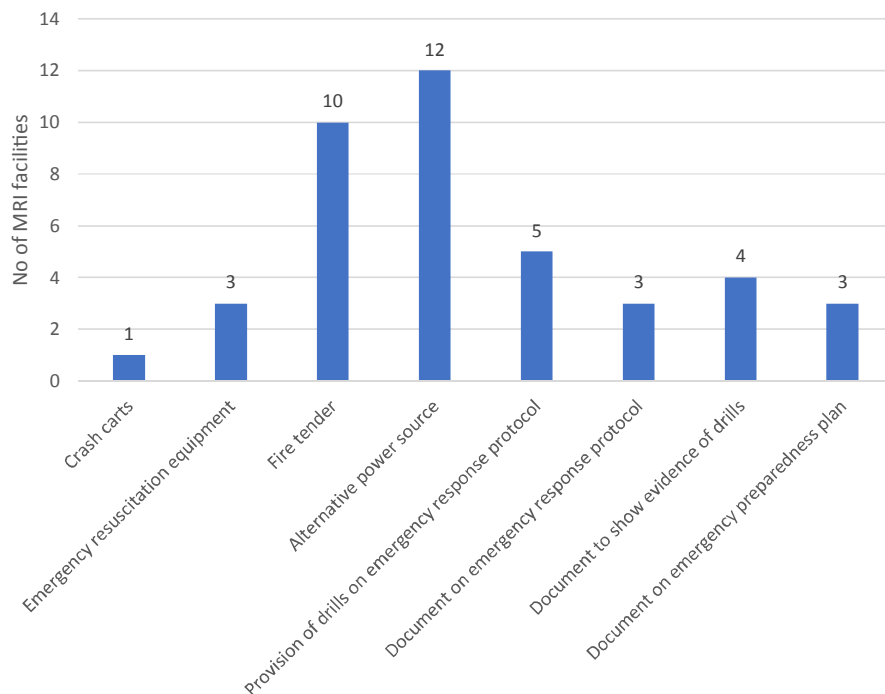
With regards to the availability of accessories for emergency preparedness, most respondents indicated they have fire tender, and other source of power in case of outage (Fig. 3). However the low availability of MRI-compatible crash carts and emergency resuscitation equipment within the MRI suites is appalling. Occasionally, patients with unstable health conditions undergo MRI, and emergency situations may occur within the MRI environment, which often includes reactions to MRI contrast agents, sedation, and anaesthesia. This situations warrants the need for resuscitation equipment with emergency medications within the vicinity of the MRI environment, particularly in either Zone II or Zone III as emergency events are difficult to access and respond to when patients are within the magnet bore [3, 5].

We noted that majority of the respondents indicated they lacked drills on emergency response protocols which is supported by their lack of documents to show for it (Fig. 3). Indeed, in a survey of MRI sites conducted by the Veteran Administration's Office of Healthcare Inspections in the United States of America to determine whether facilities ensured safety in MRI in accordance with Veterans Health Administration, it was reported that out of 50 MRI suites in 43 facilities, only 24(48%) conducted emergency response drills, 22(44%) conducted medical or

Fig. 3. Summary of respondents' indication of availability of accessories for emergency preparedness, and documentation on drills.

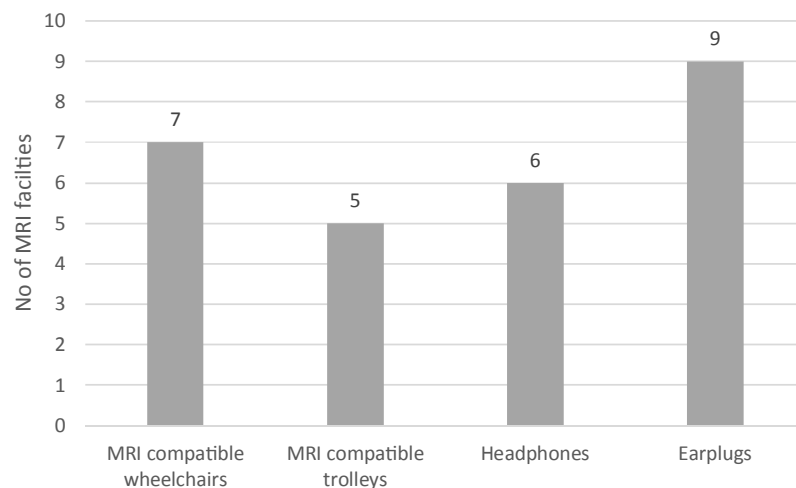
It is important that MRI suites readily have MRI compatible accessories to ensure any untoward situation within the MRI environment. Our study revealed that most facilities have earplugs, and compatible wheelchairs; however most lacked MRI compatible trolleys, and a half indicated they lacked headphones (Fig. 5). The non-availability of MRI compatible trolleys in more than half of the facilities of respondents may pose some challenges when there is the need to transport non-ambulatory patients from ferromagnetic trolleys and wheelchairs to the MRI couch. Patients that are wheelchair bound due to their condition may be helpless when they need to be transported to the scanner room. In such situations, patients have had to be supported by staff to the changing room and the scanner room, a situation which may result in more harm to the patient. The use of hearing protection materials i.e. disposable ear plugs and close fitting headphones is

Fig. 5. Summary of MRI safety accessories.

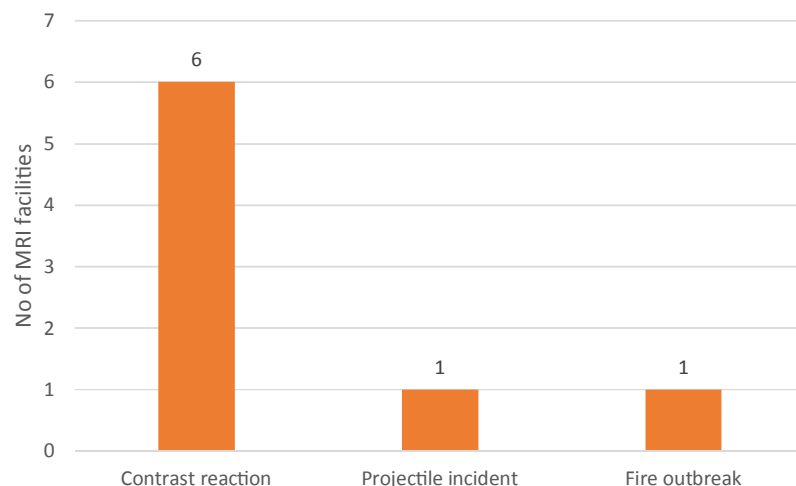
In finding out reports of MRI-related incidents in this study, contrast reaction occurred more frequently. Other reports were projectile incident and fire outbreak (Fig. 7). Gadolinium-based contrast agents are routinely used in many MRI studies used to improve tissue contrast in MRI. Although initially thought to be extremely safe compared with alternative contrast agents, several studies have raised concerns regarding their safety. Administration of gadolinium contrast agents to patients may cause nausea, headache, and severe allergic reactions [18]. Nephrogenic systemic fibrosis, a rare multisystemic fibrosing disorder which has been widely reported in the medical literature has also been found to be linked with the use of GBCAs in patients with renal impairment, noted to be most frequently associated with gadodiamide, a high risk GBCA. Coincidentally, in a recent Ghanaian study on the use of GBCAs, the authors reported that gadodiamide accounted for more than half of first line agents thus it has the largest market shares in Ghana [21]. GBCAs can also cause acute kidney injury, especially at high doses

Fig. 7. Summary of Report of adverse incidents.

With regards to report of adverse effects, only one projectile incident and fire outbreak were reported. It is acknowledged that the most significant known danger working around a strong magnet is the risk associated with the attraction of ferromagnetic devices and equipment to the magnet causing them to become projectiles [3]. Projectiles can lead to injury or even death, high cost equipment damage, and loss of imaging time [24].
