# JSES Reviews, Reports, and Techniques

# Humeral socket decoupling from the stem causes mechanical failure of a reverse shoulder prosthesis. A case report

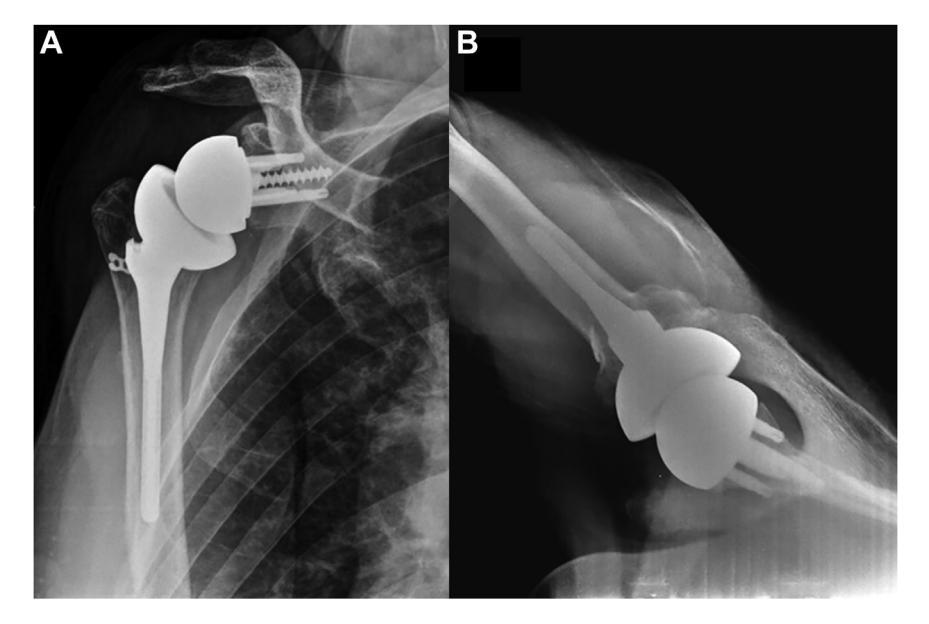
Figure 1 Six months follow-up X-rays of first RSP. Anteroposterior (A) and axillar (B) projections of the right shoulder show the correct initial position of both humeral and glenoid components of the reverse shoulder prosthesis. *RSP*, reverse shoulder prosthesis.

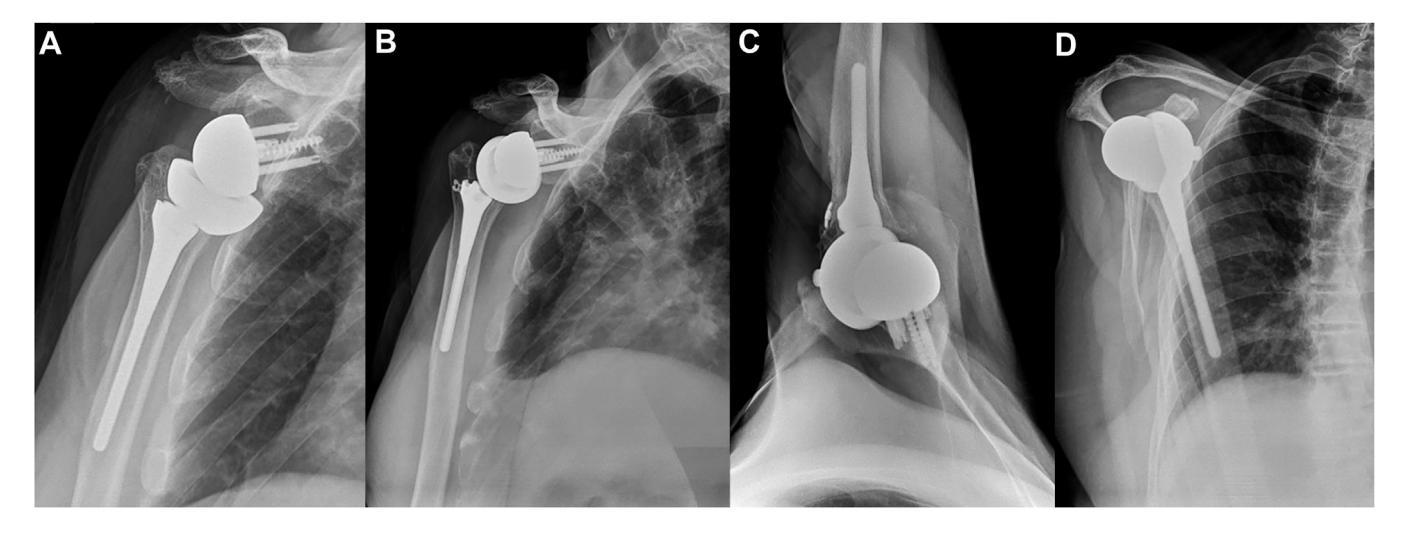
and a positive external rotation lag sign. The anteroposterior, lateral, and axillar X-ray views showed the prosthesis's failure of the HC with the humeral socket out of contact with the stem but still articulating with the geosphere (Fig. 2).

Figure 2 Implant failure X-rays. Anteroposterior (A and B), axillar (C), and lateral (D) radiographic views of the right shoulder display a variation in the position of the humeral socket with rotation on its axis.

In our case, the clinical presentation was very florid, with intense pain and functional disability, yet the etiologic mechanism was not precise. At the x-rays, it was evident that the hole humeral socket was still attached to the tray and taper, but it was separated from the stem and rotated on its axis.

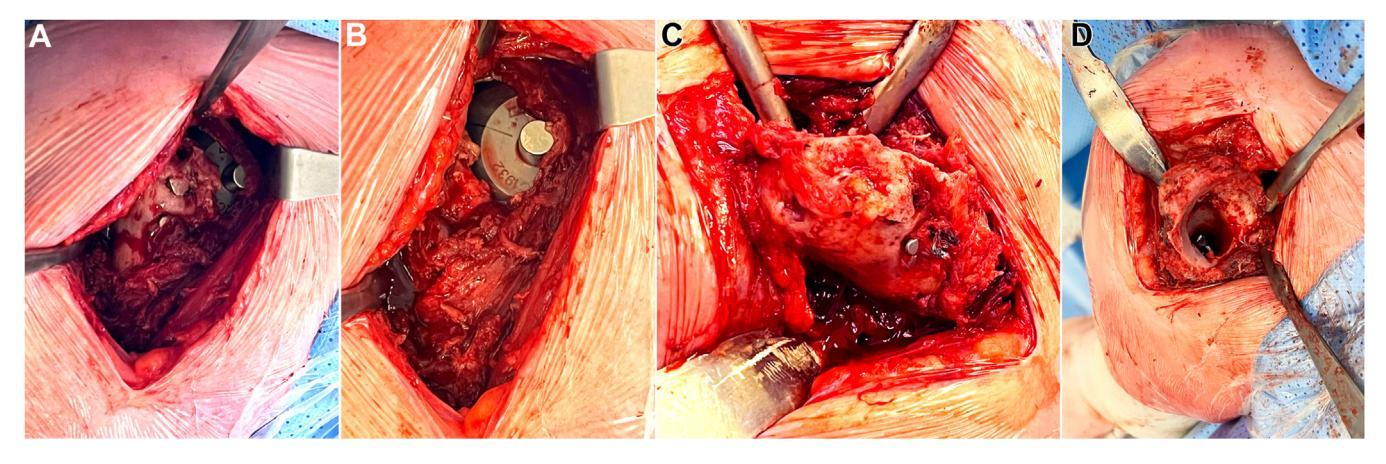
Figure 3 Surgical views of the decoupled humeral socket. Images (A) and (B) show the humeral socket decoupled from the stem, exposing the Morse taper. Pictures (C) and (D) depict the humeral bone and canal without bone defects or macroscopic signs of infection. The latissimus dorsi transfer fixation button previously performed with the rTSA appeared in place and intact. *rTSA*, reverse total shoulder arthroplasty.

The revision surgery went without complications. Even though there were no signs of loosening during the procedure, the HC was removed for further evaluation and to obtain samples for cultures. The same deltopectoral approach through the incision of the index procedure was used, finding that the humeral socket was loose and rotated on itself (Fig. 3). Causes such as an active infection through negative cultures (joint fluid, capsular membrane, humeral canal membrane, shoulder membrane, and humeral bone) or bone defects were ruled out. The new HC comprised a 7-mm stem attached to antibiotics-loaded cement, a 4+ humeral socket, and a 36 semiconstrained insert. The glenoid component (GC) was intact and stable.

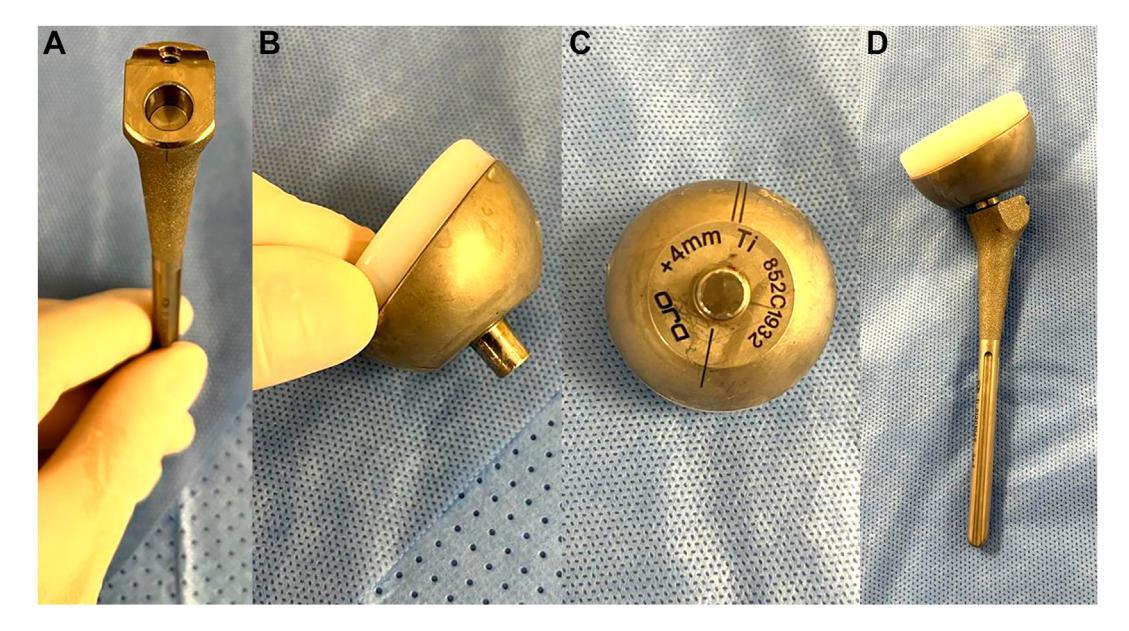
Once the failed HC was retrieved, it was noticed that the complete humeral socket was decoupled but not fractured from the stem; the manufacturer's representative inspected the HC (socket and stem) to analyze the cause of the decoupling. There were no mechanical implant failures or signs of overload, as the components appeared intact (Fig. 4).

Like the findings of McDonald et al,<sup>20</sup> in our case, the visual inspection of the retrieved components showed no signs of wear,

overload, cracks, or fracture lines at the socket-stem or tray-taper interfaces or metallic debris or glenoid notching.

We speculate that, in the absence of trauma, the HC failure of the Morse taper implant in our patient at nearly 1 year of the rTSA could likely be caused by a manufacturing deficiency or a technical or human error during the surgical procedure, such as some barrier preventing the correct assembly of the parts of the HC or low impaction force at the socket-stem union. However, the presence of a barrier is unlikely, as the surgeons would have noticed it. The manufacturer representative was present during the revision surgery and notified the headquarters; by the time of submission of this report, a response from the manufacturer had not been received.

Figure 4 Retrieved humeral components of the RSP: Stem (A), socket (B and C), and assembled component (D). Humeral components showed no signs of mechanical failure in the Morse taper or polyethylene wear. RSP, reverse shoulder prosthesis.

To overcome these potential errors, we suggest the surgeon always check the impaction and verify that the humeral module composed of stem and socket does not move after impaction; this should be part of the procedure checking list. In our setting, the manufacturer representative enters and participates in the surgery and is usually in charge of the impaction. We advise the surgeon to double-check this part of the procedure customarily.

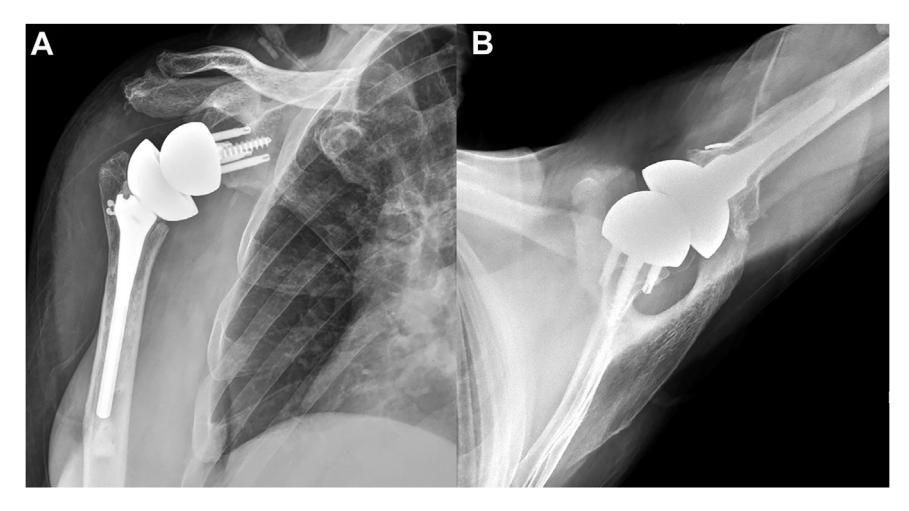
From the early POP evaluations, the patient showed functional recovery to the levels achieved before the implant failure. Eighteen months after the index surgery and 6 months after the revision procedure, the patient reported occasional pain visual analog scale 2 in the right shoulder that, at physical examination, showed an elevation of 130°, external rotation of 45°, and internal rotation to T10. The follow-up radiographic views show the implant and all its components in place and fully articulated (Fig. 5).

Figure 5 Twenty-four weeks follow-up X-rays of revision surgery. Revision follow-up anteroposterior (A) and axillary (B) radiographs of the cemented humeral component showed recovery of the position and reference parameters in all the projections.
