Research article

Degradation and performance analysis of a monocrystalline PV system without EVA encapsulating in semi-arid climate

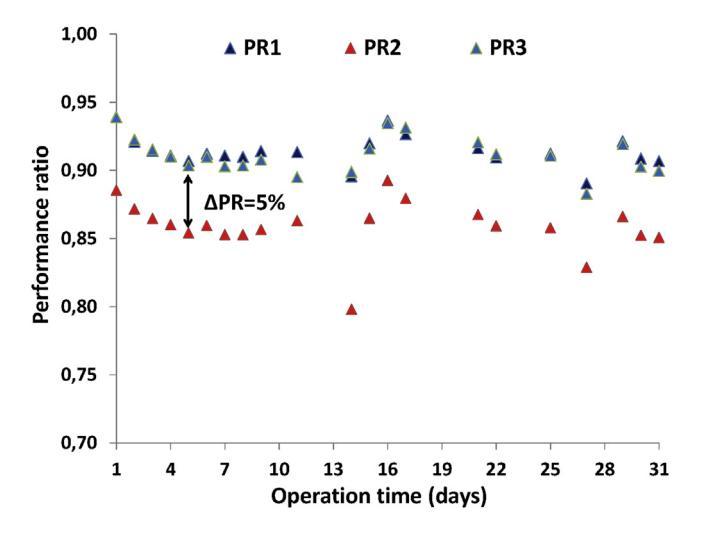
Figure 6. Performance ratio difference between investigated strings in December 2017.

values of the three strings was calculated and plotted in Figure 6. Here again we can clearly notice that the PR of the 2^{nd} string is much lower in comparison to the other strings. Indeed, the daily average difference is around 5% in comparison to both other strings. This deviation can reach 13% especially under clear sky conditions. As for the 1^{st} and the 3^{rd} strings, we can clearly notice that they produce electricity with almost the same performance, with a slight deviation of +/-1%.

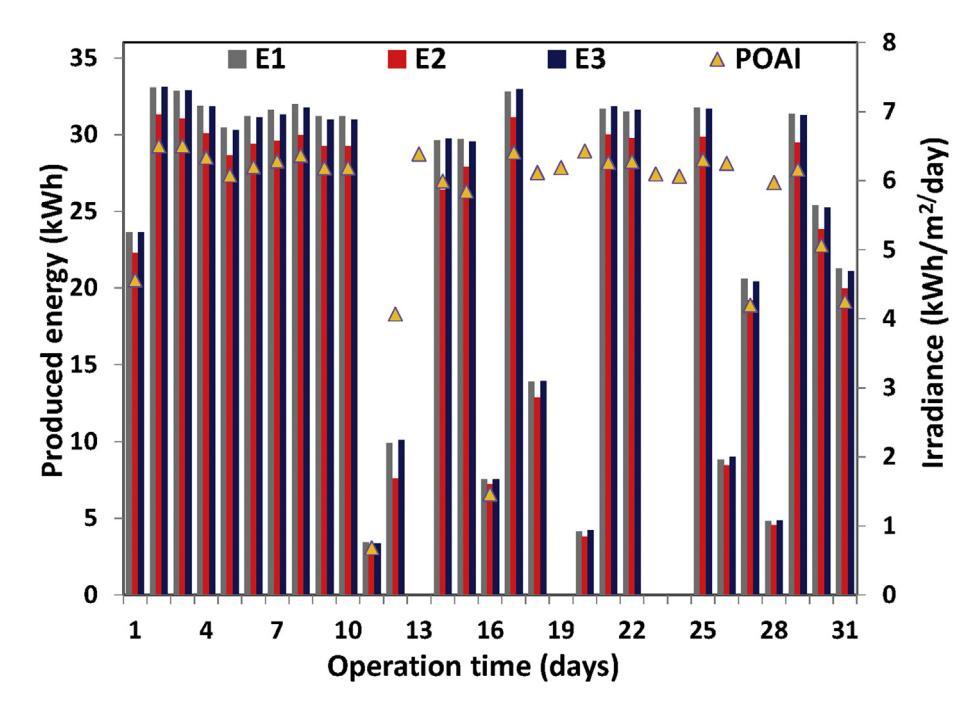
Figure 5. Daily energy of the three strings in December 2017.

December 2017, we noticed that the production of the 2^{nd} string is lower than the other two left. As it can be seen in Figure 5 the 2^{nd} string always provide less energy than the 1^{st} and the 3^{rd} regardless the sky conditions. Indeed, for a sunny day (*e.g.*, Day 3 of December) the energy produced by the 1^{st} and the 3^{rd} strings were of 32.83 and 32.87kWhe respectively, while, the 2^{nd} one produced an energy of 31.05 kWhe, which is lower by 1.8 kWhe than the others. Correspondingly, for the cloudy days (*e.g.*, Day 11 of December) the energy generated by the 2^{nd} string was of 3.25 kWhe while the 1^{st} and the 3^{rd} produced 3.44 and 3.4 kWhe respectively. Here again, the production by the 2^{nd} string is lower than the other strings by around 0.25kWhe. We need to mention that the system was nonoperational on the 13^{th} , 19^{th} , 23^{rd} and the 24^{th} because we disconnecting it in purpose for conducting indoor IR and IV-curve measurements.

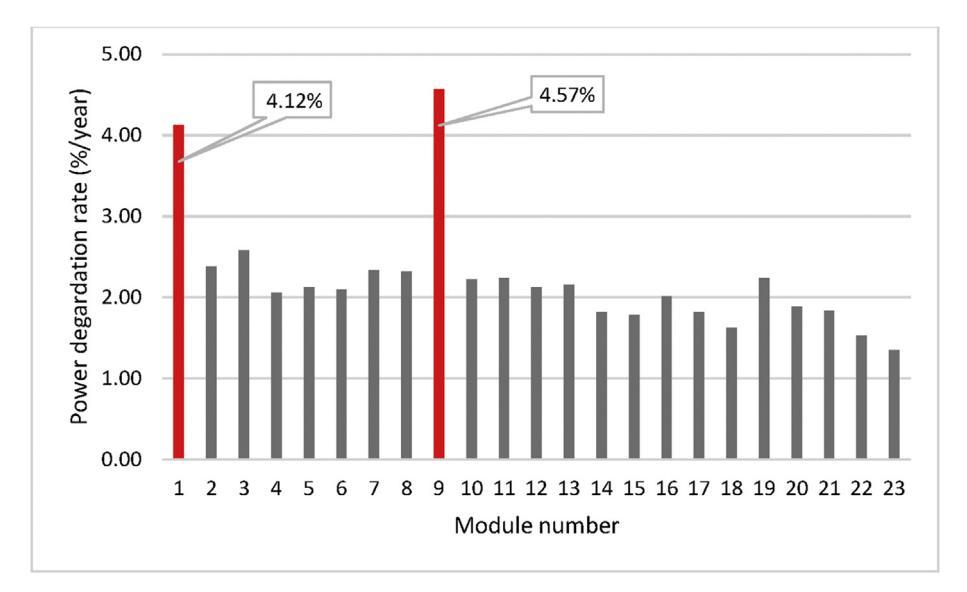
Figure 7. Power degradation rate for each individual photovoltaic panel of the 2nd string.

To detect which are the modules with the highest performances drop, and to quantify the degradation rates of their electrical parameters, the I-V curve tracer has been used. Figure 7 illustrates the degradation rate of the power output measured for each module of the 2^{nd} string. As it can be seen, after three years of exposition, the power drop is of 2% in average for all modules. Whereas, the 1^{st} and the 9^{th} modules are the most degraded ones with a drop in the power of 4.12% and 4.57% respectively.

The power degradation rate was of 4.57%/year in the modules with breakage and cracks. This drop in the power is mainly due to the drop on both the Im and Vm with 0.84 and 1.14%/year respectively.

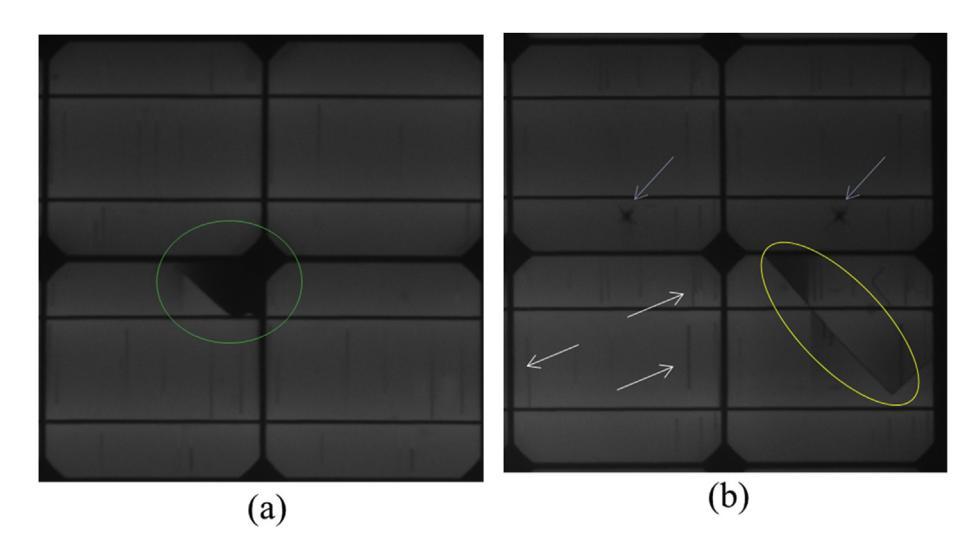
Figure 8. Cracks and breakages in some cells of affected PV modules. (a): cell breakages; (b): white line.

interruption in the cells. In order to detect the source of error in the modules 1 and 9, EL images have been taken (Figure 8). As it can be seen, reveal inhomogeneous EL emission, where several breakages cracks gridline interruption and shunt area are detected. Some of these defects isolate a part of the cells and decrease their efficiency, consequently their power output.

Indeed, the resultant power loss is strongly dependent of the defect patter such as size, geometry and orientation. These cracks can propagate and damage the contact fingers and resulting the development of cell breakages. This is mainly due to some problems of manufacturing and operation like cleaning events. In the EL image, these defects are easily detectable in the form of dark line perpendicular to the bus bar, which reveals the interrupted finger (Figure 8b –white line).

In turn, cell breakages (like to the one detected on, Figure 8a) causes the isolation of a part of the cell area which leads to significant current drop. The cell breakages are detected on the EL images as dark areas.

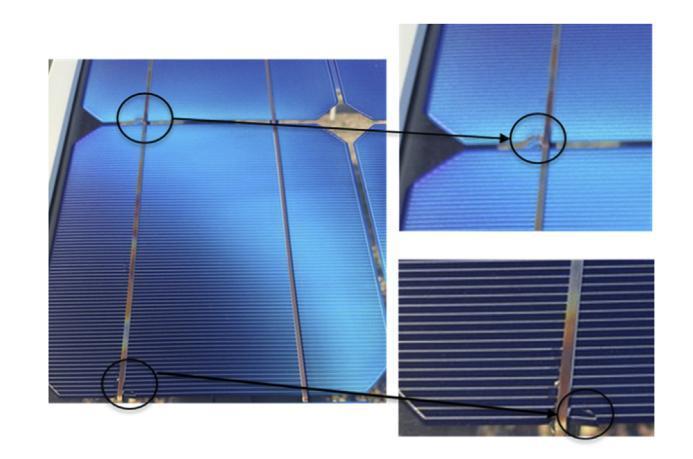
Figure 9. Visual Cracks and breakages in some cells of affected PV modules.

In the 1st and the 9th modules, the cracks of the cells can also be detected visually (Figure 9). This lead us to conclude that the power drop on these modules is mainly due to the breakage of some of their cells. This breakage is very likely due to a bad cleaning event, because we are using manual cleaning and the performances drop in the power output were recently detected.

Finally, in arid regions with high soiling rates and frequent cleaning event, we highly recommend the use of PV modules with EVA encapsulating to protect the cells against any breakage or mechanical shocks.

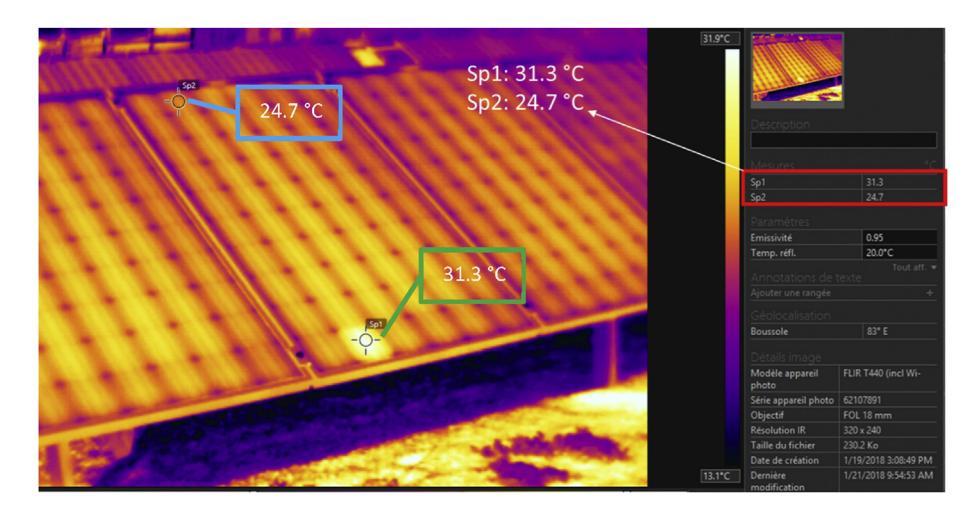
Figure 10. Infrared thermal image of PV module number 7.

Figure 10 presents an IR thermal image of a part of the 2nd string. As it can be seen, only one of the modules (the module 7) reveals a cell exhibiting a temperature difference greater than 7 °C from the neighbouring cells.

For the other modules we could not detect any hot spot. Therefore, we can say that the main source of the energy drop in our PV system is the presence of cracks and breakages in the cells and it's due to a bad cleaning and the nature of the PV modules (without EVA protection).
