Prosthetic femoral head erosion through an acetabular component treated with revision and implant preservation

Mark Daniel Kohn, MD^{*}, Navin Fernando, MD, FRCS(C)

Department of Orthopaedics and Sports Medicine, University of Washington, Seattle, WA, USA

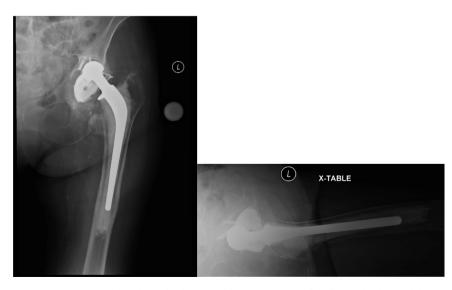
Figure 1. Anteroposterior (AP) pelvis and lateral radiograph with superimposition of the femoral head beyond the acetabulum.

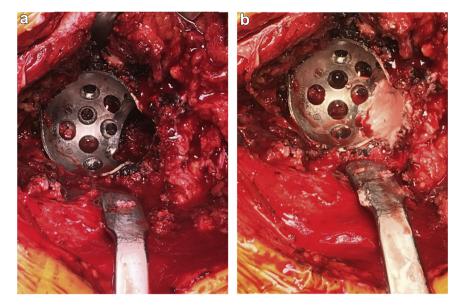
Approximately 20 percent of the cup was eroded. Given this finding, the morbidity likely involved in removing the cup, and the potential difficulty with acetabular revision given the degree of osteolysis encountered, it was felt that retention of the cup with cementation of a constrained liner would be a reasonable option. The cup was 50 mm in outer diameter with an inner diameter of

Figure 2. (a) Large erosion of the superior/posterior aspect of Harris-Galante I acetabular component. (b) Cerement bone void filler used to fill erosive defect.
